INSTITUTE FOR FISHERIES RESEARCH  
DIVISION OF FISHERIES  
MICHIGAN DEPARTMENT OF CONSERVATION  
COOPERATING WITH THE  
UNIVERSITY OF MICHIGAN

REPORT NO. 497

GENERAL OBSERVATIONS ON THE CONDITION AND EFFECTS OF  
STREAM IMPROVEMENT DEVICES IN VARIOUS UPPER AND LOWER MICHIGAN RIVERS

J. W. Leonard

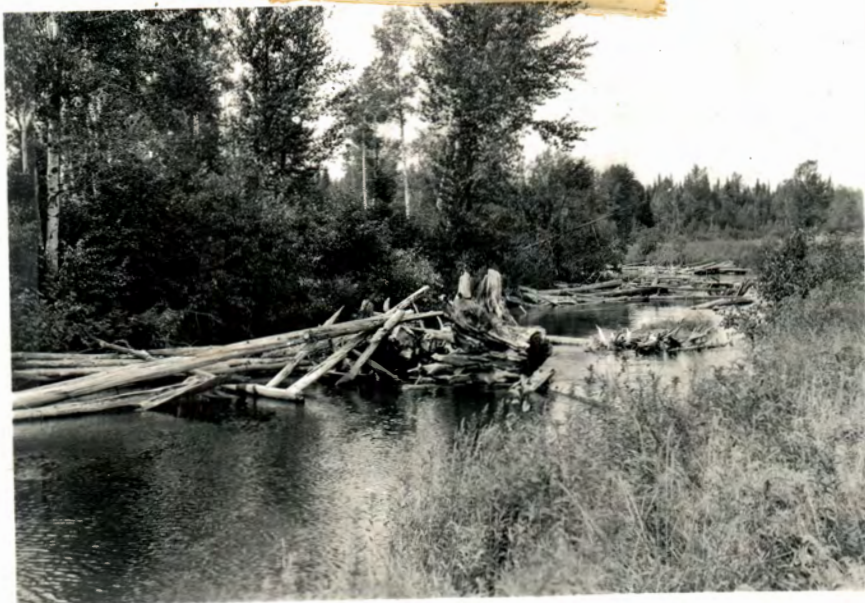
United States Park Service work in Pigeon River, "Hay field" section. Such installations cannot operate efficiently, or fulfill definite purposes, because of their lack of coordination in design, and lack of adequate moorings, which allows them to change position.

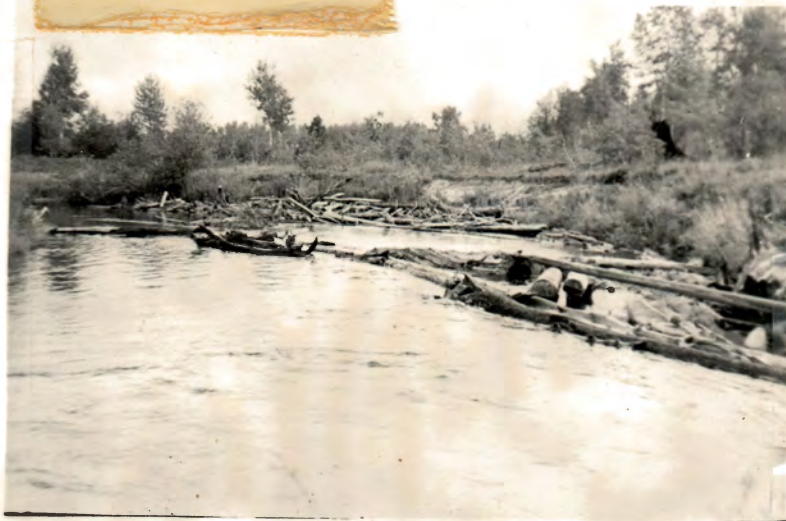
United States Park Service work in Pigeon River just below the "Vanderbilt Bridge." Such agglomerations of drift materials may be expected to partially check bank erosion and provide fish cover. These ends could be obtained, however, without blocking the channel and so impeding the fisherman and offering dangerous resistance to ice and floods.

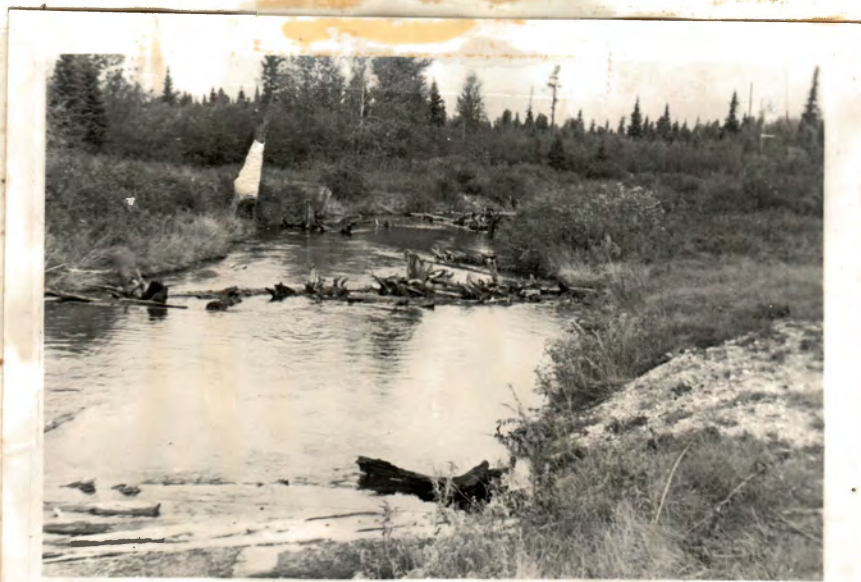
United States Park Service work in Pigeon River. Such barriers cannot be expected to withstand ice action. They make needless obstructions for the fly-caster. In this stream and others similar to it, where periodic floods and ice action are to be expected, the channel should never be completely bridged across by barriers.

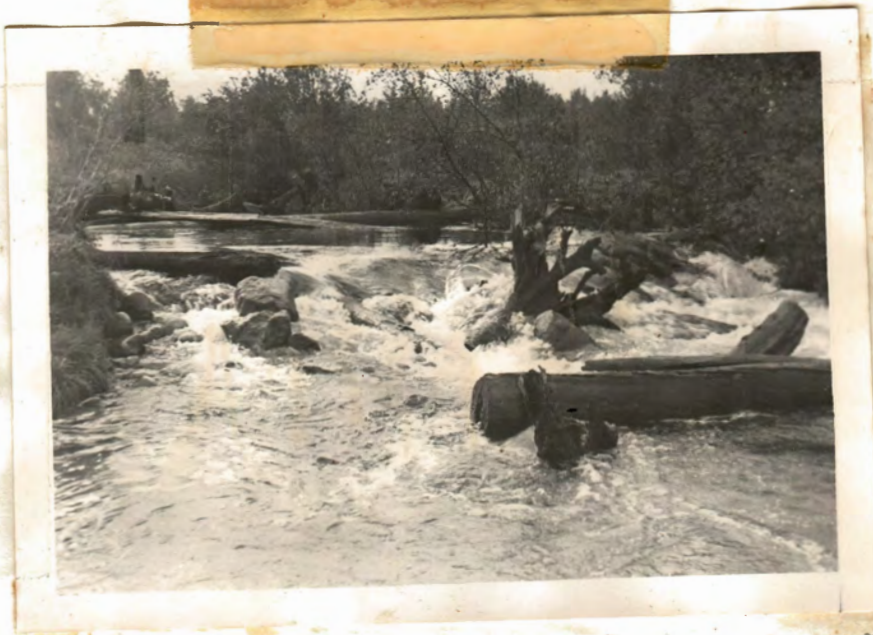
United States Park Service work in Pigeon River. A high-face dam of this type is likely to silt in and be damaged by ice action.

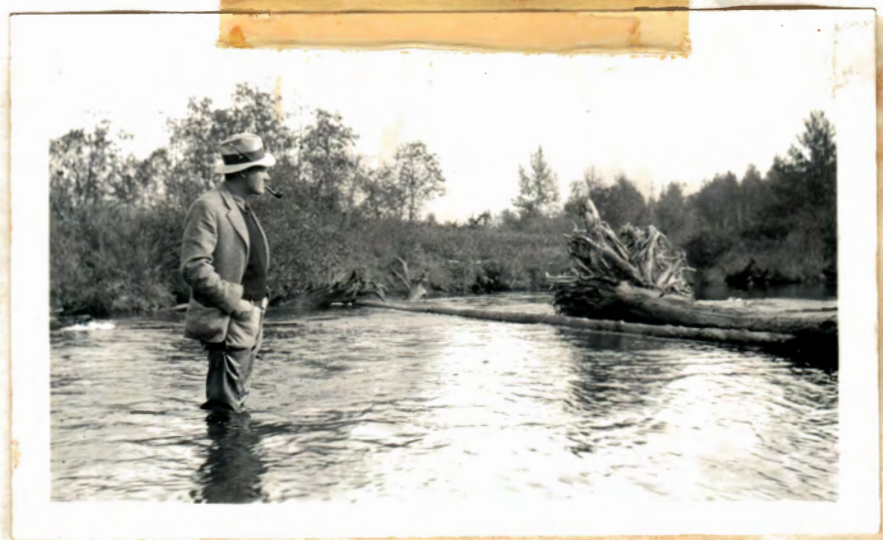
United States Park Service work in the Pigeon River. Where the water is seen to be knee deep it was formerly hip deep, due to an efficient wing deflector. The hole produced by it is filled in since the deflector was removed by the U.S.P.S. The log jam seen across the stream will cause fishermen much annoyance since it interferes with fly fishing.
