MICHIGAN DEPARTMENT OF CONSERVATION
Research and Development Report No. 93*

STABILIZATION OF AN ERODED RIVER BANK

By Clarence M. Taube

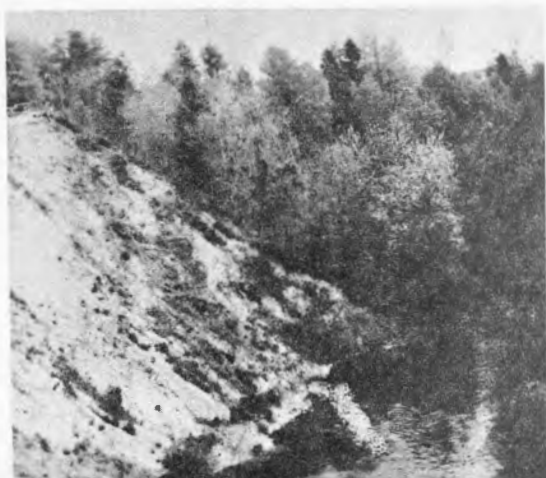
I first photographed the bank and deflector while employed as a creel census clerk on Pine River during the 1939 trout season (Fig. 1a). Other pictures of the site were taken in subsequent years. By 1964 it was apparent that the photographs told a story of the progress of stabilization.

The bank was eroded and bore very little vegetation in 1939 (Fig. 1a). A picture taken eight years later (Fig. 1b) shows marked improvement and that the spread of plants was mainly downstream from the vicinity of the deflector. Some invasion had also occurred below the rim on the downstream side of the bank, the side most resistant to stabilization.

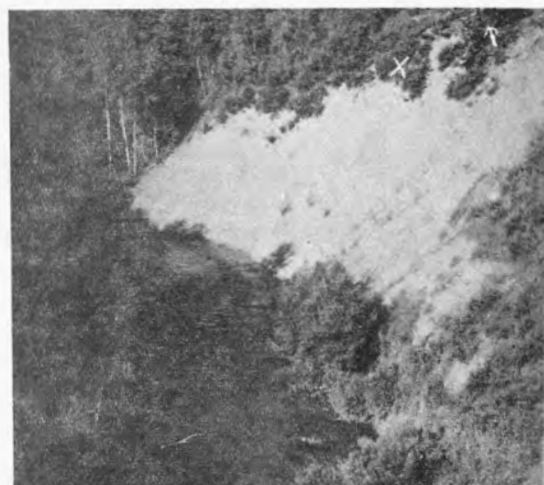
b

A photograph taken of the bank in 1938 is on file at the Institute for Fisheries Research. Besides suggesting that some vegetation may have been planted on the slope, this picture shows log-supported terraces on a small area, which probably were constructed when the current deflector was installed. The location of the terraces is not included on my 1939 photograph (Fig. 1a), but it appears in the 1947 photograph and is marked with an x (Fig. 1b).

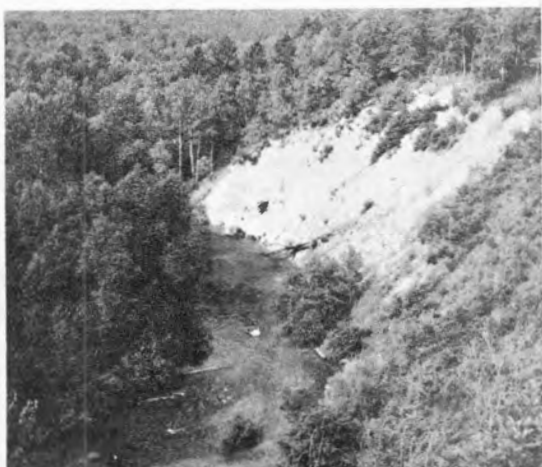
c

Vegetation appreciably extended its coverage during the next three years (Fig. 1c), but also further erosion occurred. On the resistant area, some of the shrubbery apparent in Figure 1b is absent in Figure 1c. Also, a red pine (Pinus resinosa) that stood on the brink in 1947 (an arrow on Figure 1b points to the base of the trunk) was gone by July 1950; what likely were its remains lay at the base of the slope (Fig. 1c).

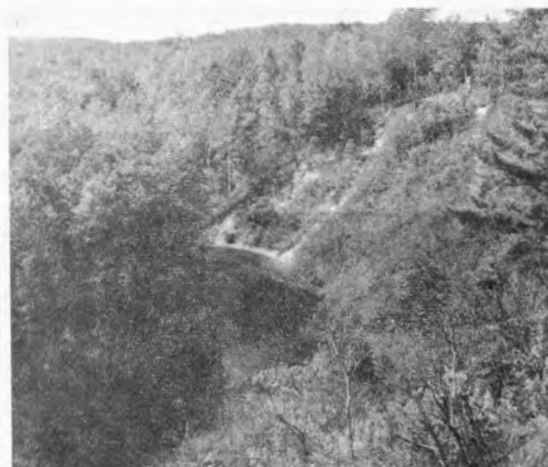
d

Vegetation covered much of the bank by 1964, even on the retarded area (Fig. 1d).

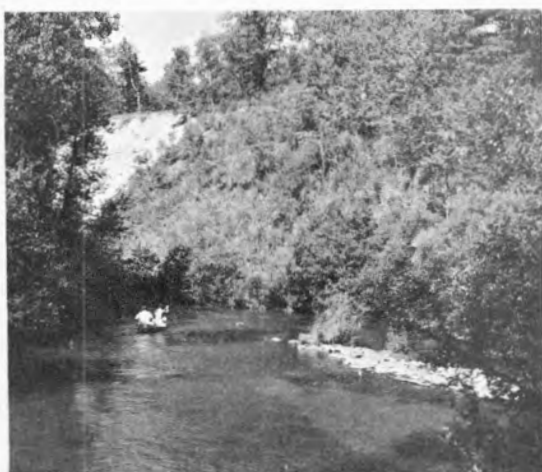
e

In August 1966, I took more photographs and examined the bank in some detail. Stabilization of the downstream side of the slope had suffered a recession. A strip of bank was denuded from top to bottom, and much of the sand had gone into the river (Fig. 1e). People sliding down the slope evidently caused most of the damage. The bank is on a public access site which is used by canoeists and tourists as well as fishermen.

Hindsight suggests that stabilization of this bank could have been hastened by additional practices, such as (1) providing a deflector

immediately upstream from the resistant area, (2) riprapping the base of the incline with rock, and (3) planting vegetation to augment natural seeding. Protecting the bank from foot traffic with fencing would also have brought about quicker and more permanent stabilization.

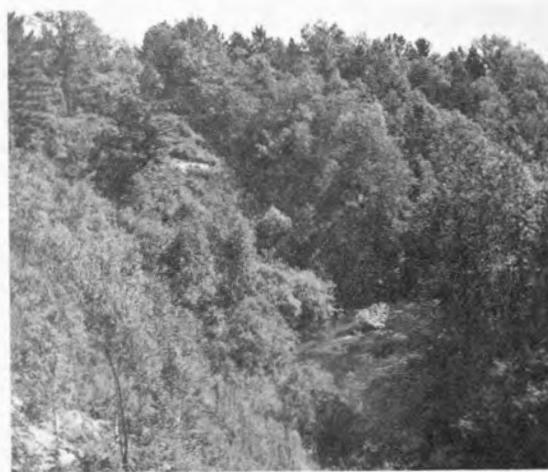
f

The progress of stabilization was excellent upstream from the "slide" (Figs. 1e and 1f). Some 20 species of the more prevalent terrestrial plants were noted. No one species was distinctly dominant, but goldenrod (Solidago sp.) was especially conspicuous. Several grasses were present. Although abundant on the upland, bracken (Pteris aquilina) and sweet fern (Myrica asplenifolia) were scarce on the bank. Shrubs included alder (Alnus sp.), willow (Salix sp.), sumacs (Rhus typhina and R. copillina), wild grape (Vitis sp.), prickly ash (Zanthoxylum americanum), hawthorn (Crataegus sp.), black raspberry (Rubus occidentalis), blackberry (Rubus sp.), and wild rose (Rosa sp.). (Besides anchoring the soil, the briary shrubs doubtless also discourage foot traffic on the slope.) The trees were mainly black cherry (Prunus serotina), black locust (Robinia pseudo-acacia), and three species of poplar--Populus tremuloides, P. grandidentata, P. balsamifera. Quaking aspen (Populus tremuloides) and shrub-size black locust were most abundant.
