**2016 BELLE ISLE
COMPREHENSIVE
HYDROLOGIC
ASSESSMENT**

In response to tasks 2A and 2B of the Lake Okonoka Habitat Restoration project, this report aims to gain an understanding of the current hydrology on Belle Isle specific to the +/- 200 acre natural area referred to as the wet-mesic flatwoods forest (flatwoods).

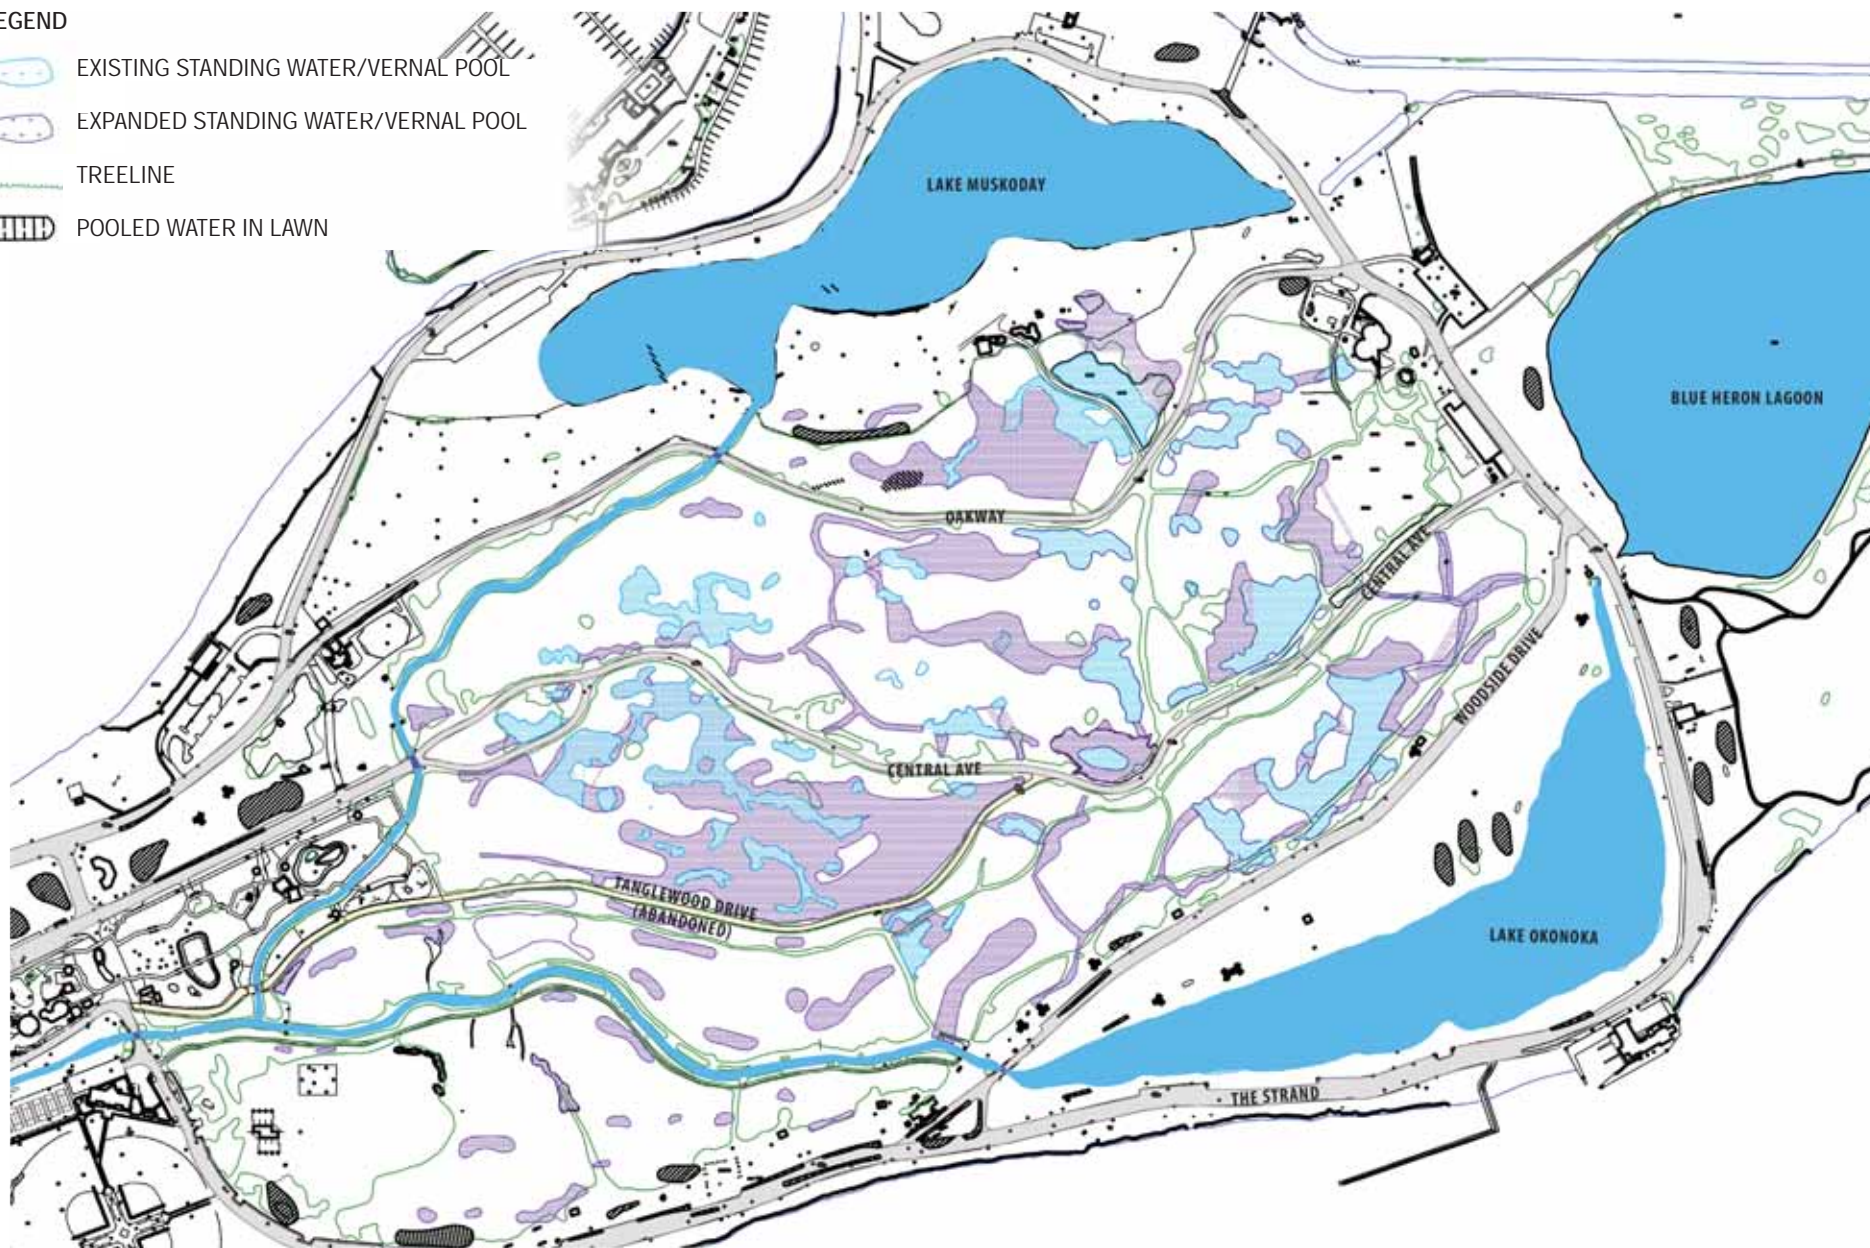
Figure 4. Forest Hydrology-Pools

General observations of the pools indicate that some areas currently are holding too much surface water, while others are not holding enough and that the causes vary based on location within the site. Pools that appeared to be in balance included water adapted tree species with flared collars (*buttresses*) at water- or ground-level and the absence of understory vegetation. This is an indication of a persistent condition that may have extended back to the late 1800's before park construction. At pools where excessive water was present, some tree species were under stress or dead, remaining trees did not appear to have flared collars and persistent standing water was observed through late summer and early fall. The understory was

observed to be dense with large colonies of ash (*Fraxinus spp.*), maple (*Acer spp.*) seedlings or spicebush (*Lindera benzoin*) suggesting that this condition is more recent. Areas that were excessively dry contain no standing water, even though topography suggests that it should and ditching appears to be the cause of this condition. Tree health was considered good but Amur honeysuckle (*Lonicera maackii*) was observed to be the most abundant understory species and is an upland species that may have taken hold due to draining.

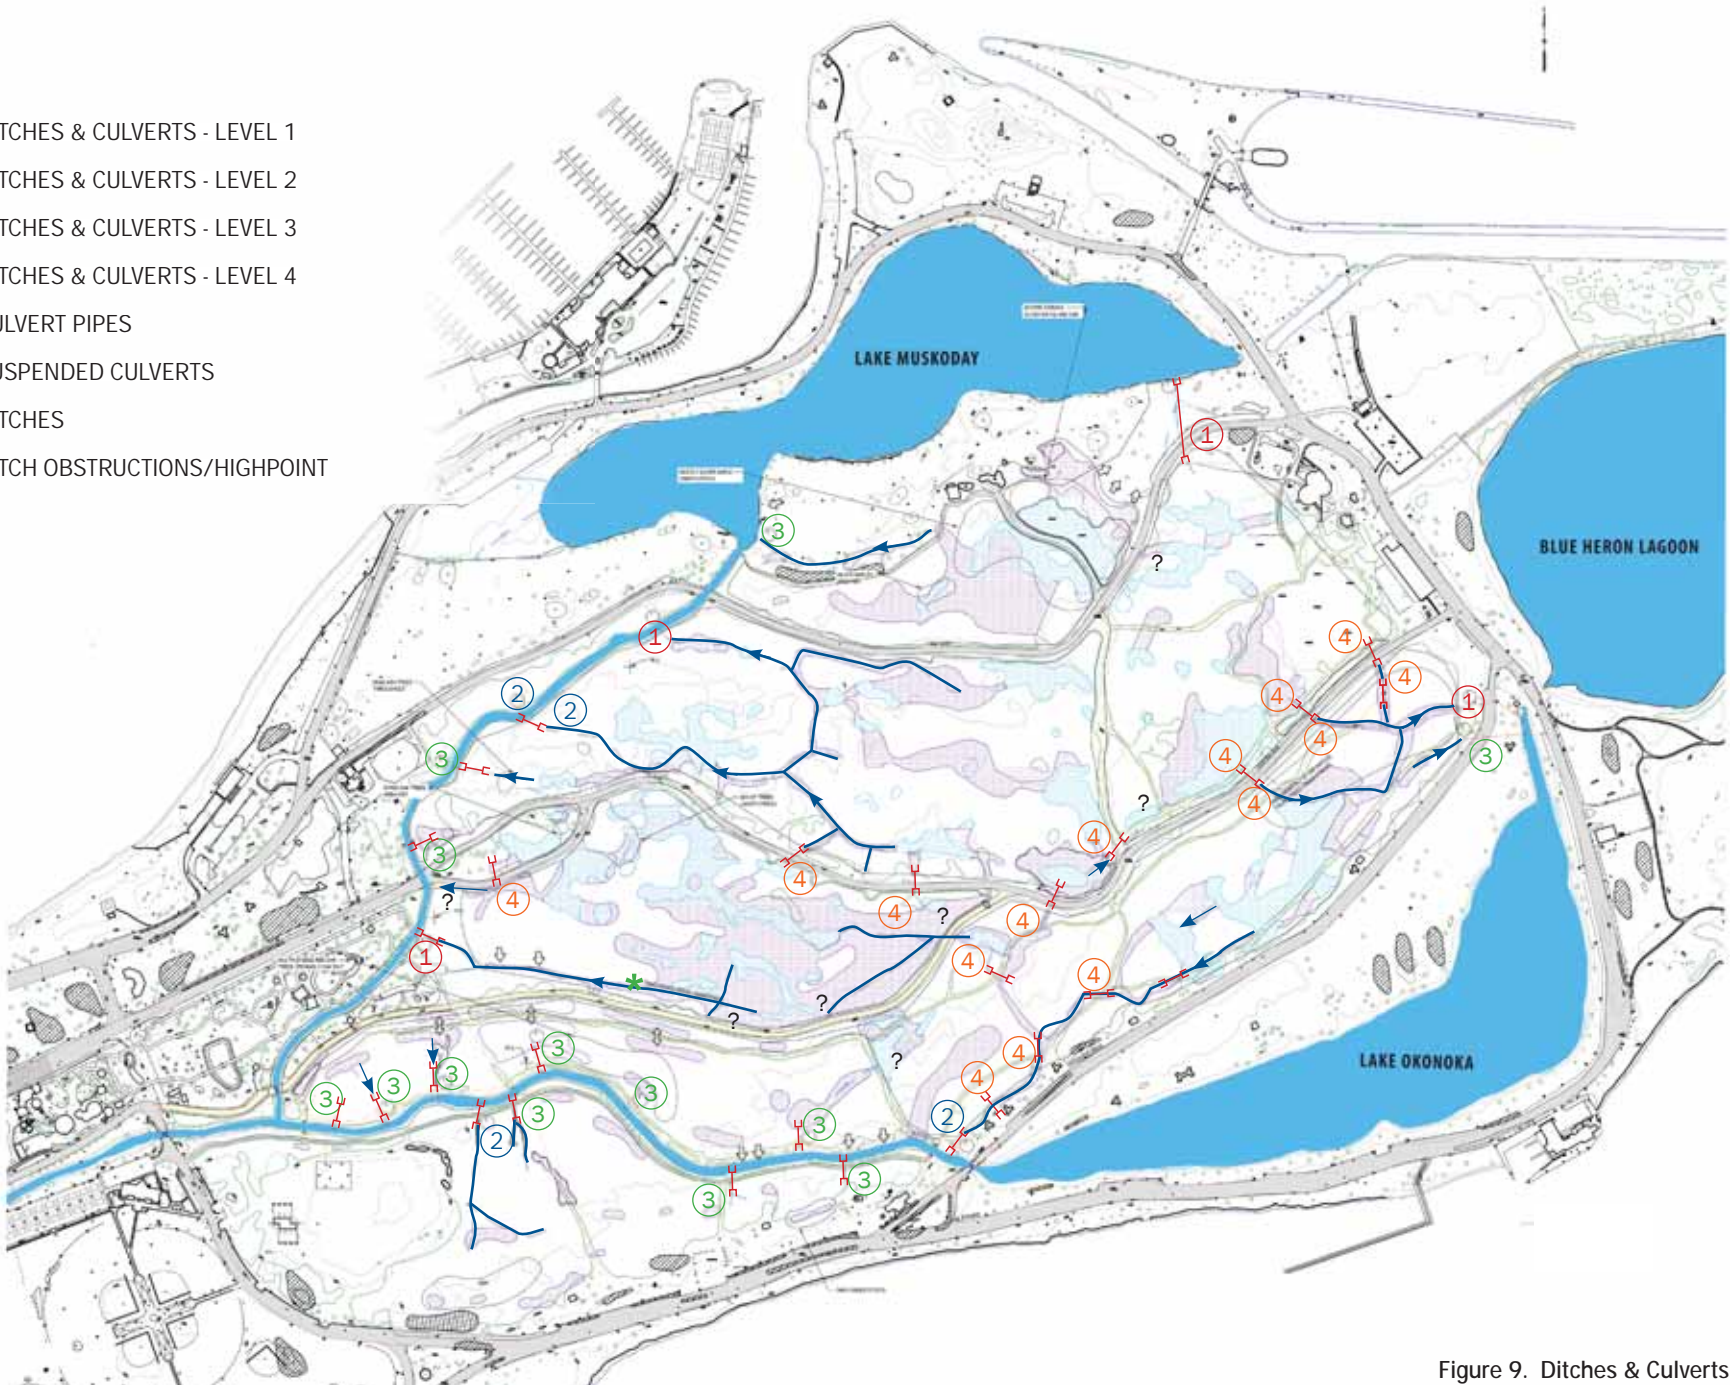
Figure 9. Ditches & Culverts

deepest and widest, have a well-developed network of lateral ditches and/or serves as the only outlet for that area. Three of the outlet culverts are located in some of the lowest topographic elevations within the flatwoods and somewhat follow the historic drainage patterns. The fourth ditch adjacent to Safari Zoo actually reverses the direction of the historic flow and discharges into Sylvan Canal. The impacts on pool development within the influences of the ditching is clear. Pool development is almost non-existent except within the actual banks of the ditches and ponding water is only evident during spring runoff. The level 1 underground storm sewer system draining the flatwoods to Lake Okonoka will be removed as part of the work associated with the habitat enhancements and will be converted to overland flow.

The reminder of the level 4 pipes are associated with historic bridle trails and are now abandoned and overgrown with mostly honeysuckle or fallen ash trees. In these locations, small diameter pipes were either placed on top of existing grade and fill placed above, or they were partially embedded into the soil with ditching similar to what was observed along Central Avenue. In several instances, either the trail has been washed out rendering the pipes non-functional, or the pipes are mostly plugged with soil causing larger pools to form that would otherwise be dry.

- Remove all culvert pipes and fill all ditches to match adjacent grades. Where soil is windrowed from original excavations, use this soil as backfill. Under certain conditions, ditches may have to remain as part of preserving the canals but will require control structure(s) to regulate the pools being effected by said ditches.

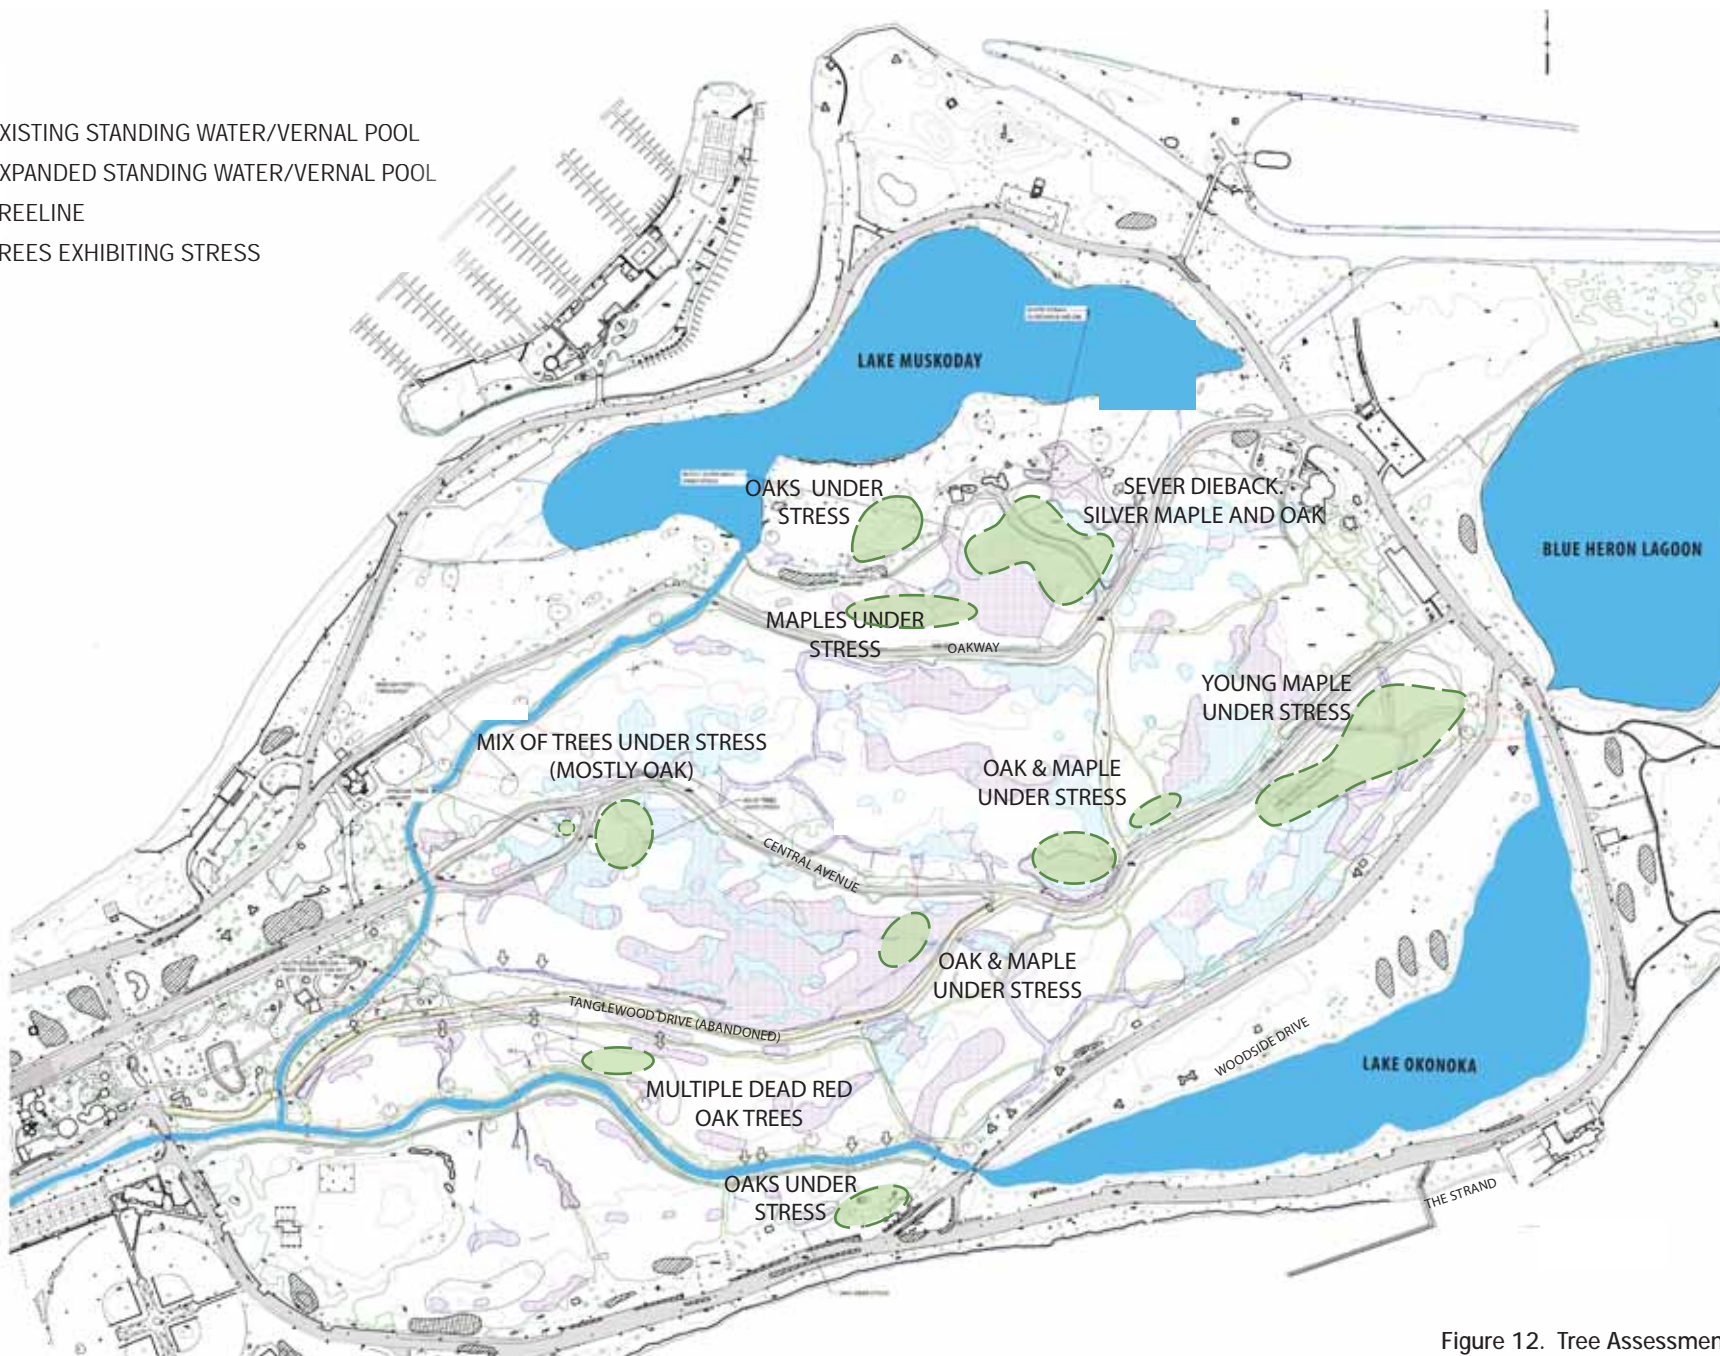
Figure 12. Tree Assessment

- During the growing season, canopy conditions were visually evaluated for health and vigor, and it became clear that a number of oak species and some maple species are under varying stages of decline or dead. This was mostly attributed to the presence of prolonged standing water (Figure 12). These locations are described in greater detail in the *Flatwoods Enlargement Analysis* section.
- In late-summer, at the onset of plant dormancy, most of the trees shown in Figure 12 are identified as being under stress and were experiencing early dormancy (approximately 2 weeks ahead of the healthier stand of trees, even though many of these areas no

- Historical canopy cover of the flatwoods was defined as a closed canopy. Today several locations are now considered semi-open to open canopy. This condition has allowed sunlight to penetrate to the forest floor encouraging dense growth of understory vegetation including the invasive species reed canarygrass (*Phalaris arundinacea*), amur honeysuckle (*Lonicera maackii*), and common buckthorn (*Rhamnus cathartica*) among others.
- Today, 100% of the three ash species have succumbed to the emerald ash borer including the 28 state-threatened pumpkin ash (*Fraxinus profunda*).
- Fallen trees have blocked ditches in at least three locations, increasing the amount of ponding trapped behind the obstructions.
- Reduced transpiration could be linked to increased pool size.

- Establish a tree planting program using Belle Isle genotypes to replace lost ash trees where existing trees are not recolonizing. Ideally, more oak species would be introduced since silver maples are the dominant species and are generally performing well.

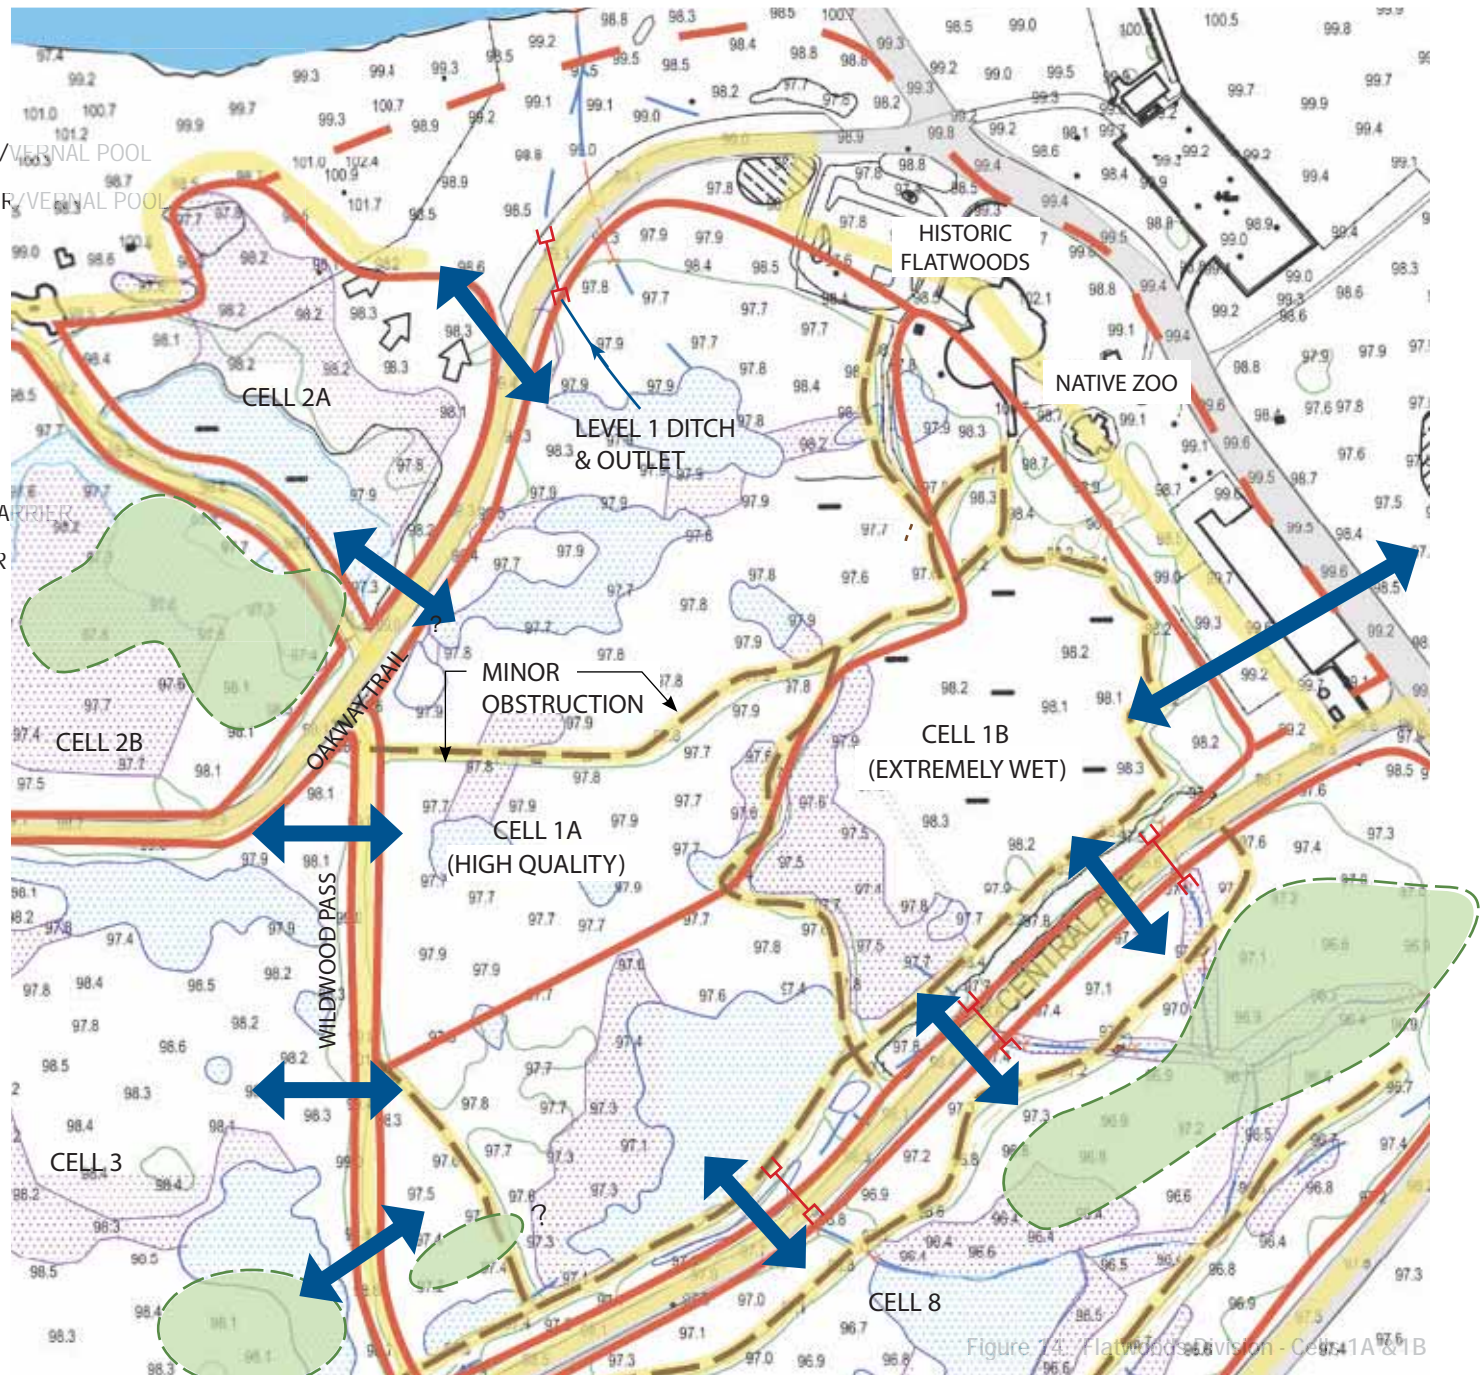
Figure 14: Flatwoods Division - Cells 1A & 1B

Cell 1B is remarkably different from 1A and represents one of the most degraded areas in the flatwoods. The path separating 1A from 1B and micro-topography represents the divide between these areas and prevents water from being released to Lake Muskoday. Cell 1B is bisected by numerous foot paths and the effects of trail fill is most apparent on surface hydrology, causing large areas to remain flooded throughout most of the growing season and creating shallow water emergent wetland conditions. Most of this area historically drained to the Detroit River to the east (now occupied by the Blue Heron Lagoon) but now only drains into Cell 8 via three equalizer pipes below Central Avenue. These pipes are set too low and are partially silted in, significantly reducing their ability to release ponding water. The level 4 equalized pipes are connected to well defined

Most of the historic forest canopy (closed canopy) is absent, and the remaining few oak trees are under stress. Emerald ash borer and excessive ponding appear to be the cause for the absence of forest canopy. A recent program to eradicate phragmites (*Phragmites australis*) in this area has been mostly successful but could result in higher water levels due to decreased transpiration.

- Remove internal foot path fill and restore grades to match existing adjacent elevations.
- Wildwood Pass should be fully removed within this cell unless there is intention to retain this as a path. If retained, construct at least one boardwalk section in a strategic location, creating surface water connectivity to Cell 3 and leave remaining fill in place.
- Control invasive species.

- Remove all internal foot path fill and restore grades to match existing adjacent elevations.
- Wildwood Pass should be fully removed within this cell unless there is intention to retain this as a path. If retained, construct boardwalks the entire length to restore connectivity between cells.
- Consider removal of the corner of the Nature Zoo outdoor exhibits and associated fill up to Lakeside Drive and consider alternate surface water connectivity to the Blue Heron Lagoon (historical condition) via concrete channel through the road.
- Control invasive species.

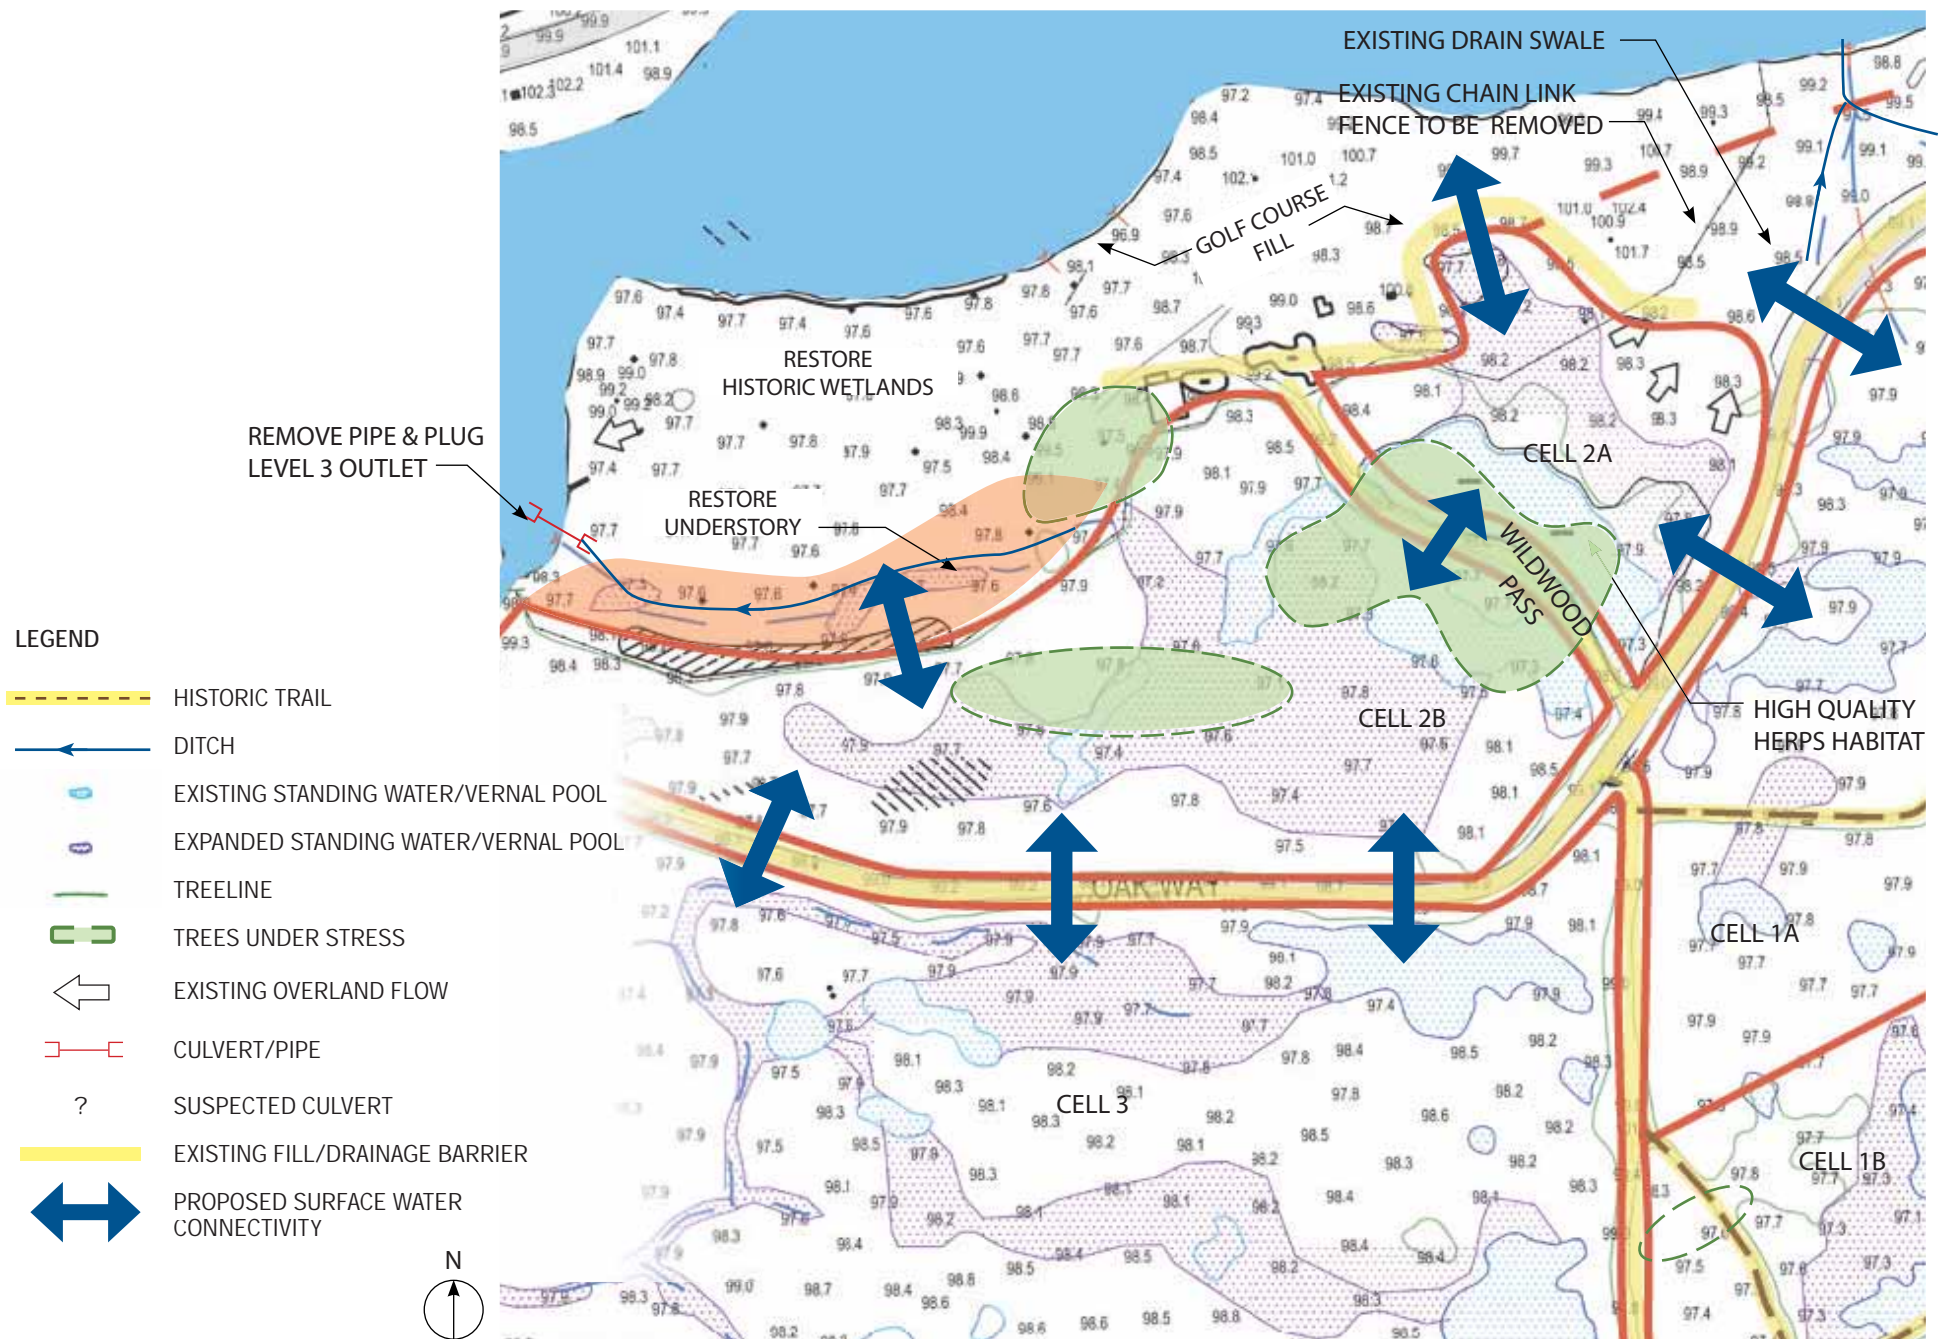
Figure 15. Flatwoods Division - Cells 2A & 2B

Cell 2A is +/-3 acres and contains mostly standing water that historically drained toward Lake Muskoday. It was also historically connected to Cell 1A and 2B, but no level 4 culverts were observed under Oakway or Wildwood Pass. Wildwood Pass and the golf course fill currently create drainage barriers, and there is no clearly defined outlet such as a

drainage ditch or culvert pipe. During extreme high water periods, surface water drains to the east and overflows across mowed lawn before discharging to Lake Muskoday. The original open water pool is the deepest pool in the flatwoods, contains an abundance of herpetofauna and serves as an important habitat. All of the trees within this pool have died, some are still standing and provide excellent habitat for cavity dwelling bird species. This condition has existed for a considerable length of time and is considered a stable system supporting excellent herpetofauna habitat.

Conversely, the eastern half of this cell also contains prolonged inundation and has caused significant dieback to the remaining large diameter oak species. This is one of the pools that seems to be growing in size and could be attributed to fallen ash trees (but is uncertain) or possible plugged level 4 pipes that were not encountered. These dying trees can be clearly seen from Oakway Trail and are most likely beyond the point of recovery even if the excess water is removed. Dense colonies of several juvenile tree species are becoming established in this location indicating that if this excess water is removed, the flatwoods canopy trees will become reestablished.

Cell 2B is +/- 11 acres and contains a large pool adjacent to the Wildwood Pass across from the Cell 2A pool. No physical connection was observed and water in Cell 2B is slightly lower in elevation than 2A. In the spring, this pool

enlarges to the west and occupies a substantial portion of the cell's interior that eventually is reduced to a small perennial pool adjacent to Wildwood Pass. The entire cell discharges from a single location directly behind the abandoned golf course building. Due to golf course fill between this discharge and Lake Muskoday, water draining from the cell interior sheet flows westerly just outside the chain link fence (no clearly defined ditch) and eventually discharges into Sylvan Canal at its confluence with Lake Muskoday via a small drain tile and overland flow. It is unclear how far into the golf course the drain pipe extends, but it appears to be no more than 50 feet to 75 feet long. Where the cell surface water discharges into the golf course, the large oak trees are starting to show signs of stress. Adjacent to this point, a small cattail pond exists and is discharging additional water (broken water main) into the swale. The excess water within the interior of the cell and tree decline (chlorine) could be the reason for the current condition.

Within the cell, no surface water discharge to the canal was observed and existing grades are over 1 foot higher than the remainder of this cell, suggesting dredge spoils were placed along the bank. It is difficult to determine the connectivity between Cells 2B and 3 due to the level 1 ditch that parallels Oakway Trail in Cell 3.

Tree conditions seem to be mostly good except for a number of maples adjacent to Wildwood Pass within the perennial pool and a smaller cluster of similar species within the interior, suggesting that this cell is exposed to excessive standing water. The loss of ash trees are clearly noticeable, especially along the western edge of the cell approaching Sylvan Canal where tree canopy is open to semi-open, reed canarygrass (*Phalaris arundinacea*) is the predominantly understory vegetation and no seasonal pools were observed. Amur honeysuckle (*Lonicera maackii*) is also predominant in this location due to the absence of historic hydrology that may have been originated from Cell 3.

- Repair the broken water main or abandon in place.
- Consider the restoration of the golf course to wet meadow wetlands between the drainage swale and Lake Muskoday by dispersing the cell discharge water (includes shallow excavations).

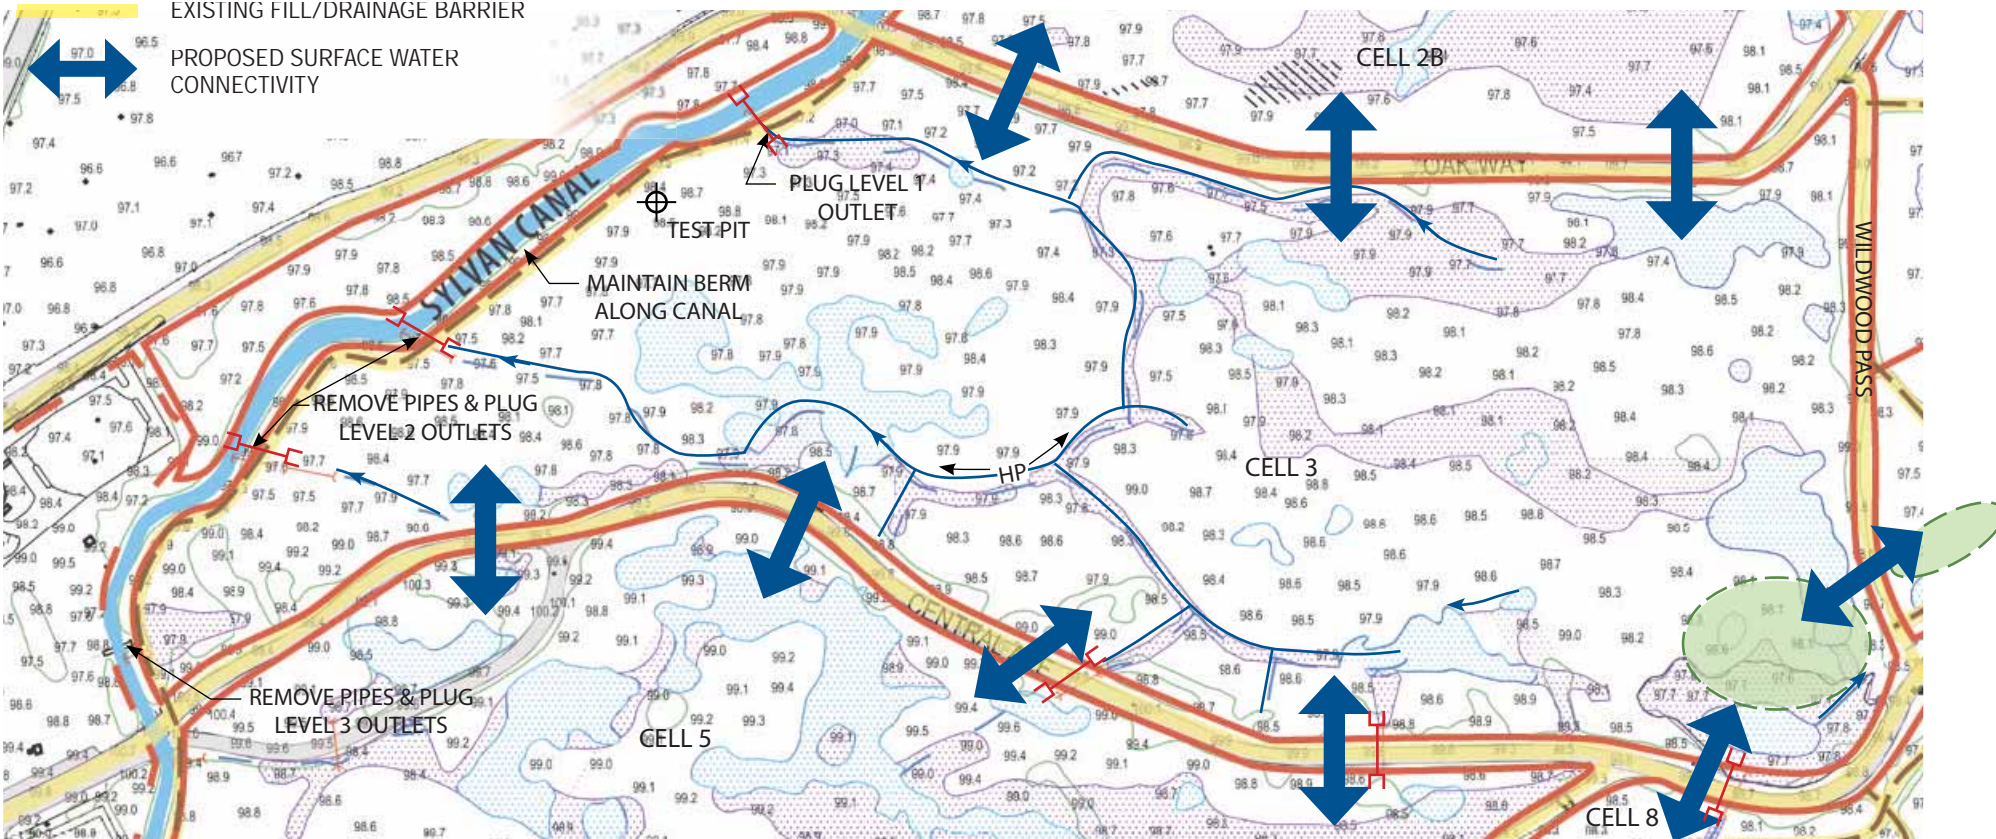
Figure 16. Flatwoods Division - Cells 3

Defined by Oakway Trail, Sylvan Canal, Central Avenue and Wildwood Pass, Cell 3 encompasses +/- 39 acres including Sylvan Canal (Figure 16). From a hydrologic perspective, the western half is heavily degraded due to ditching. The ditching is extensive and impacts over 50% of the cell. Historically, Cell 3 drained north and northwest across Oakway Trail and the Sylvan Canal through Cell 2B to the wetland complex now occupied by Lake Muskoday and the abandoned golf course. Today, the entire cell drains into Sylvan Canal. The three drainage ditches (level 1 and level 2) were strategically constructed through the lowest elevations of the cell before discharging into the Sylvan Canal. The impacts on pool development from these ditches are evident. Within this zone of influence, pools are small and linear and mostly associated with the ditches or are seasonal (spring runoff). The level 1 drainage outlet and ditch has the greatest impact on cell hydrology and extends furthest into the site. It is deep and wide near its outlet and meanders throughout the western half of the cell. The two level 2 and one level 3 ditches and outlets have localized impacts on cell hydrology. All four outlets contain small diameter cast iron pipes that allowed cell water to drain to the canal below the informal foot path that still exists today. At the level 1 outlet, the culvert is washed out, heavily eroded and a boardwalk section was installed to maintain trail access.

Ponding in the eastern half of the cell is well developed with three linear pools that eventually are drained by the primary ditch and through evaporation. By late summer, pools are dry except for a small area in the southeast corner next to Central Avenue. In at least three locations, equalizer pipes were observed across Central Avenue connecting to and draining Cells 5 and 8, which attempts to follow the natural flow patterns but are mostly blocked, and no flow was observed (see Cell 5 narrative).

Tree condition throughout the cell appears healthy except for a small cluster of maples in the southeast corner of the site that is attributed to ponding water. Like Cell 2B, the loss of ash trees is clearly noticeable especially along the western edge of the cell approaching Sylvan Canal where tree canopy is semi-closed to open, reed canarygrass (*Phalaris arundinacea*) is the predominantly understory vegetation, and no seasonal pools were observed. Amur honeysuckle (*Lonicera maackii*) is predominant in this location due to the absence of historic hydrology. No surface water discharges to the canal except at the ditch outlets, and existing grades are over 1 foot higher than the remainder of this cell suggesting dredge spoils were placed along the bank for trail use.

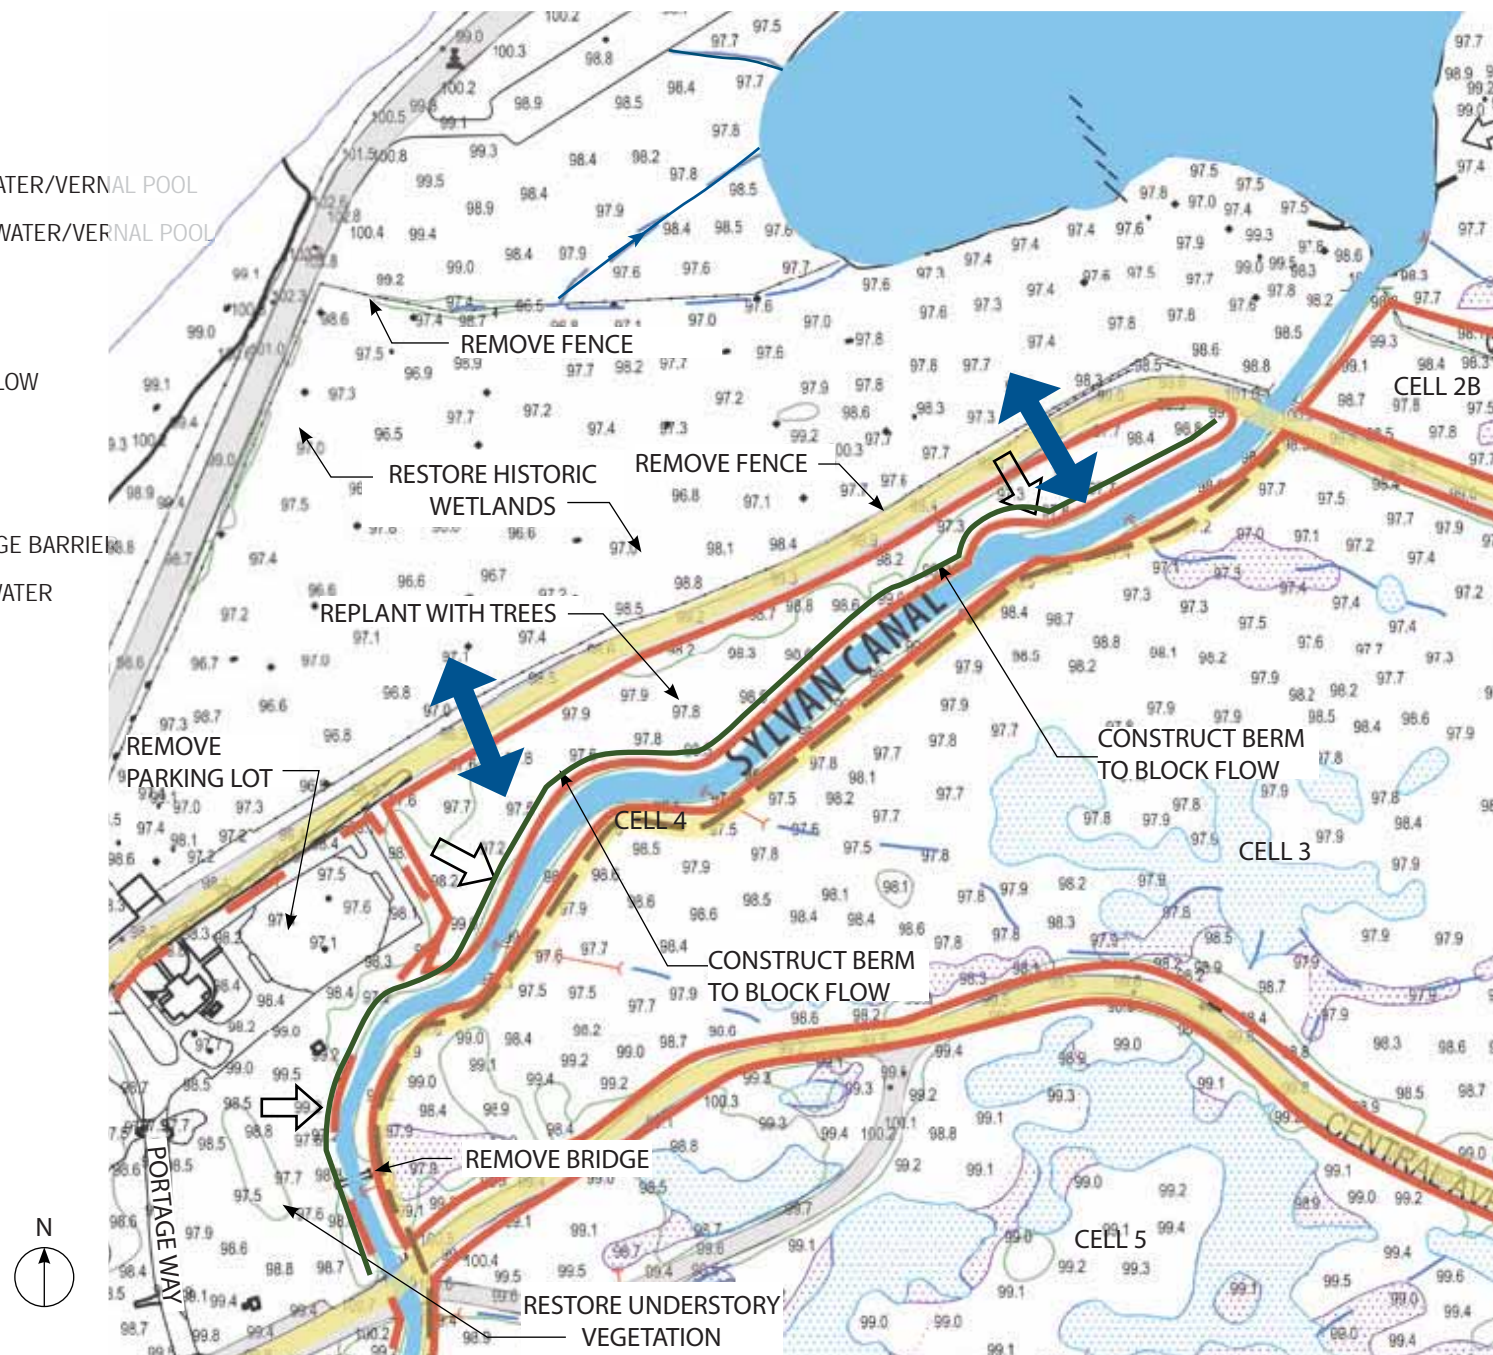
Figure 17. Flatwoods Division - Cell 4

Cell 4 has been heavily degraded and is considered low quality due to several factors.

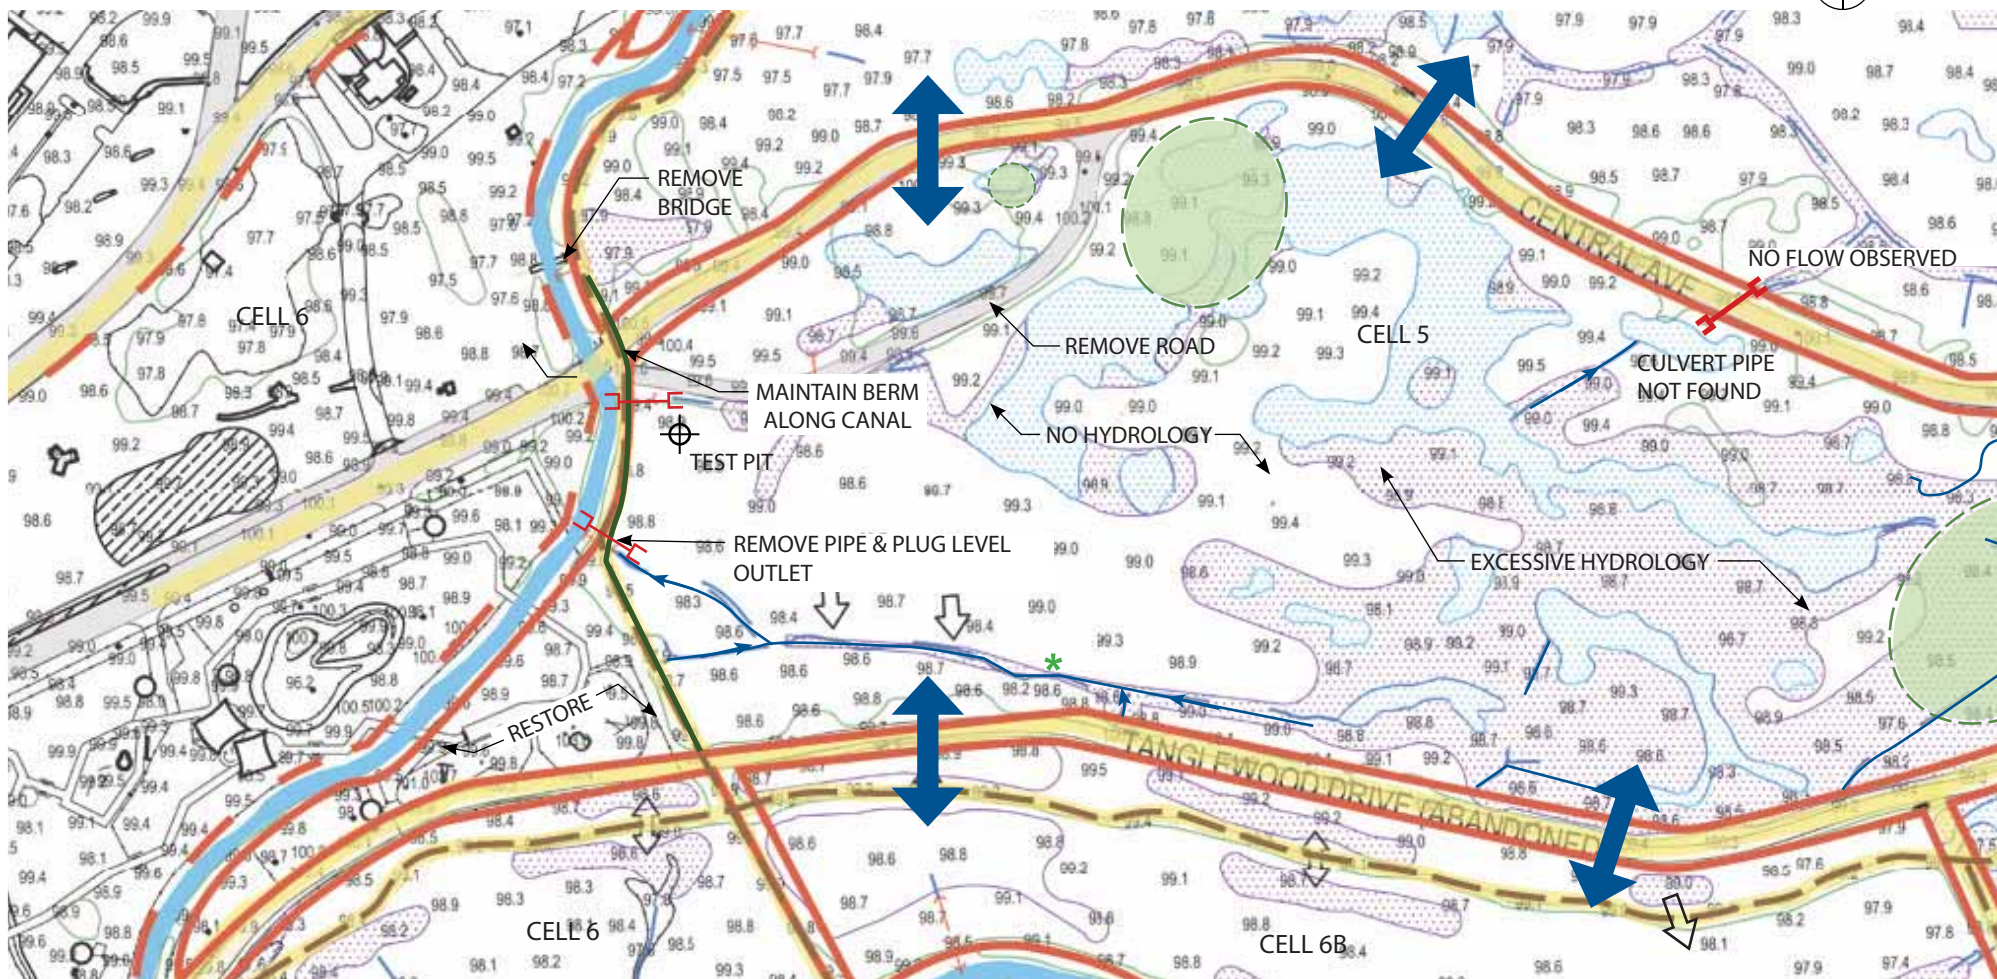
Figure 18. Flatwoods Division - Cell 5

Across the cell, tree conditions appear mostly healthy with a good mix of oak and maple species. In two locations, trees are showing stress attributed to ponding water. At the northwest corner of the cell, adjacent to and within the Central Avenue loop (Shadow Nook), several oak trees are in decline suggesting that the ponding has been occurring for a number of years. At the eastern side of the cell, a large cluster of silver maples are beginning to show water related stress, indicating a more recent occurrence of expanded ponding. Like most of the other cells, the loss of ash trees are clearly noticeable, especially along Tanglewood Drive where walking through the numerous downed trees and dense honeysuckle is extremely difficult.

- Reduce footprint of Central Avenue to a single-lane or shared-use path including all shoulder fill (below contour elevation +/- 99.0), or remove in its entirety, creating surface water connectivity to Cell 3. If allowed to remain, consider the installation of boardwalk sections in the road to allow conveyance of surface water between cells (four locations).
