**2016 BELLE ISLE
COMPREHENSIVE
HYDROLOGIC
ASSESSMENT**

In response to tasks 2A and 2B of the Lake Okonoka Habitat Restoration project, this report aims to gain an understanding of the current hydrology on Belle Isle specific to the +/- 200 acre natural area referred to as the wet-mesic flatwoods forest (flatwoods).

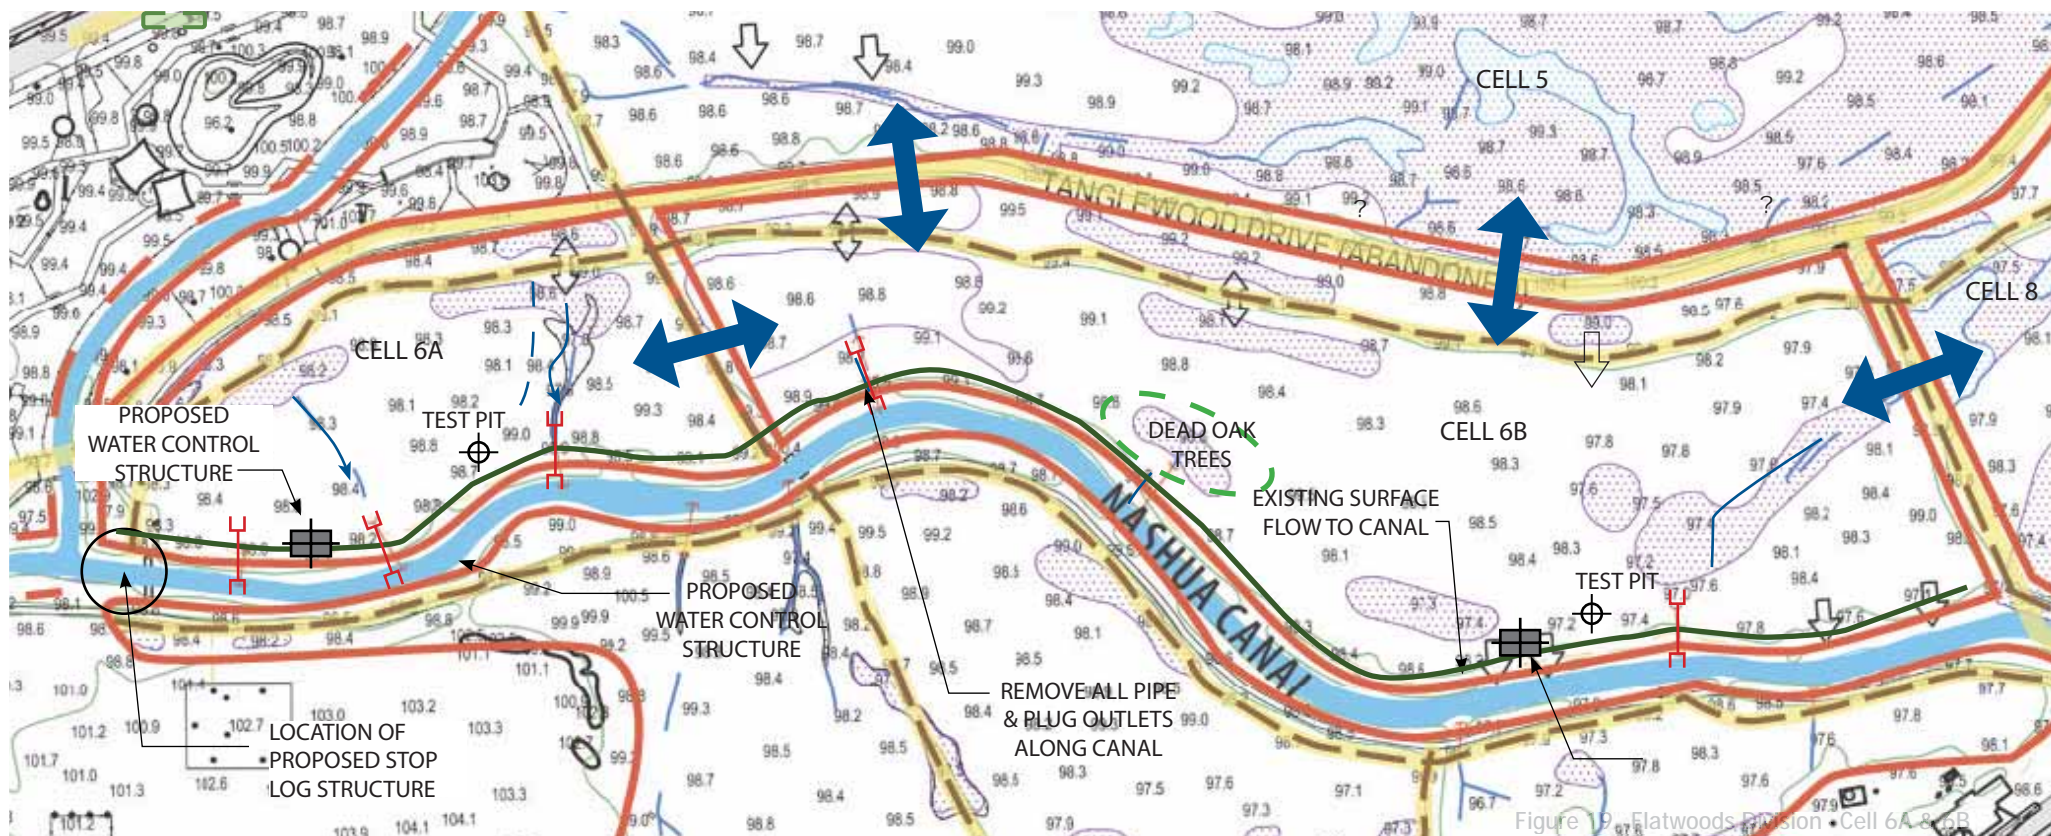
Figure 19 Flatwoods Division - Cell 6A & 6B

One note of interest is that the resident beaver(s) occupy this portion of Nashua Canal, and gnawing on the riparian trees was observed.

- Consider restoration of this cell to extend to Vista Drive to follow its original boundary. This will require the removal of a large amount of fill, the basketball courts and the handball court. At a minimum, consider flatwoods understory restoration around the perimeter of this fill to historical west limits (Vista Drive).
- Remove surplus fill placed in flatwoods at northeast corner of mowed field and fill area.
- Between basketball court and Nashua Canal, widen natural areas as much as possible (+/- 100 feet) and install at least one water control structure to maintain linear pools.

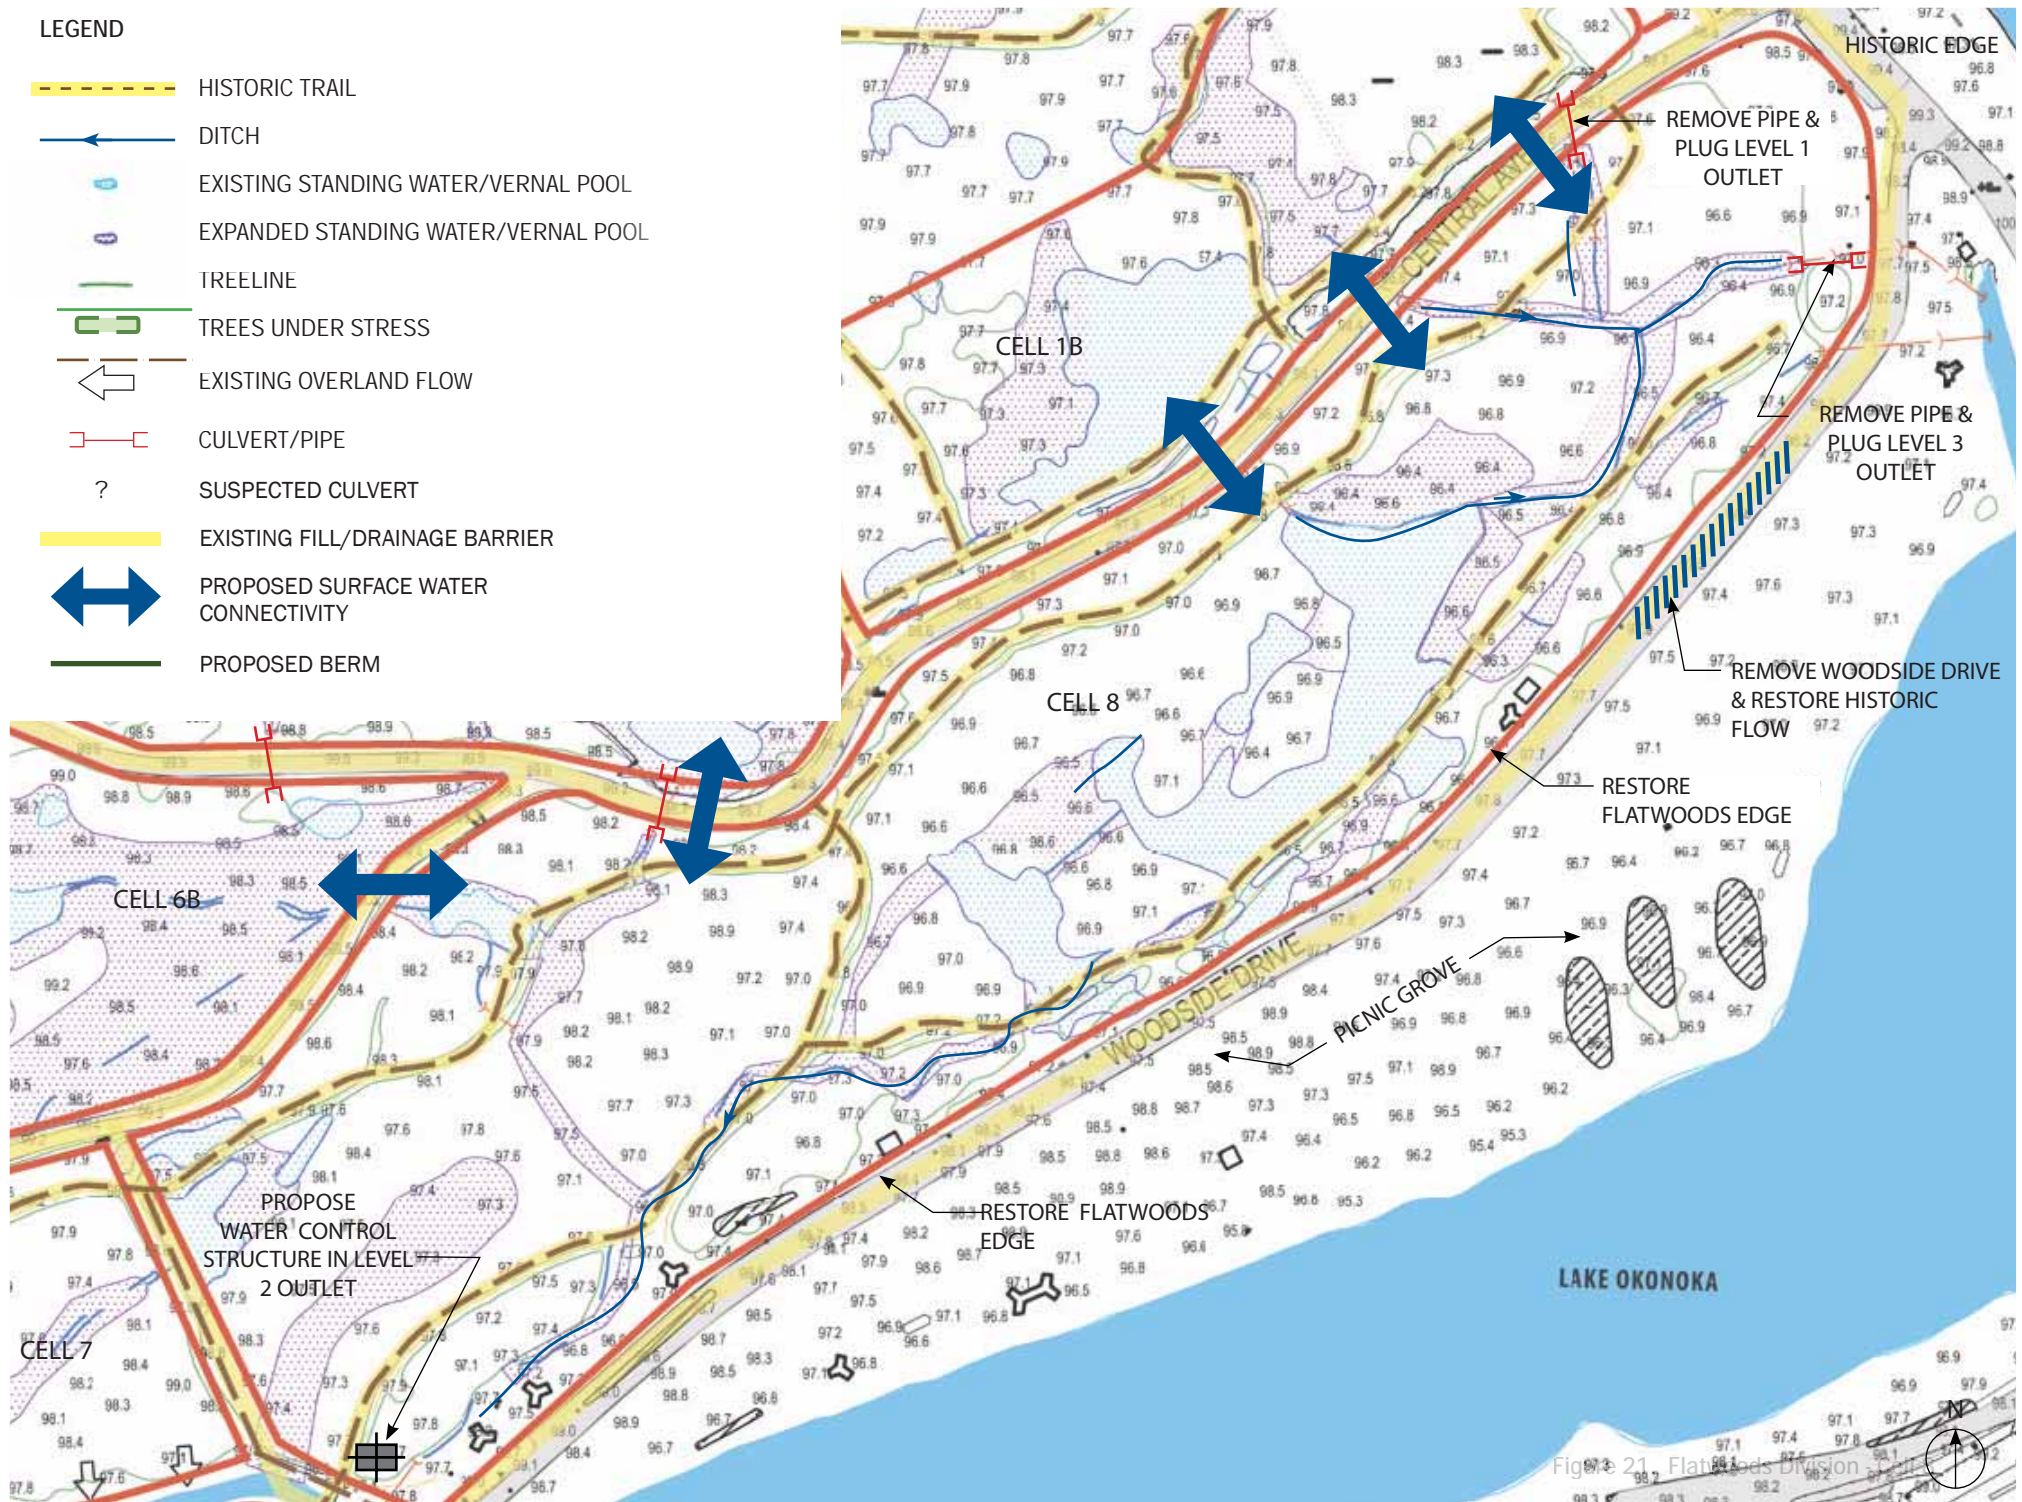
Figure 21. Flatwoods Division

The canopy ranges from semi-dense to closed due to the absence of significant amounts of ash trees. Honeysuckle is abundant throughout this cell and occurs extensively in the fill areas associated with the internal bridle trails.
