SEC 9, T22N, R10W

SEARCH FOR LINE TRAIL
WEST LINE SEC 9

RE: Sections 4 & 9, Town 23 North, Range 12 West, Springville Township, Wexford County.

CONTROL DIAGRAM

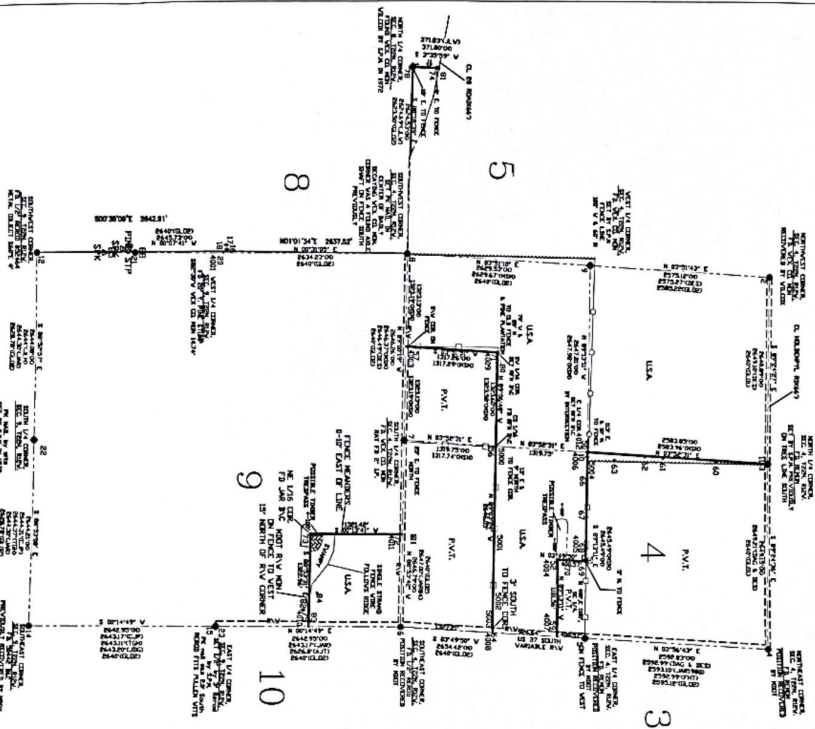
A control survey was completed around Sections 4 & 9 and all record Government corners were recovered with the exception of the following.

At the East One-quarter of Section 9 we located the bottom half of a PK nail that fit one record witness (Power Pole West). The remaining witnesses of record had no nails for measurement. Based on the Surveys of record for this section line, it appeared that the corner was to be established midway and on line between section corners. The found broken PK was 2.0 feet south of SP. Reset this corner midway and on line between section corners with a pointed 1/2" by 3" rerod (concrete rod under asphalt). Placed nails in record witnesses and measurements checked close.

At the Southwest Corner of Section 9 the Spike of record was located and tied. In addition approximately 4.0 feet to the Southeast a strong dip was located (sounds like fairly large object). The issue of double monuments will need to be resolved.

At the South One-quarter of Section 9 the record RR spike was gone and a PK was set temporarily for tie purposes. In the process of establishing this position based on record witnesses we found that one of the record witnesses was recorded wrong (power pole SE, bad distance) the three remaining witnesses checked good. This corner may also need to be resolved based on two monuments at the Southwest Corner. (Recorded as a lost corner and set midway and on line)

The West One-quarter Corner of Section 9 was set by James Ray PS at a fence corner according to record. GLO calls for a 20" Yellow pine stub. At approximately 14' East of the Ray Quarter corner the remains of a 20" Yellow pine Stump was located that seems to better fit the GLO corners North and South. At the Ray position no stump remains were found and the fence does not appear to be that old. Not sure if the existing fence was constructed on older fence location, (to much snow). This corner location will need to be resolve.
