**Upper River, Tahquamenon River**  
Luce County  
Tahquamenon River Watershed, last surveyed 2009

**Environment**

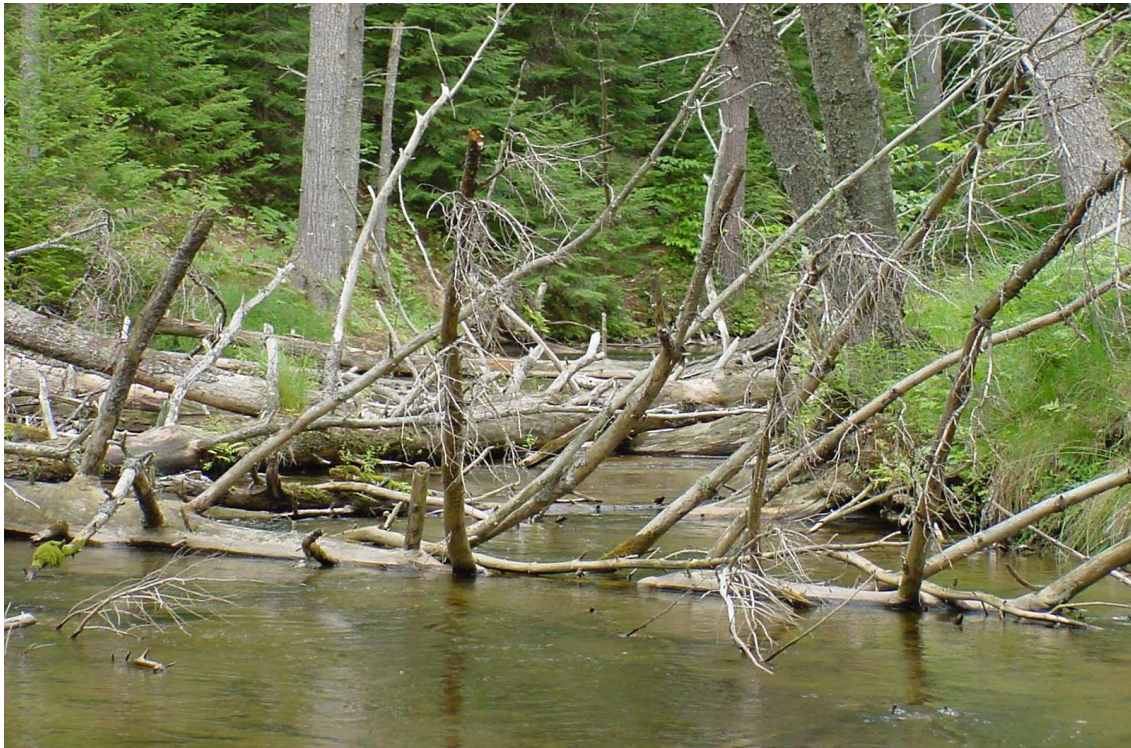
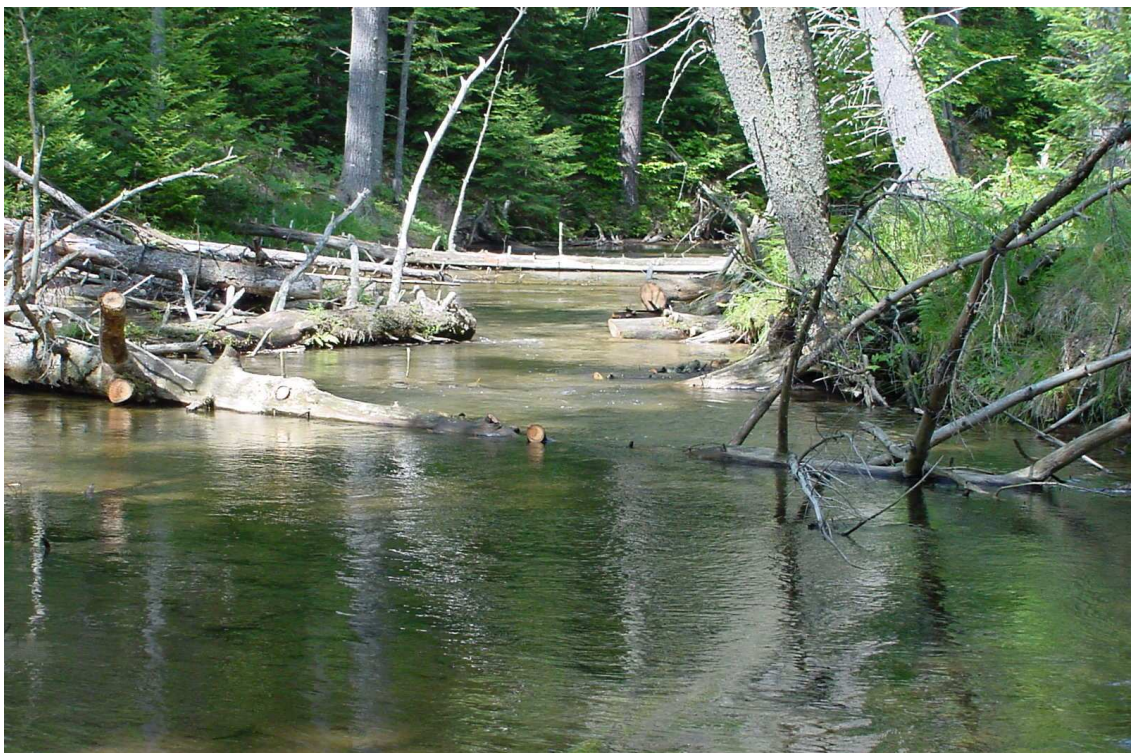
Figure 2. Before and after examples of stream work completed in the Upper River, Tahquamenon River, Luce County, 1999-2001.

Before stream work

After stream work

A multi-year habitat enhancement effort took place from 1999-2001 encompassing about 6 mi of this section. The effort was almost entirely directed at in-stream woody structure, with some minor removals and much placement modification (Figures 2, 3). Visual surveys during and following the work showed some surprisingly rapid habitat changes. In some instances, removal of one downed tree resulted in new flows scouring a channel more than two ft depth within one hour. In other instances, banks that had been actively eroding were isolated from the new stream channel by the next morning. Modifying placement of in-stream materials to narrow the existing channel several times exposed gravel substrate within 24 hours. In addition, scoured sand was re-deposited by water currents into backwater areas, effectively narrowing and deepening the channel. Judicious removal or modification of large woody debris allowed scouring of deep holding water underneath that structure and increased habitat diversity in the channel. Above all else, the effort was designed to be as natural-looking as possible.

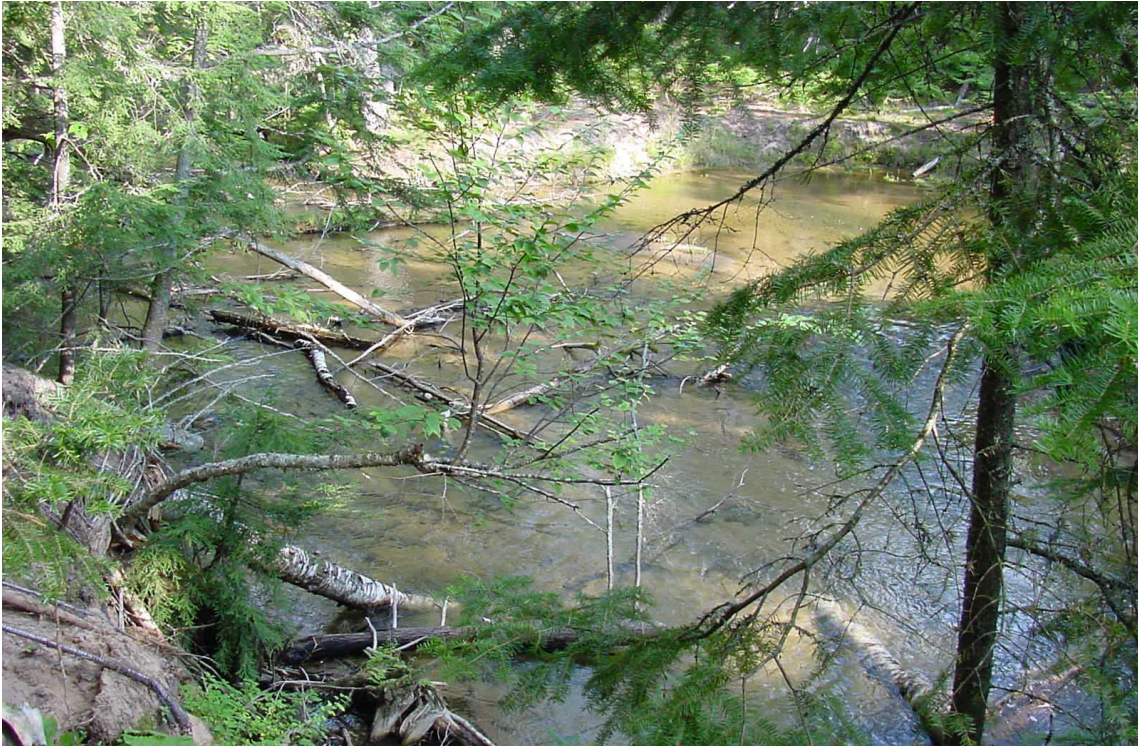
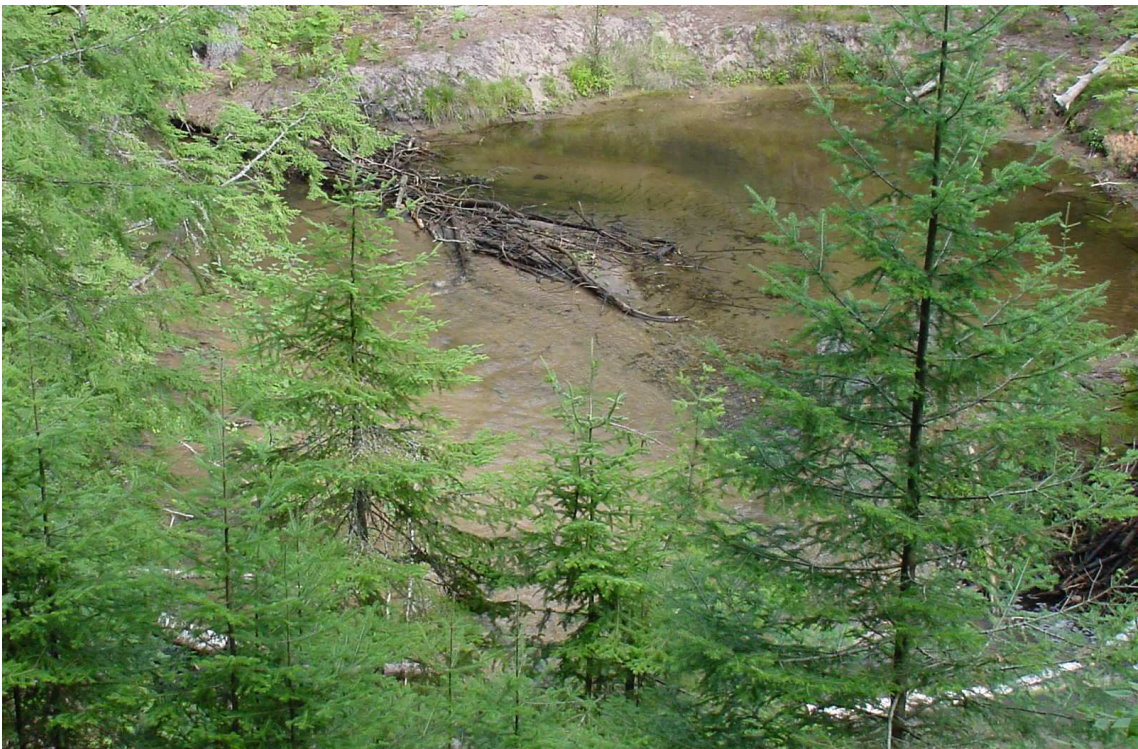
Figure 3. Before and after examples of stream work completed in the Upper River, Tahquamenon River, Luce County, 1999-2001.

Before stream work

After stream work

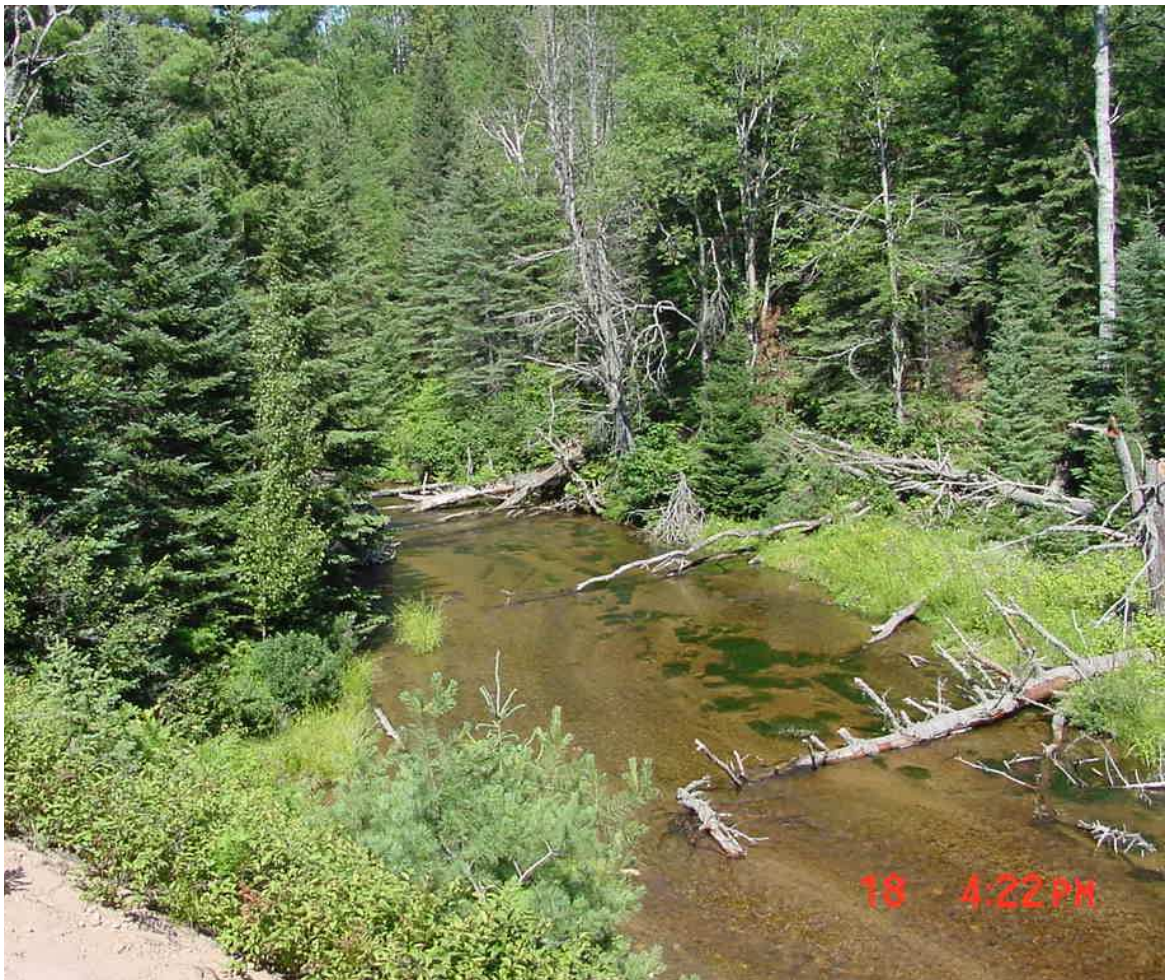
Angler access is another source of bank erosion. The State of Michigan-owned access site for the 2009 electrofishing survey features a level parking area with a steep 15-20 ft sand bank to the river's edge (Figure 4) and a vegetated two-step drop 100 ft downstream. There, a narrow, flat floodplain collects loosened sediment before it reaches the river. Despite the more environmentally sound alternative immediately downstream, anglers continue to slide down the sand bank, causing increased erosion into the river. A possible bank protection project will entail a log fence barrier along the top of the sand bank, and a sign pointing to the path at the two-step drop.

Figure 10. The sand bank at the parking site for the State of Michigan owned access site, designated as the standard survey site for status and trends sampling, Upper River, Tahquamenon River, Luce County, T47N, R12W, Section 34.
