Foch Lakes

Montmorency County, T32N, R01E, Section 28
Black River watershed, last surveyed 2018

Tim A. Cwalinski, Senior Fisheries Biologist

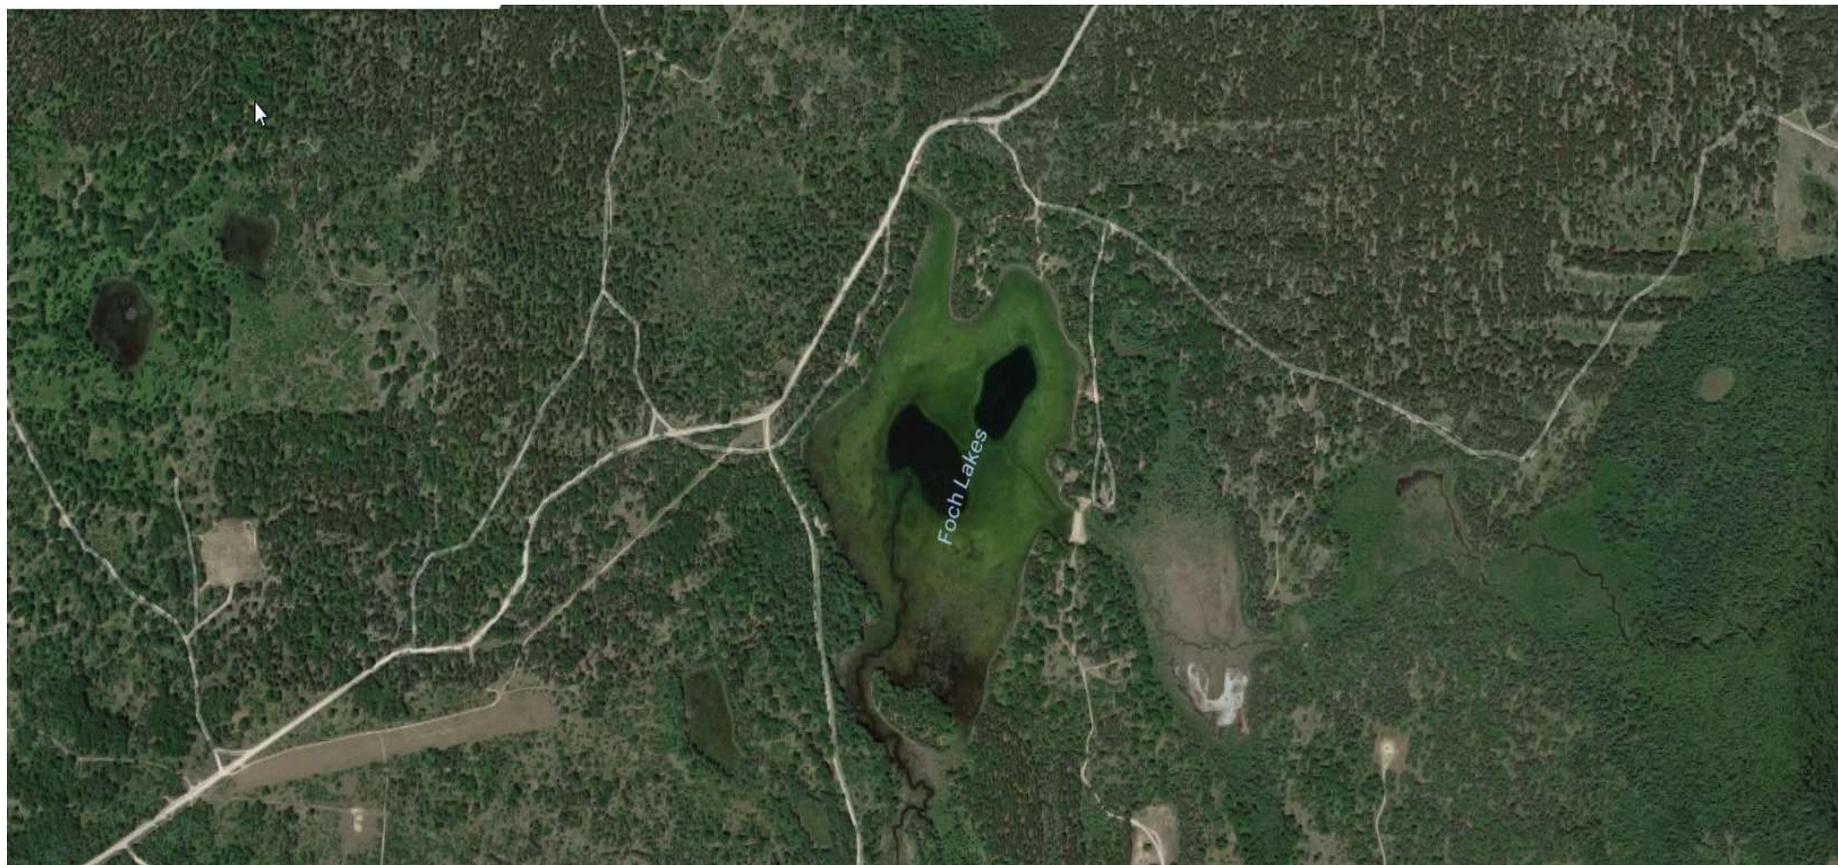
Figure 2. Aerial photo showing Foch Lakes natural basins and surrounding impounded area.

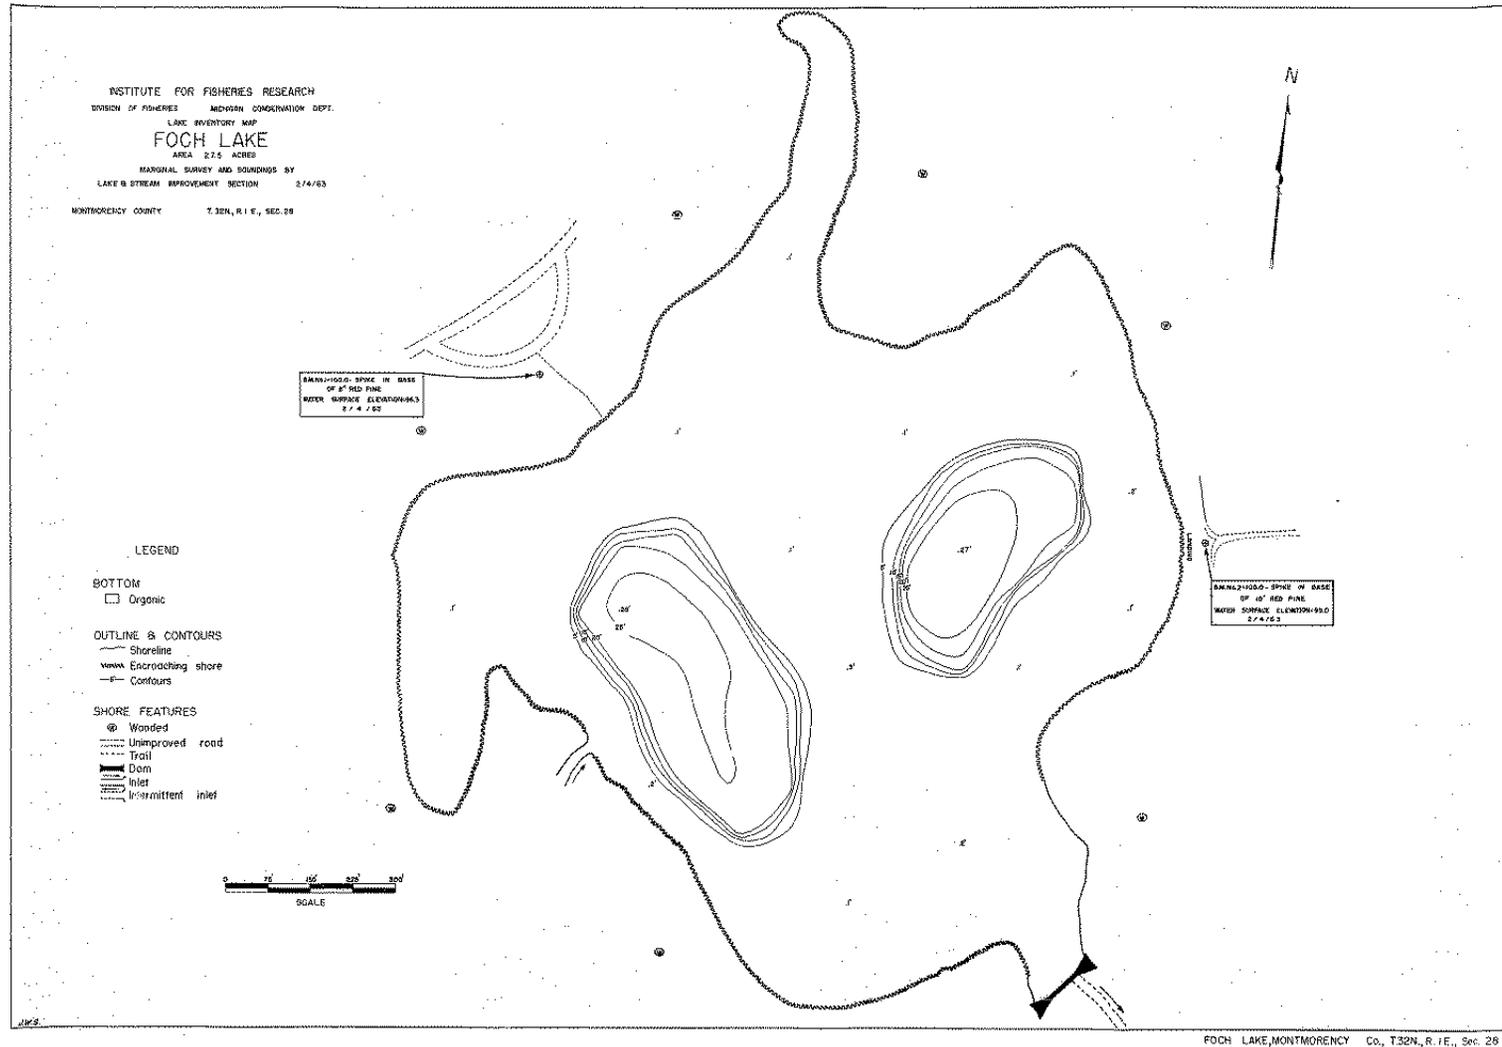
Figure 3. Original bathymetric map for Foch Lakes and impounded area, 1963.

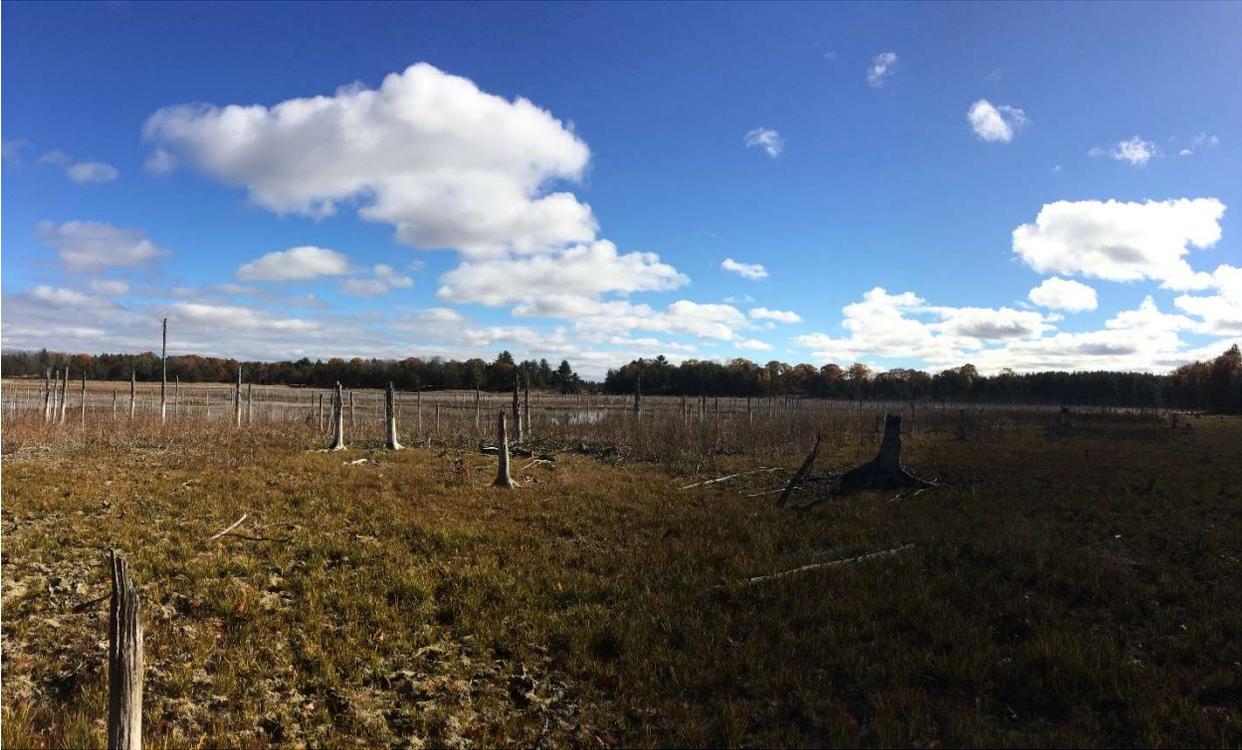
Photo 1. Foch Lakes bottom substrate and environment under recent drawdown.

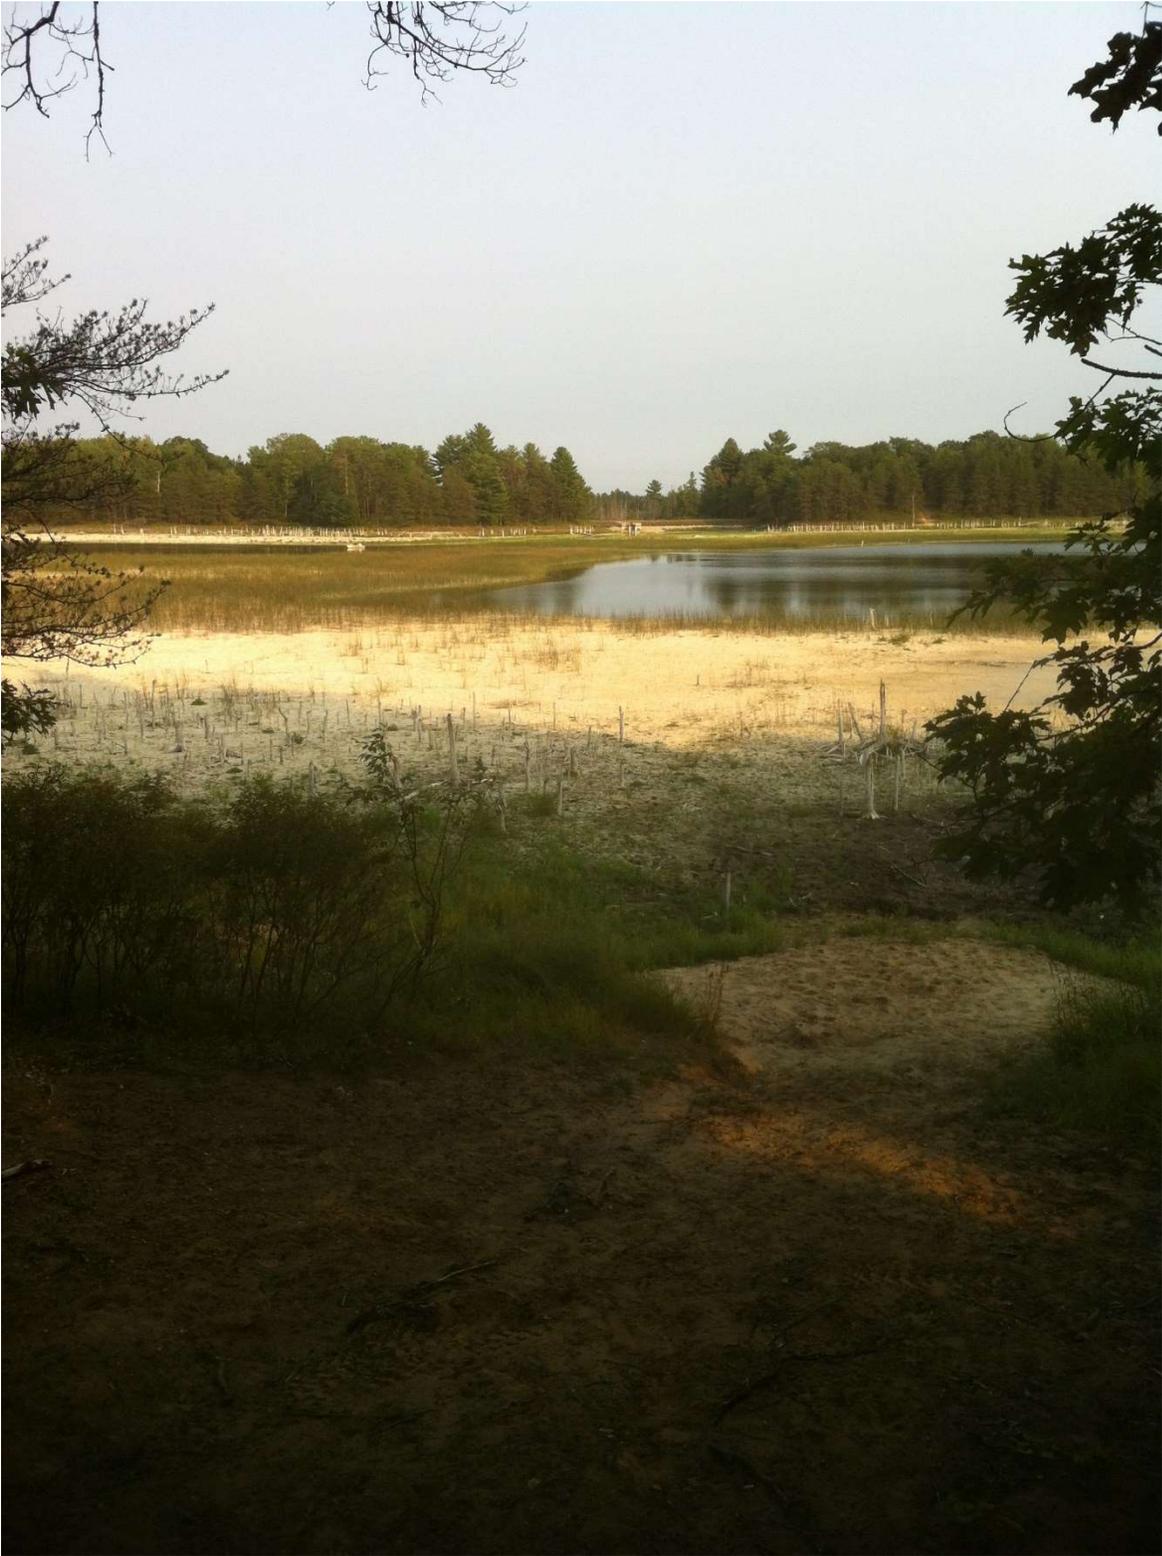
Photo 2. Foch Lake under a recent drawdown for dam renovation. The natural lake basins are evident as is the old dam spillway.

The control structure of Foch Lakes floods approximately 85 surface acres when all stoplogs are inserted. The flooding was first created in 1955 but only impounded a surface area of approximately 23 acres. The flooding was modified for repairs in 1963 to expand the surface acreage to what it is today. The control structure is owned by the Michigan Department of Natural Resources (MDNR) Fisheries Division, which is responsible for its routine structural inspections and maintenance. Despite multiple repairs over the decades, the structure continued to deteriorate and a 2011 MDEQ safety inspection required complete drawdown of the flooding and return to the natural lake basins to allow better examination of the structure. Local fisheries managers heard from many users of the flooding regarding the drawdown, and weighed the options of complete removal or renovation. In 2013, Fisheries Division received significant funding from the MDNR Dam Management Grant program with lesser matching funds from local entities to renovate the entire structure. The flooding was drawn down in 2014, the control structure and outlet were completely replaced in the fall of 2015, and the flooding was restored to its normal pool elevation.
