Report No. 1286

June 11, 1951

AN INVESTIGATION OF THE PIKE SPAWNING AREA AT THE  
NORTH END OF OTSEGO LAKE, OTSEGO COUNTY,  
MICHIGAN, DURING APRIL, 1951

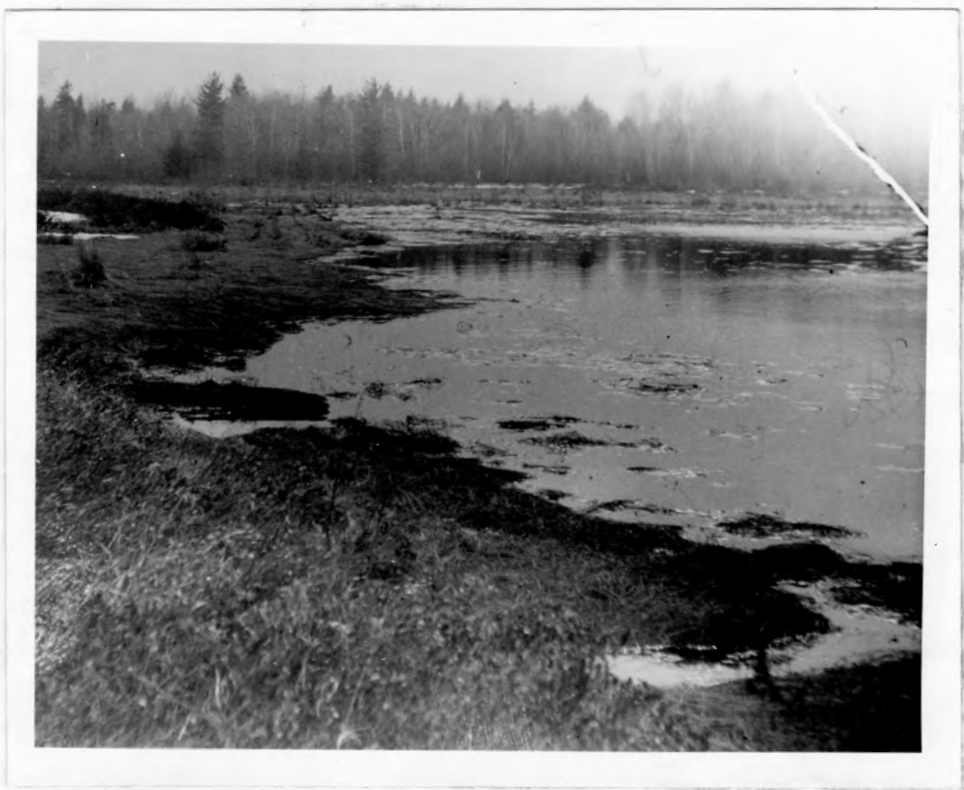
Figure 2.--Photo taken April 8, 1951, looking west along peninsula on left and lagoon on right in section A. (All locations and directions of photos shown on map, Figure 1.)

On April 8, on my way to Douglas Lake, Cheboygan County, I stopped at Otsego Lake to check conditions at the "pike factory." Conditions found are shown partly by figures 2 to 5. The state of the thaw and ice breakup seemed ideal for a pike run at that time, but no fish were in evidence. Most of the marsh contained open water, section A (see Figure 1) being entirely flooded to depths of 6 inches to 1 foot, and sections B and C from 1 to 2 feet. Efforts had been made to connect sections A and B at the south end of fill No. 1 (where a culvert was later placed) but were ineffectual. Thus pike had no access to either section B or Section C. It was easily seen that the water level in section B was at least 6 inches higher than that in section A. The water gage reading on April 8 was 1.37, the temperature of the lake water was 37° F., and the temperature of the water in the marsh varied from 50° to 52° F. on the east side of the fills to 40° to 42° F. on the west side of the fills (due to the presence of ice still remaining on the west side of the fills). There was approximately 10 feet of open water around the north end of the lake. Mr. Marlatt had seen no evidence of a pike run as yet in daily checking.

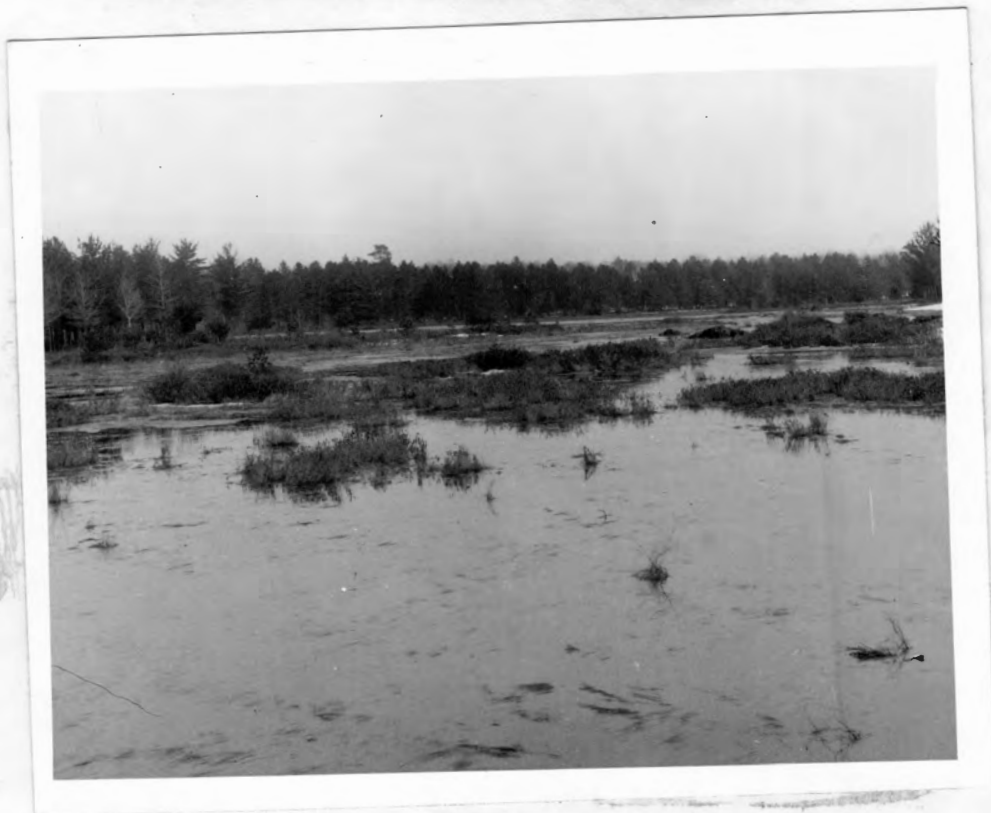
Figure 3.--Photo taken April 8, 1951, looking northeast across section A. Lagoon shows in distance in center background.

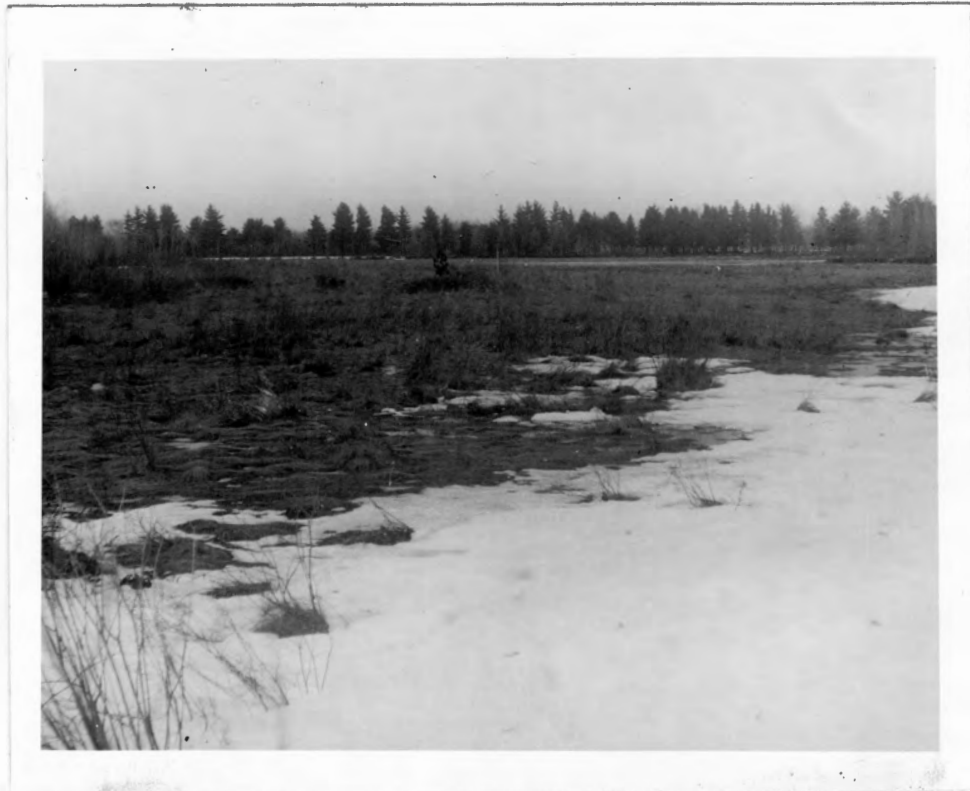
Figure 4.—Photo taken April 8, 1951, showing section B from center of fill No. 1.

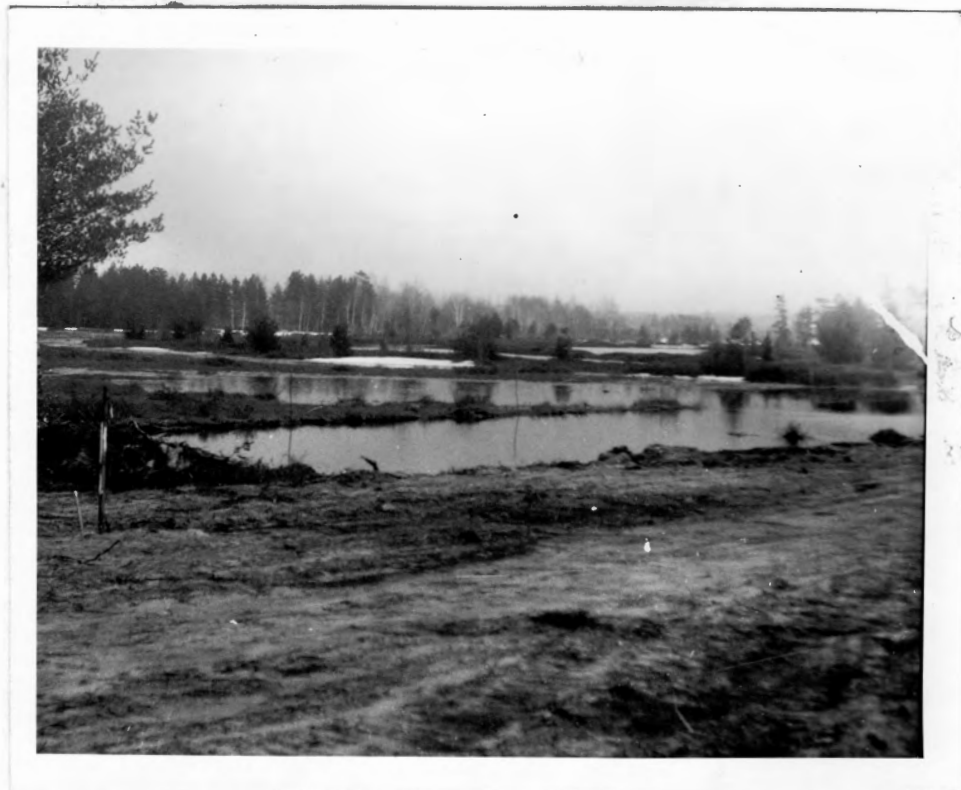
Figure 5.—Photo taken April 8, 1951, showing section C, looking southeast from the north end of fill No. 2.

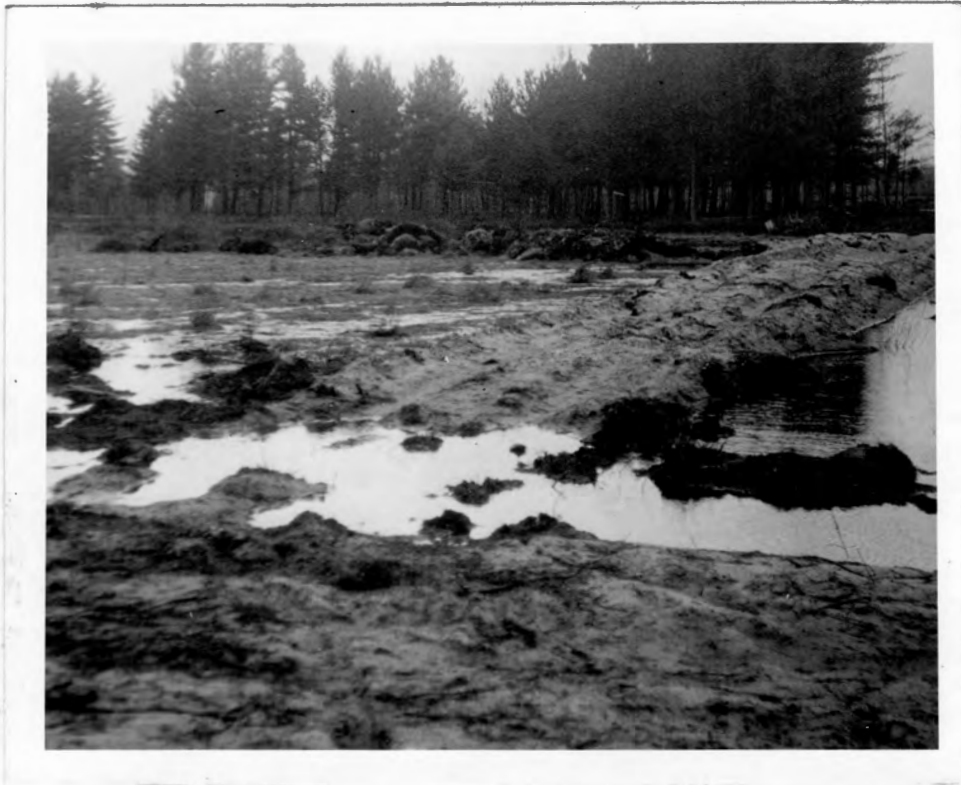
Figure 6.---Photo taken April 15, 1951, looking northwest along fill No. 1. Foreground shows attempt to connect sections A (on left) and B (on right) by ditch at future location of culvert.

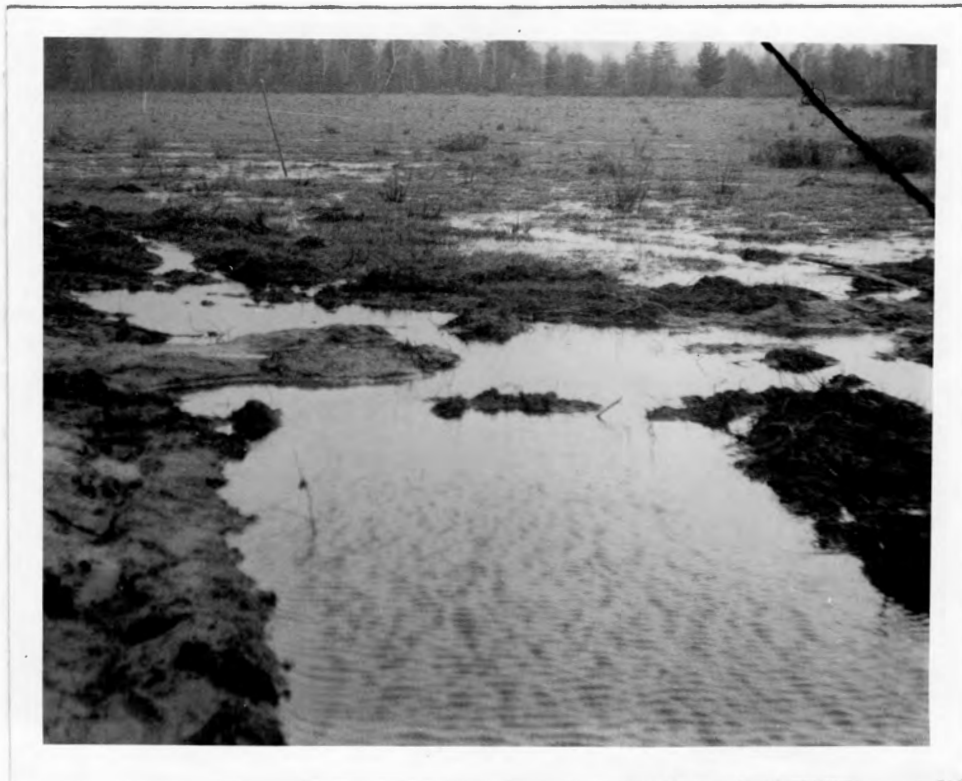
Figure 7.---Photo taken April 15, 1951, looking west across ditch shown in Figure 6, and showing dryness of most of section A. (Lagoon off picture at left.)

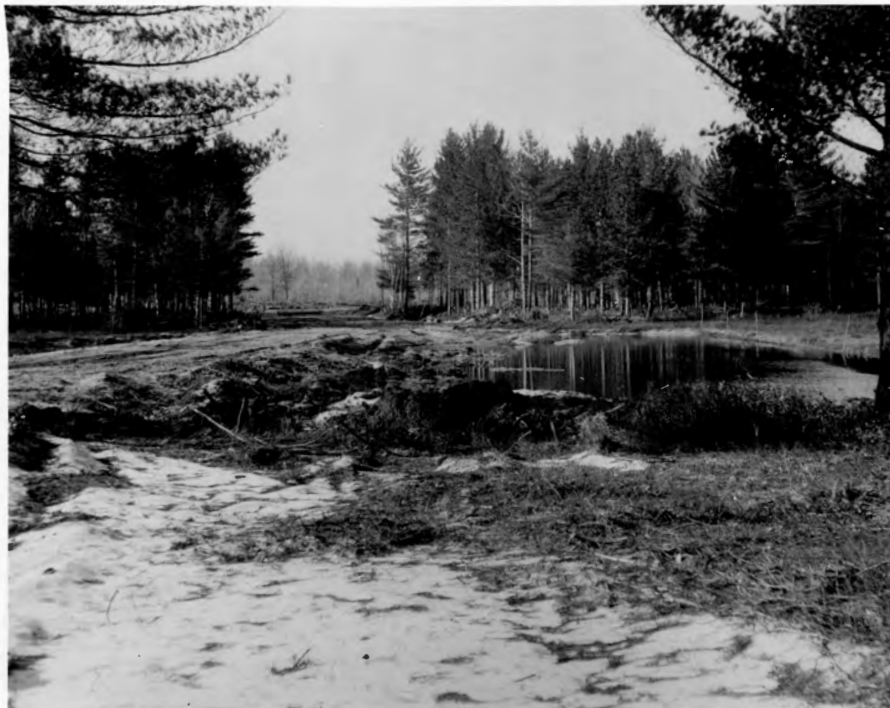
Figure 8.—Photo taken April 26, 1951, showing fill No. 2 (on left) from south end and dredging to its right.

Various cuts and dredgings done to the south and east of fill No. 2 for the purpose of connecting section C directly with the lake and serving as boat channels giving access to the rear of the eastern peninsula were serving rather efficiently to lower the water level in section C, which except for the canals and several potholes was nearly dry. These cuts are

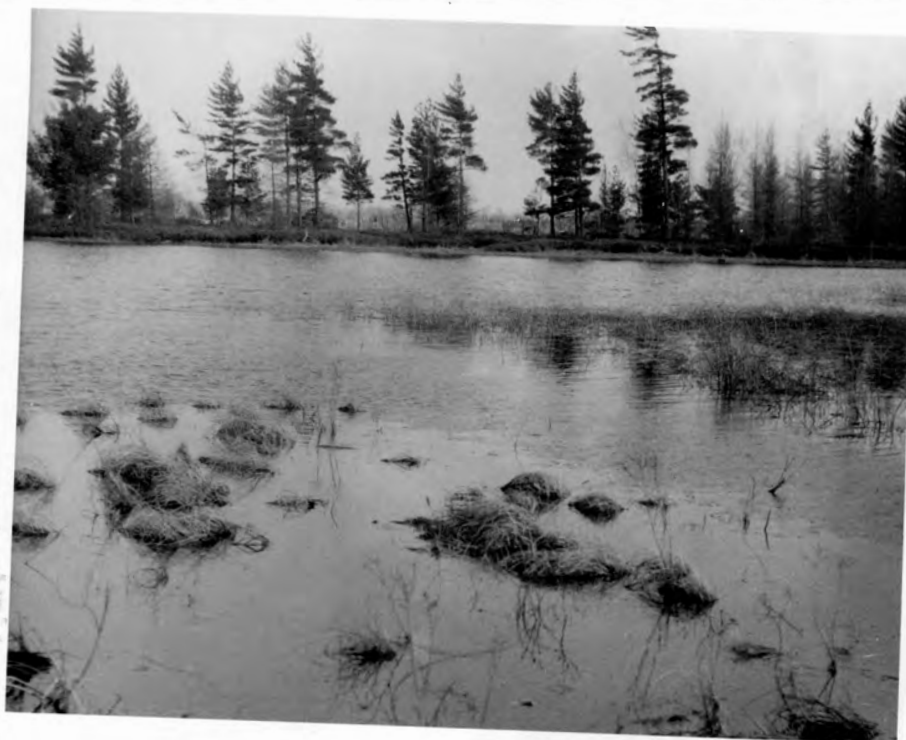
Figure 9.—Photo taken April 27, 1951, looking south across lagoon in section A, showing partly flooded grass in foreground where pike were observed spawning.

On April 27, 3 pike were seen at the edge of the lagoon at about 5 P.M. Two of these seemed in the act of spawning but my presence caused the larger female to dart into the lagoon. The male was easily caught by hand in the shallow grassy water. Examination of the male showed it to be 22 inches in length and ripe. A search of the immediate area was unproductive as far as freshly extruded eggs were concerned (Figure 9). The water temperature at the spot where the male was captured was 64° F., while the lake temperature was 54° F. One other fish was seen in shallow water nearly about an hour later but escaped capture. Mr. Summers was present at the lake at the time, digging a channel through fill No. 1 for the culvert, and observed the ripe male.
