Report No. 1300

AN INVESTIGATION OF THE PIKE SPAWNING AREAS IN AND AROUND
DOUGLAS LAKE, CHEBOYGAN COUNTY, MICHIGAN, DURING THE SPRING OF 1951

J. E. Williams

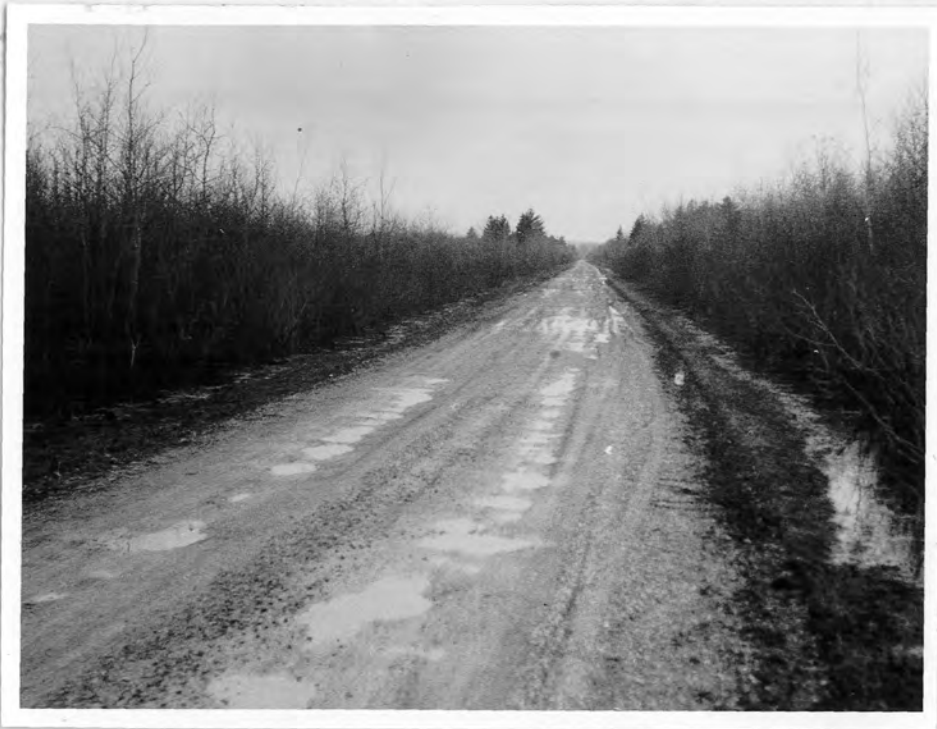
Figure 3. Looking west toward Van (1 1/2 miles) along Van Road. Van Ditch is at the right. April 13, 1951.

The question remains then, what is to be done about Van Ditch? The condition of the ditch at the present time is such that, while serving as a spawning place for pike, it is a trap as far as the fry are concerned, due to the thickness of vegetation in it. A screen could be placed at the mouth of the ditch to prevent pike from using it. Pike would not however, be prevented from using the flooded woodland west of the lake by a screen at Van Ditch, but would probably use the other inlets along that shore more freely. This would reduce easy violations directly from Van Road and make the violators get back in the woods where they might be more difficult to see and apprehend. A screen would furthermore pose a considerable maintenance problem as it could easily develop into a dam, stopping the flow even earlier in the ditch. There is the further hazardous possibility that pike, prevented from using the ditch by the screen, would still congregate at it and be even easier targets for a spear than while in the ditch. It is therefore the writers suggestion that the ditch be redredged in order to clean out the excessive vegetation. The ditch was originally dredged in order to hasten the run-off of spring flood water which covered Van Road. The ditch is no longer efficiently

performing this function. While redredging Van Ditch would undoubtedly make it easier for violators to find and spear pike in the ditch, it will ensure that at least some of the fry resulting from spawning here will reach the lake. In certain spring seasons when there is a prolonged dry period following the snow meltage, the water level in the lowlands may be reduced rapidly enough to strand some adult pike. Normally, however, most of the adult pike should escape back to the lake.

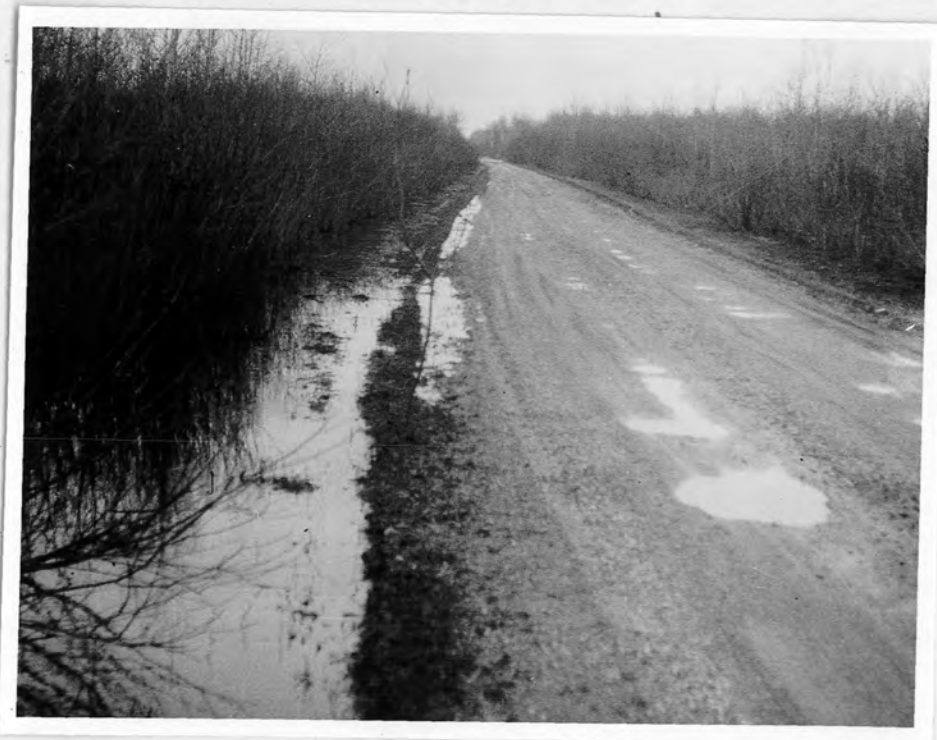
Figure 4. Looking east toward Douglas Lake (one mile) along Van Road. Van Ditch appears at the left. April 13, 1951.

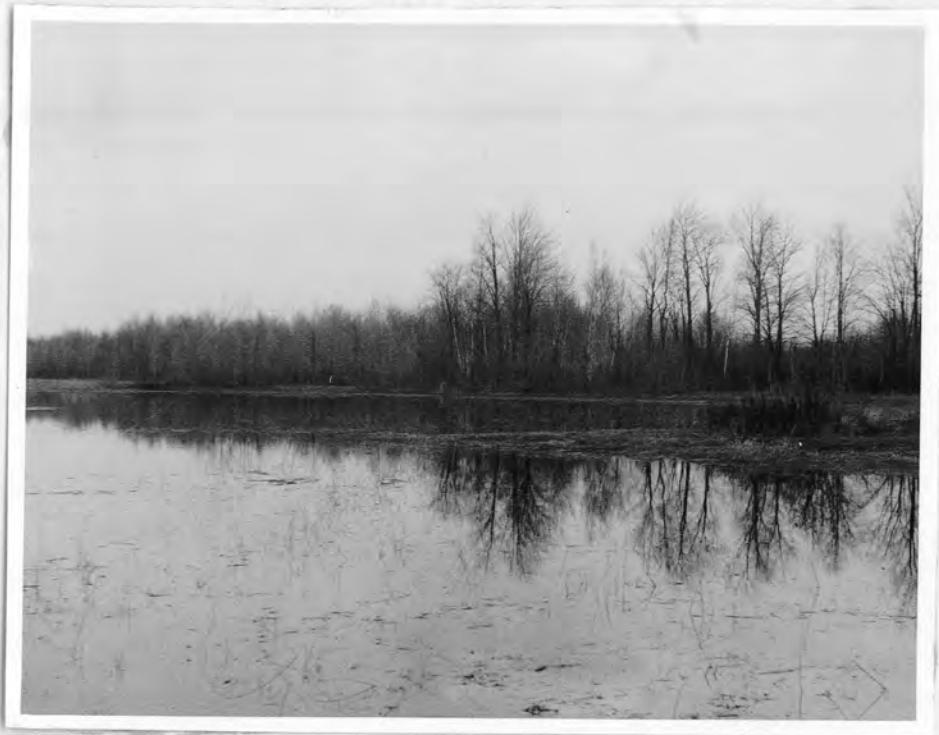
Figure 5. Looking northwest from the point west of the mouth of Lancaster (Bessie) Creek, showing ideal spawning ground typical of much of Marl Bay. April 11, 1951.

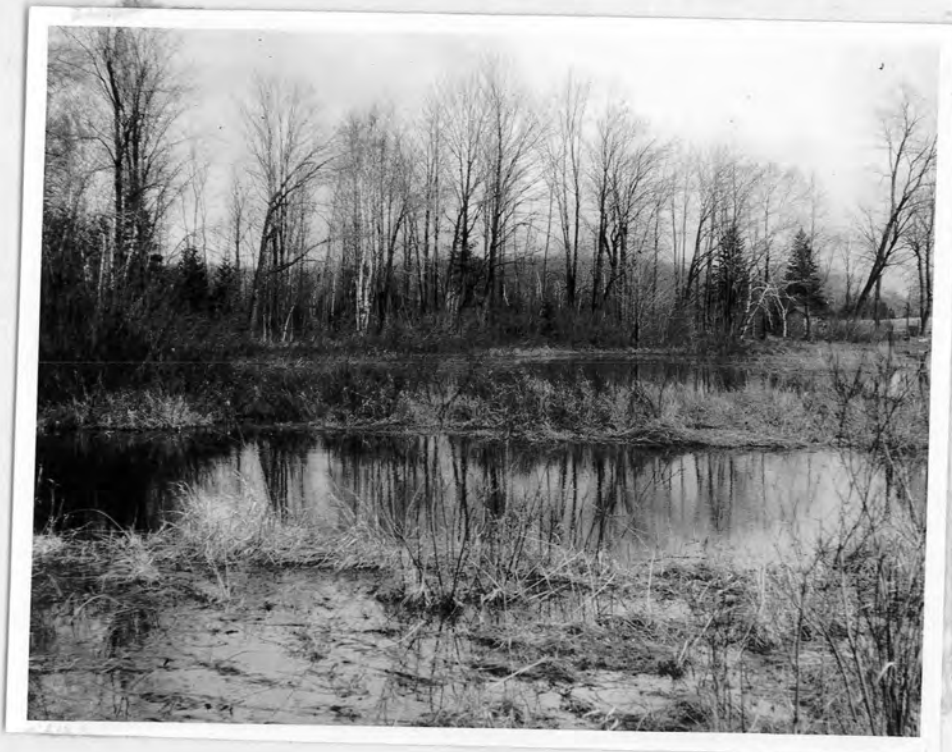
Figure 6. Looking northeast from the western side of the mouth of Lancaster (Bessie) Creek, showing flooded area ideal for pike spawning. The bay in the center background has the same shallow, grassy bottom. April 11, 1951.
