Report No. 1347

OBSERVATIONS ON PIKE SPAWNING AT THE NORTH END OF  
OTSEGO LAKE, OTSEGO COUNTY, DURING THE SPRING OF 1952

John E. Williams and Floyd E. Simonis

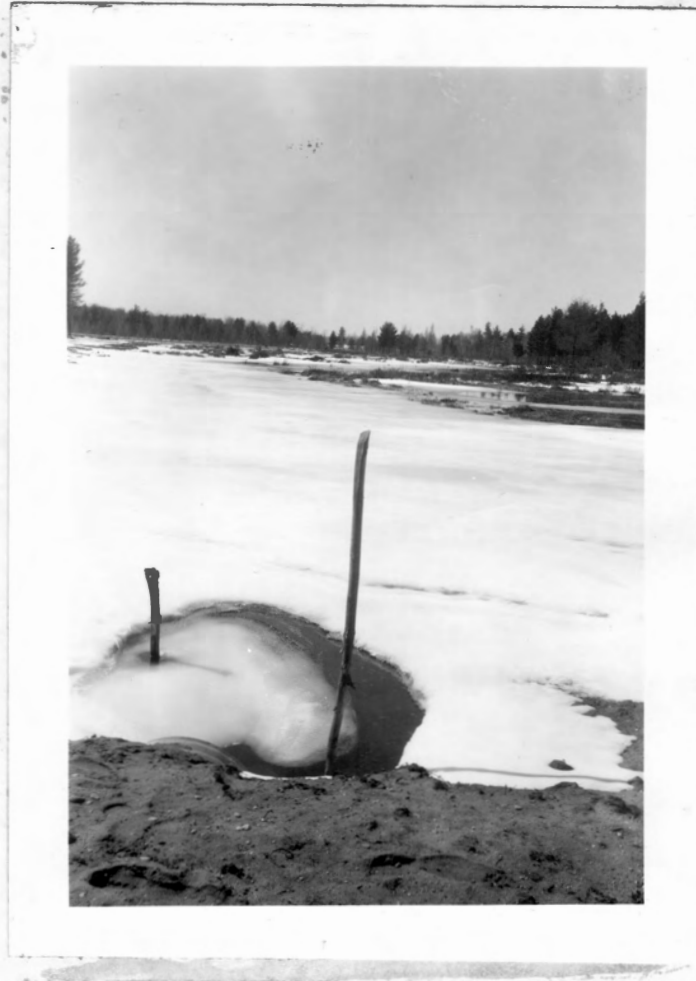
Figure 3. Photograph taken April 8, 1952 looking eastward at Section C from the south end of fill No. 2. Upstream end of Culvert No. 2 and water level gage No. 7 in foreground. U. S. G. S. gage reading 1.90 feet (1273.90 feet m.s.l.).

On April 8, both authors were present and, although some melting had occurred, conditions were not advanced enough to bring on pike spawning. Conditions which prevailed are shown in the photographs of Figures 3 and 4. Additional pictures taken, but not included in this report, are in the senior author's files.

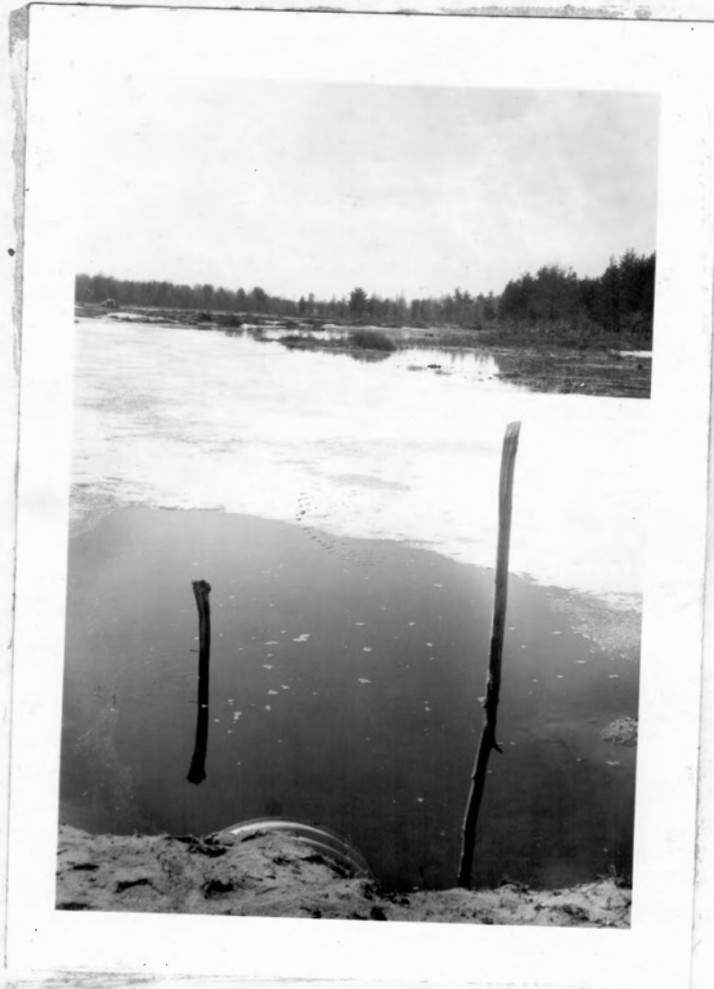
Figure 4. Photograph taken April 8, 1952 looking <sup>WF</sup> eastward at Section B from the south end of fill No. 2. Downstream end of Culvert No. 2 in foreground. U. S. G. S. gage reading 1.90 feet (1273.90 feet m.s.l.).

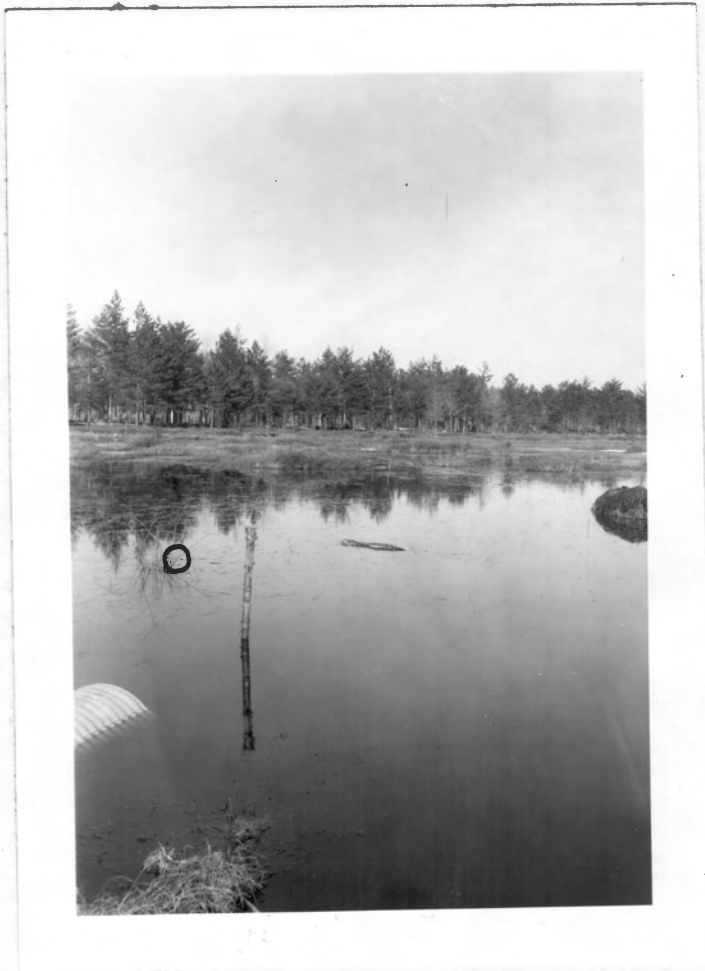
Figure 5. Photograph taken April 15, 1952 looking westward at Section B from the south end of fill No. 2. (same location as Figure 4, but one week later). Downstream end of Culvert No. 2 in foreground. Nail in left side of stake in left foreground indicates the stipulated height of the top of the culvert, or 1274.5 feet m.s.l. U. S. G. S. gage reading 2.07 feet (1274.07 feet m.s.l.). Heavy spawning action was going on at this time in the open water in the background, beyond the ice.

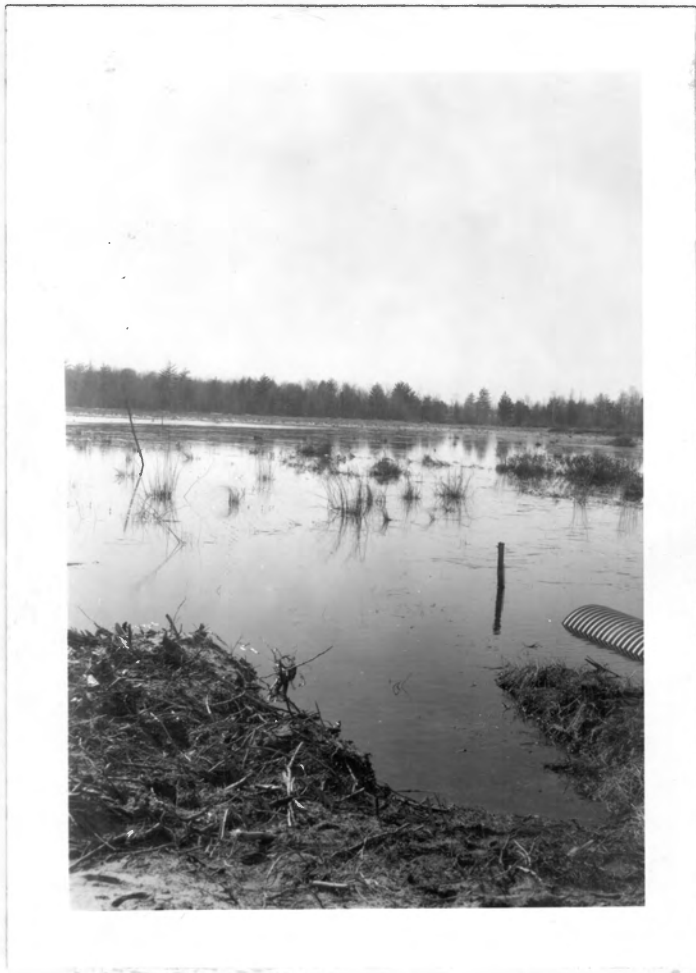
Figure 6. Photograph taken 3:00 p.m. April 15, 1952 looking northeastward at Section B from the south end of fill No. 1. Upstream end of culvert No. 1 in left foreground. U. S. G. S. gage reading 2.07 feet (1274.07 feet m.s.l.). Heavy spawning action was going on in the section at this time. The circled area indicates the location of the two pike shown in Figure 8.
