Dowagiac River - Pucker Street Dam Draw Down Experience
Berrien County, T07S, R17W, Secs 12, 13, 14, 22, and 23
Surveyed May 1999 through September 2002

Jay K. Wesley

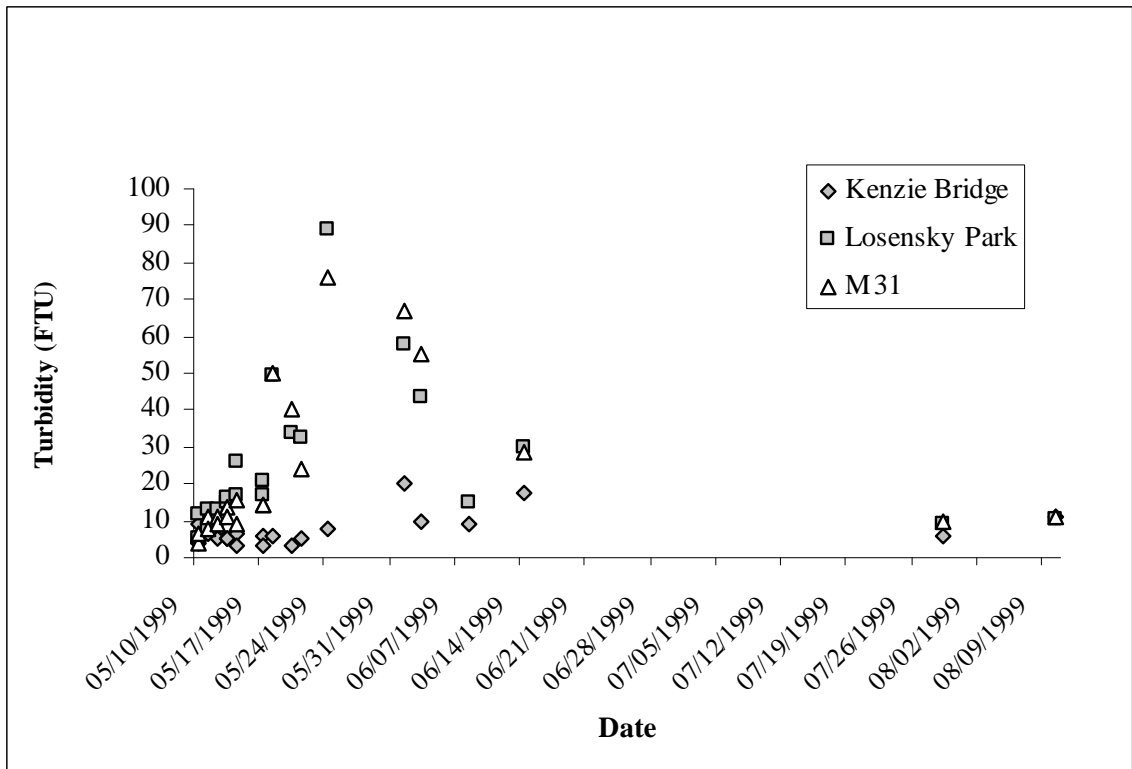
Figure 3. Turbidity of the Dowagiac River during the Pucker Street Dam draw down.

Turbidity remained at or below 15 FTU at all monitoring stations for the first week after the draw down started (Figure 3). Losensky Park consistently had higher turbidity than the control site at Kenzie Bridge and M-31 downstream. Turbidity increased in the second week and remained high for about three weeks while the river cut a new channel through the impoundment. Bottom sediments from the impoundment were exposed to air after the first week of the draw down. Turbidity peaked around May 24th at 90 FTU. By August 1999, the turbidity at all three sampling stations was the same and appeared to be back to normal levels for the river.

Turbidity measurements were elevated for about a month. Even with the highest turbidity of 90 FTU, it did not appear that turbidity was high enough to cause noticeable mortalities of fish and invertebrates. Only one dead white sucker was observed at the M-31 station. Rowe et al. (2002) showed mortality in smelt and some invertebrates with turbidity over 1,000 FTU. It is not clear what effect long-term exposure to turbidity had on feeding behavior and survival of fish and invertebrates. Most studies are conducted for 24 hrs or simulate pulses of sediment similar to rain events. Dam draw downs increase turbidity for longer periods of time. Dissolved oxygen remained above 8 mg/l in the lower river throughout the high turbidity exposure and may have increased survival of fish and invertebrates.

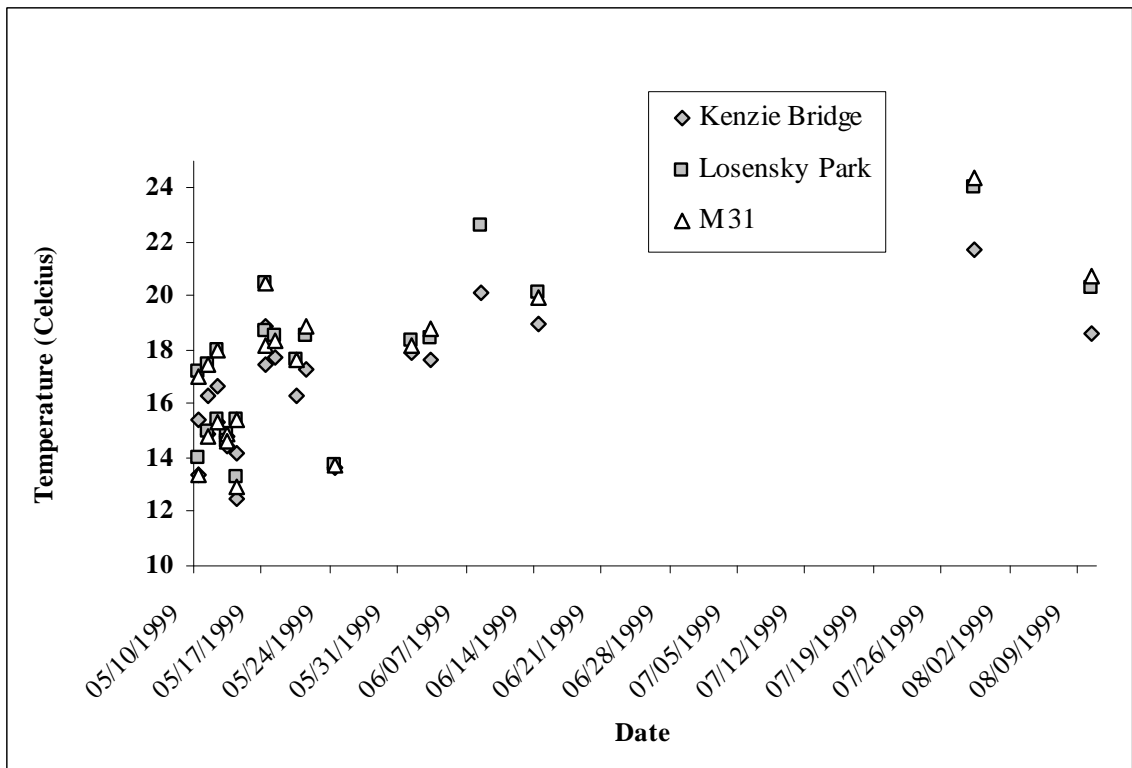
Figure 4. Temperature of the Dowagiac River during the Pucker Street Dam drawdown.

Temperature ranged from 13 to 23 °C with Kenzie Bridge consistently lower than the two sites below the impoundment (Figure 4). In late June and August, recorded temperatures were as much as two °C cooler above the impoundment. This difference was more evident post drawdown than before the drawdown. The July 2000 mean temperatures were 18.6 °C for Kenzie Bridge and 18.8 °C for M-31.

Stream temperatures warmed through the impoundment by at least two degrees after draw down due to increased sun exposure and presence of dark sediments. After two years of vegetation growth and narrowing of the river channel, the temperatures upstream and downstream of the dam were similar. M-31 July mean temperature decreased two °C in 2000 compared to measurements in 1993 (Wesley and Duffy 2003). This was a positive result of the project and will assist future management of trout and salmon in the lower river. Anglers have observed more Chinook salmon and steelhead smolts than in the past, a likely result of colder summer temperatures.

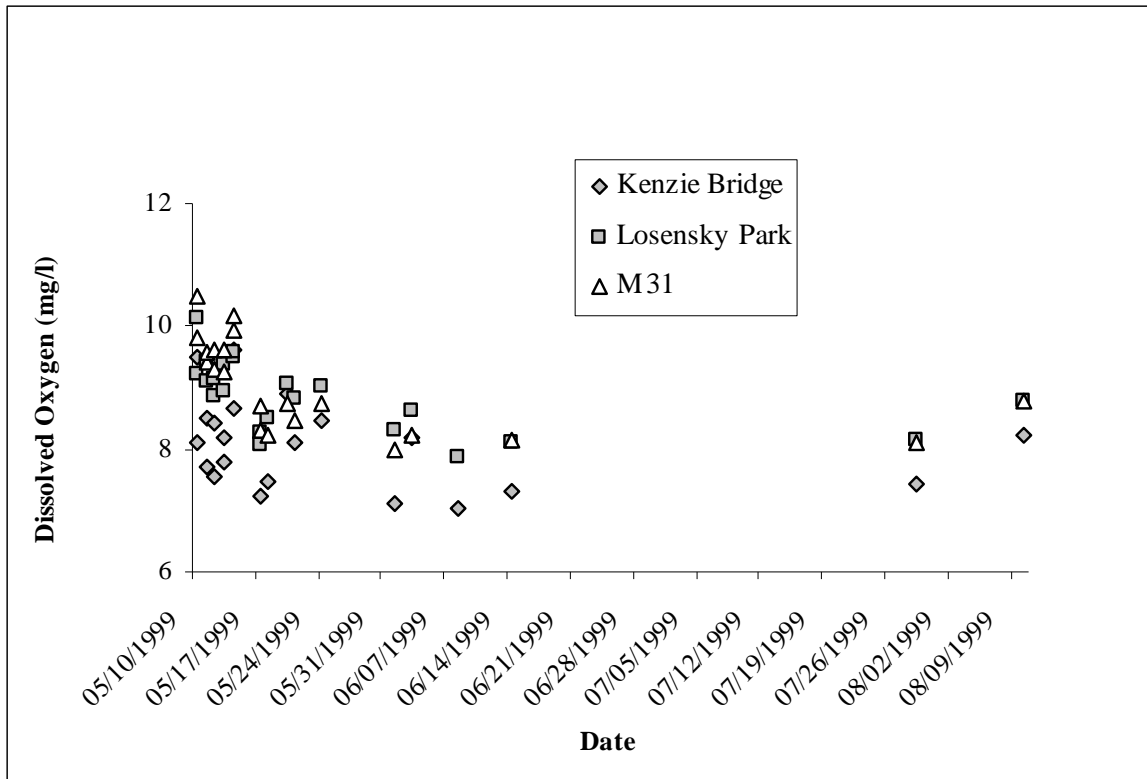
Figure 5. Dissolved oxygen of the Dowagiac River during the Pucker Street Dam drawdown.

Dissolved oxygen remained high throughout the drawdown (Figure 5). Oxygen was highest when river temperatures were lower. Losensky Park and M-31 monitoring sites had higher dissolved oxygen concentrations than the Kenzie Road site, which was probably due to atmospheric mixing of air and water going over the dam and riffles in the lower river.

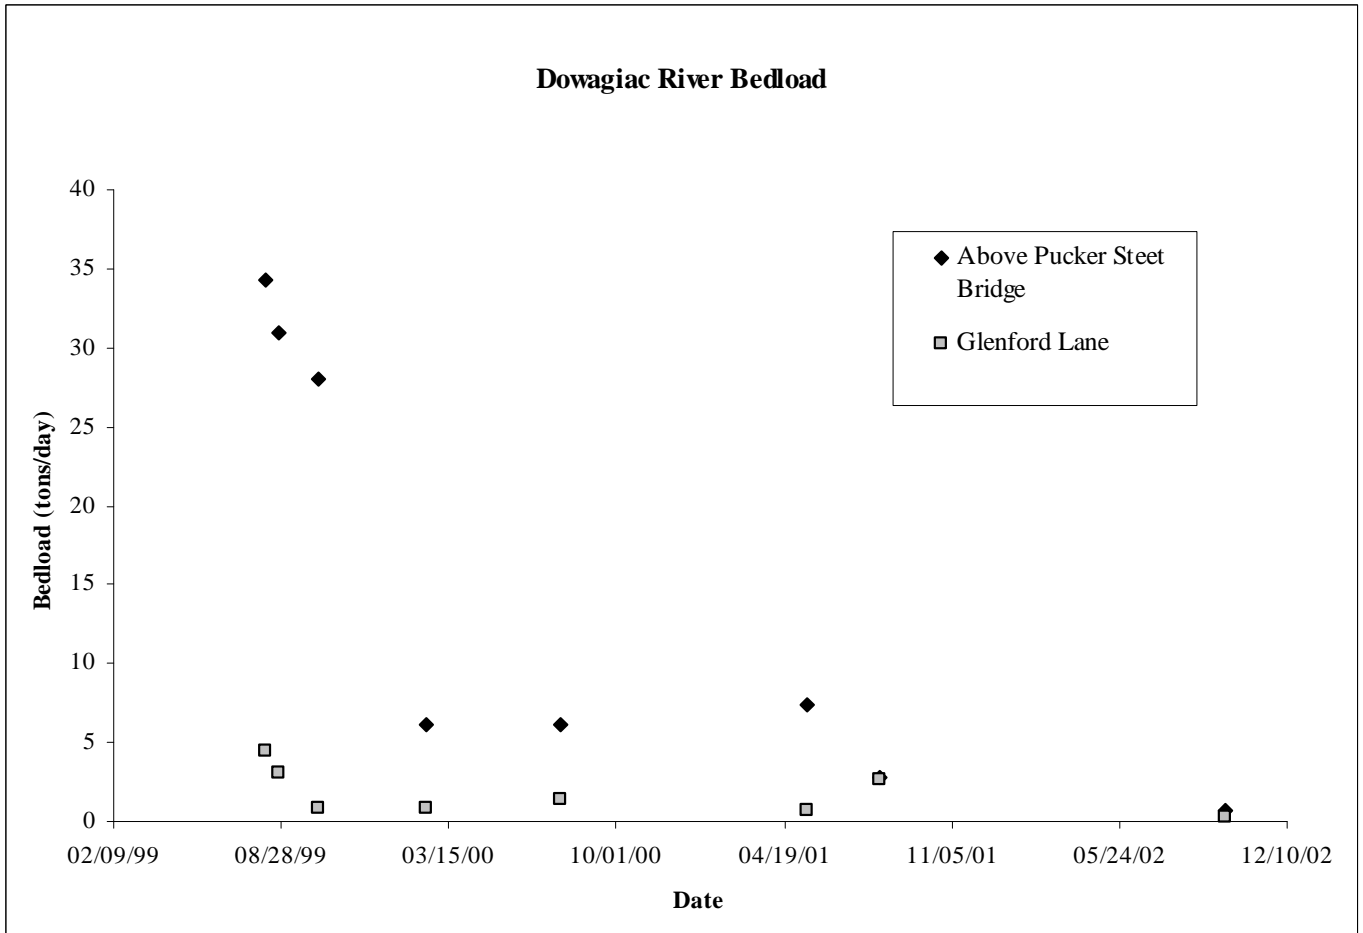
Figure 7. Dowagiac River bedload above Pucker Street Bridge and Glenford Lane.

Bedload estimates were 35 tons per day when the trap was first installed while estimates at Glenford Lane ranged from five to less than one ton per day depending on river discharge (Figure 7). The bedload above Pucker Street Bridge remained high through the fall of 1999. From spring of 2000 through spring of 2001, the bedload above the dam remained at about five tons per day. In the fall of 2001, the bedload estimates above the Pucker Street bridge and Glenford Lane were approximately the same at 3 tons per day. At this time, trap cleaning frequency was down to about once every 6 months. The bedload estimates were again the same in September 2002 at less than one ton per day. At this time, the City of Niles and Fisheries Division officially abandoned the trap. The mountain of sand that was created with the sand spoils was leveled, top soiled, and seeded (Appendix 1, Pg 7).

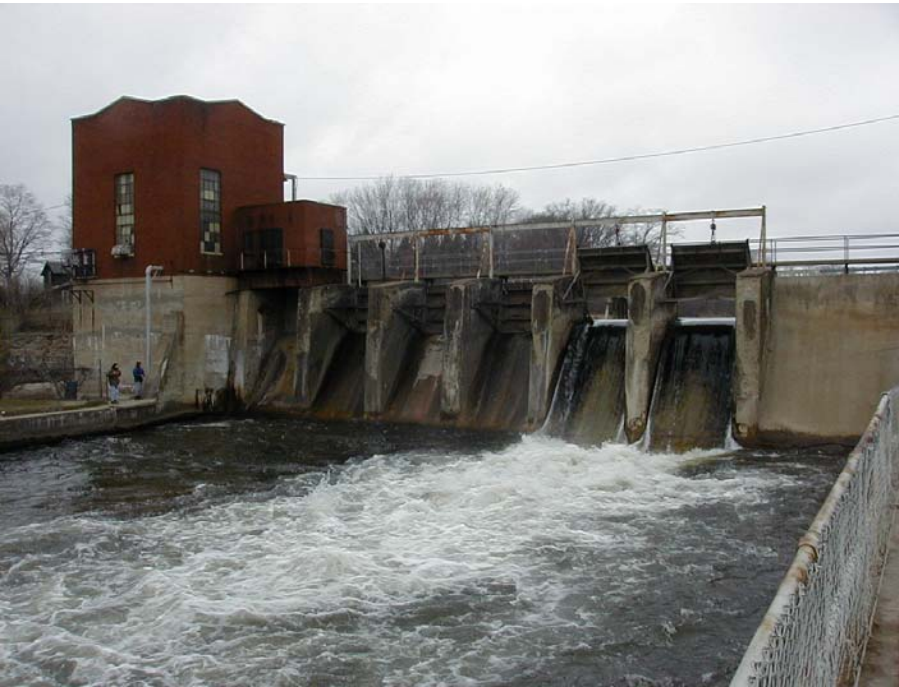
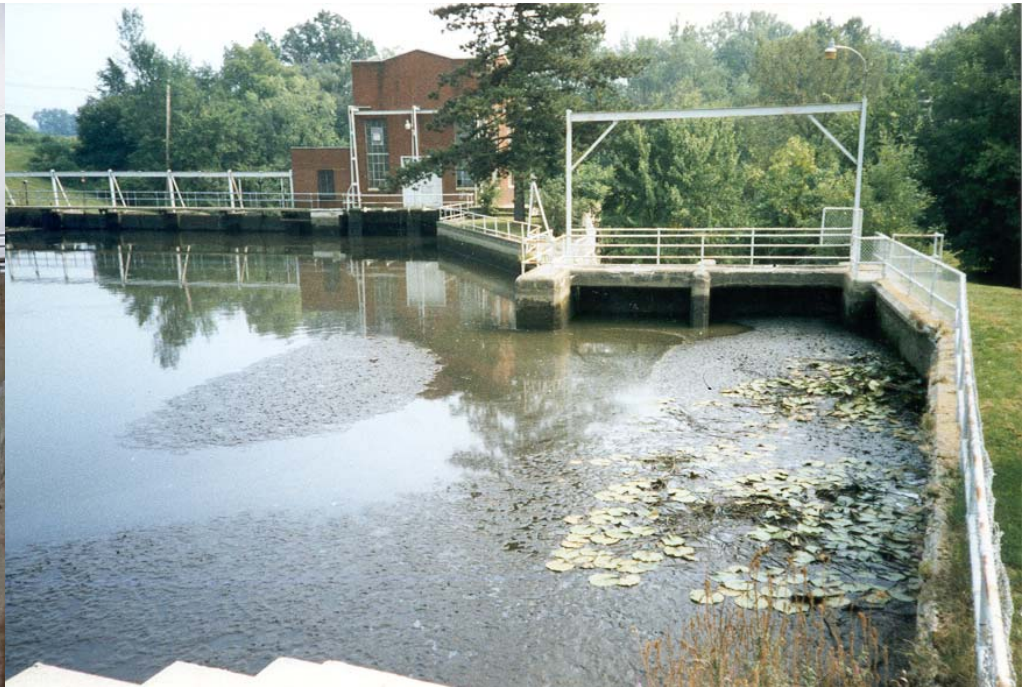
Pucker Street Dam in Niles, Michigan.

The Pucker Street Dam (Appendix 1, Pg 1) is the only mainstem barrier and is located approximately three miles upstream of the Dowagiac River's confluence with the St. Joseph River (Figure 1). The dam is in Niles Township, Berrien County and is owned by the City of Niles. The impoundment at full head of 20 ft creates a narrow 60 acre impoundment that has an average depth of three feet.

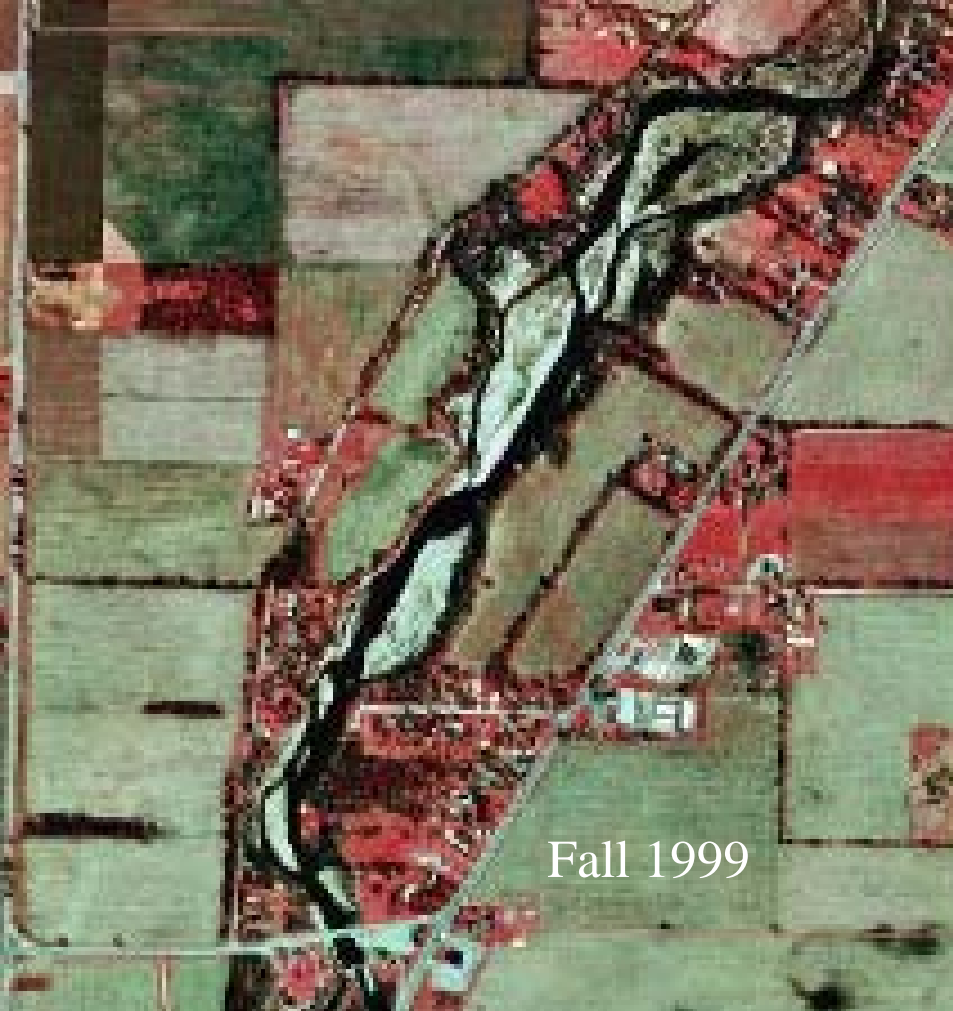
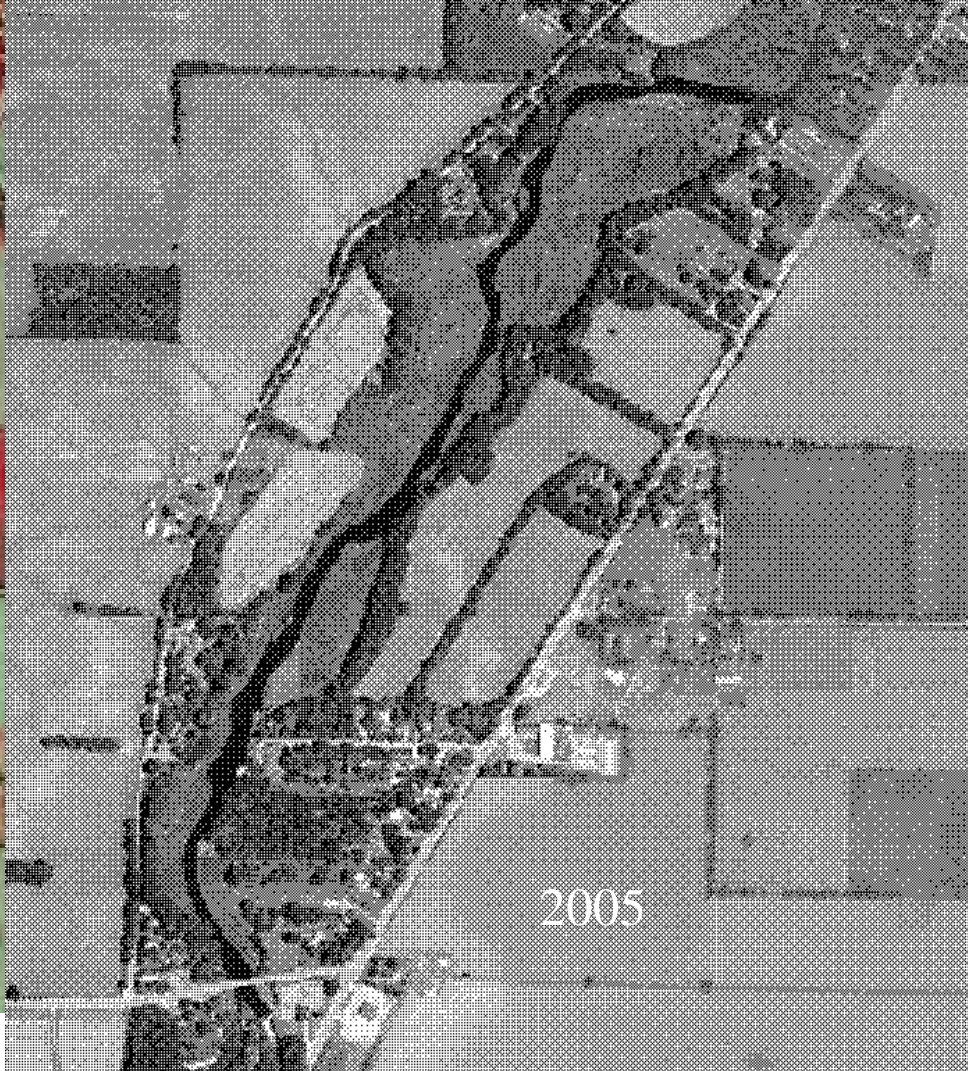
Aerial view of Pucker Street Impoundment post draw down.

The major goals of this project were to create run of river flow and eliminate frequent sediment pulses as flow gates at the dam were manipulated. The permanent raising of the gates and draw down accomplished both goals but at a high initial and short-term cost of increased sand bedload. After three years, the impoundment reverted to an 80 ft wide river channel with riffles, runs, and pools and

substrates consisting of clay, sand, gravel, and cobble (Appendix 1, Pg 6). The long-term change was the introduction of a natural sand bedload below the dam. The dam was an effective sand trap for over 80 years. The run of river flow and natural sediment transport will be healthier for river morphology and biology.

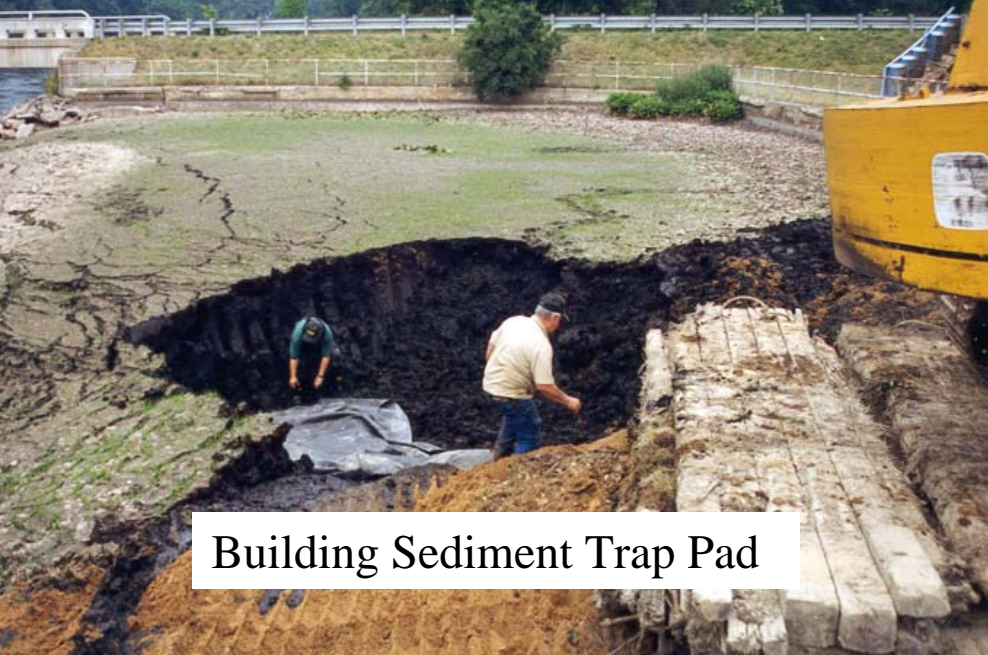
Building Sediment Trap Pad

The deposition of sand observed on June 8, 1999 was of great concern, so the Fisheries Division Heavy Equipment Crew moved in and constructed a sediment trap immediately above the dam on June 10th. An excavator was used to remove organic sediments along the river and replaced them with sand and gravel to create a stable pad for trap cleaning. An extended 60 ft boom excavator was used to reach as far across the river as possible to create a deep hole to collect the sand bedload. The original trap was 95 ft long, 50 ft wide, and 8 ft deep (Appendix 1, Pg 7).

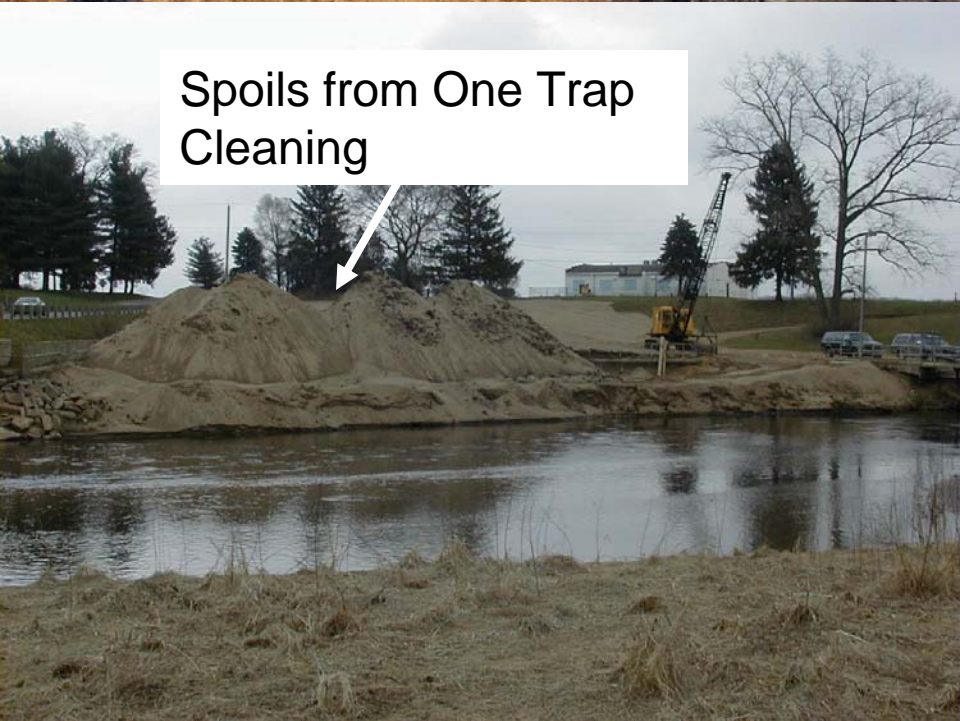
Spoils from One Trap Cleaning

The sand bedload was so high that the sediment trap filled on a monthly basis. Costs to dredge the trap ranged from \$3,000 to \$4,500 depending on the equipment used and contractor. The Fisheries Division Heavy Equipment Crew cleaned the trap with a rented long reach excavator for \$3,000. A contractor was hired with a drag line that cost \$4,500. The dragline method was preferred because it could dig the trap wider and deeper. The final trap size was 110 ft long, 70 ft wide and 12 ft deep. The trap was maintained until September 2002 when bedload estimates at the dam were equivalent to background estimates. The sediment trap was cleaned 14 times (two times by Fisheries Division and 12 times by contractors) at a total cost of approximately \$50,000, which was shared between Fisheries Division and City of Niles. Approximately, 48,000 cubic yards of sand were removed from the river (Appendix 1, Pg 7).

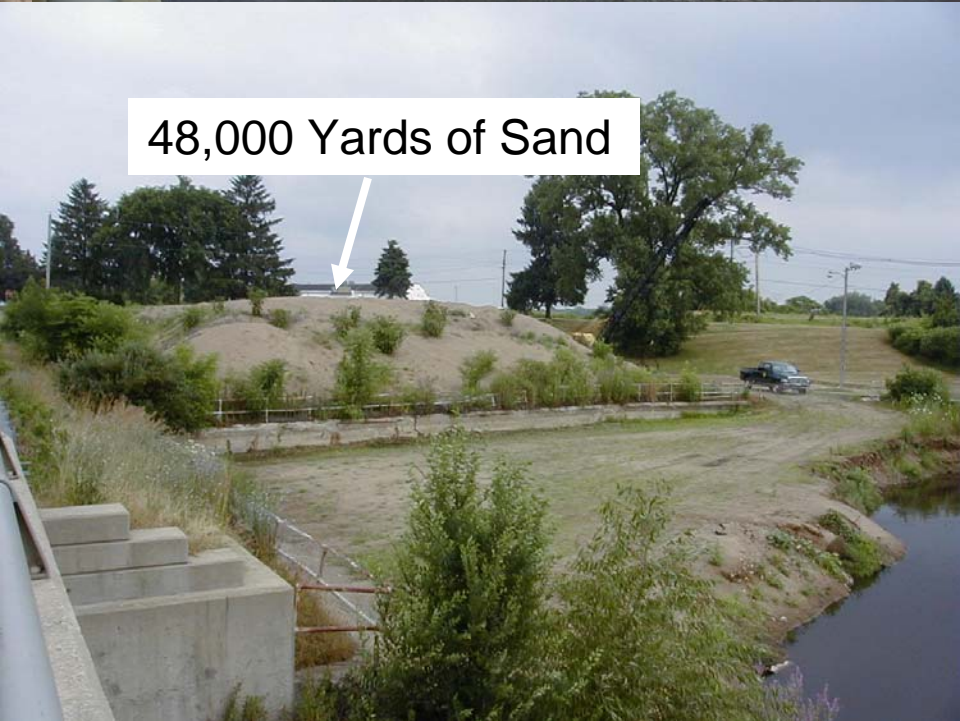
48,000 Yards of Sand

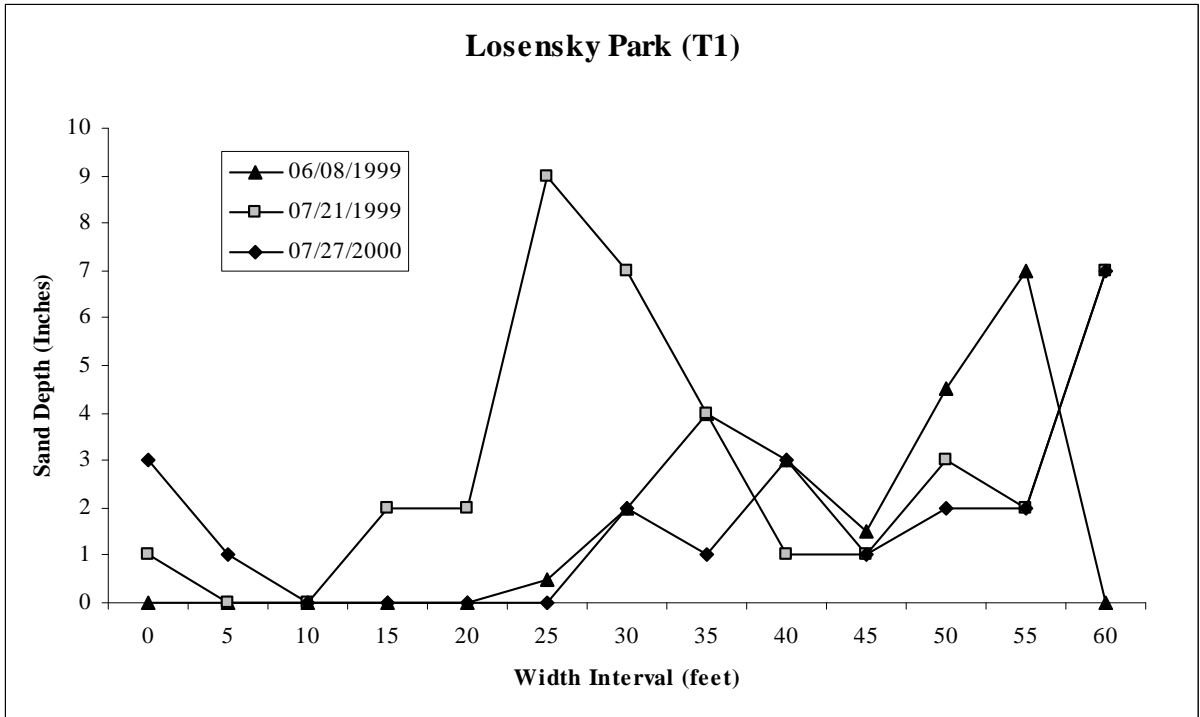
Sand depth cross-section of the Dowagiac River at Losensky Park (T1).

Sand depth cross-section results for transects 1 through 7 on the Dowagiac River from June 8th, 1999; July 21, 1999; and July 27, 2000.

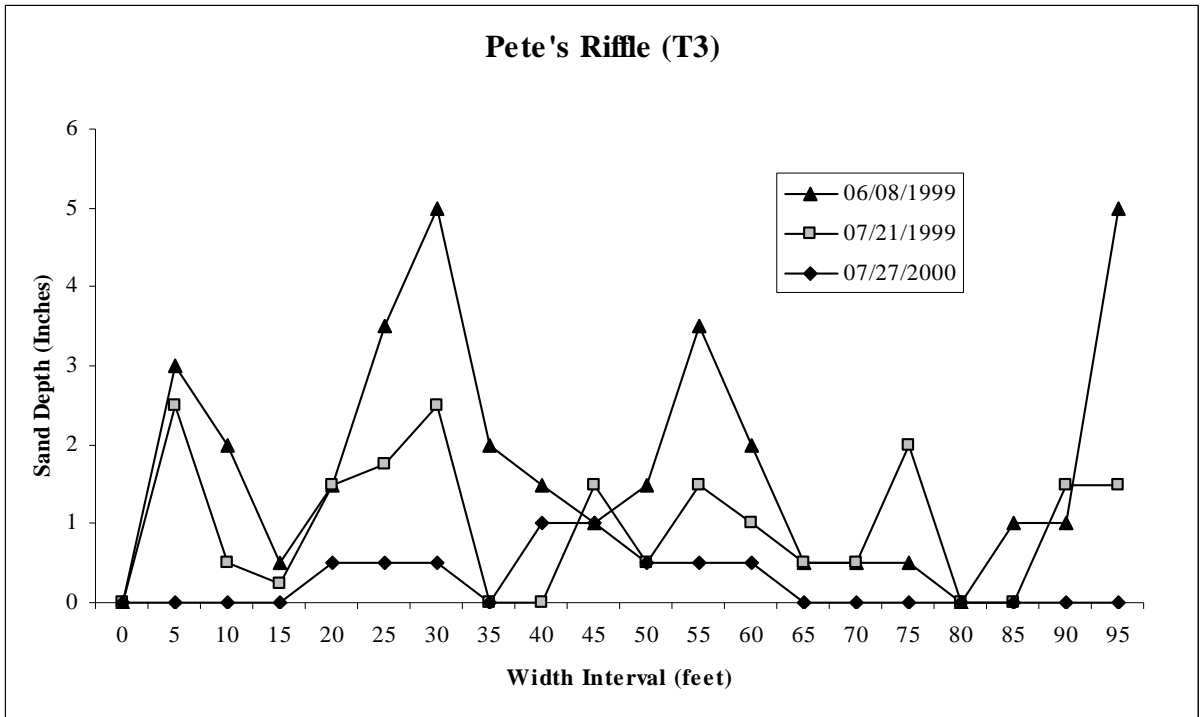
Sand depth cross-section of the Dowagiac River at Pete's riffle (T3).

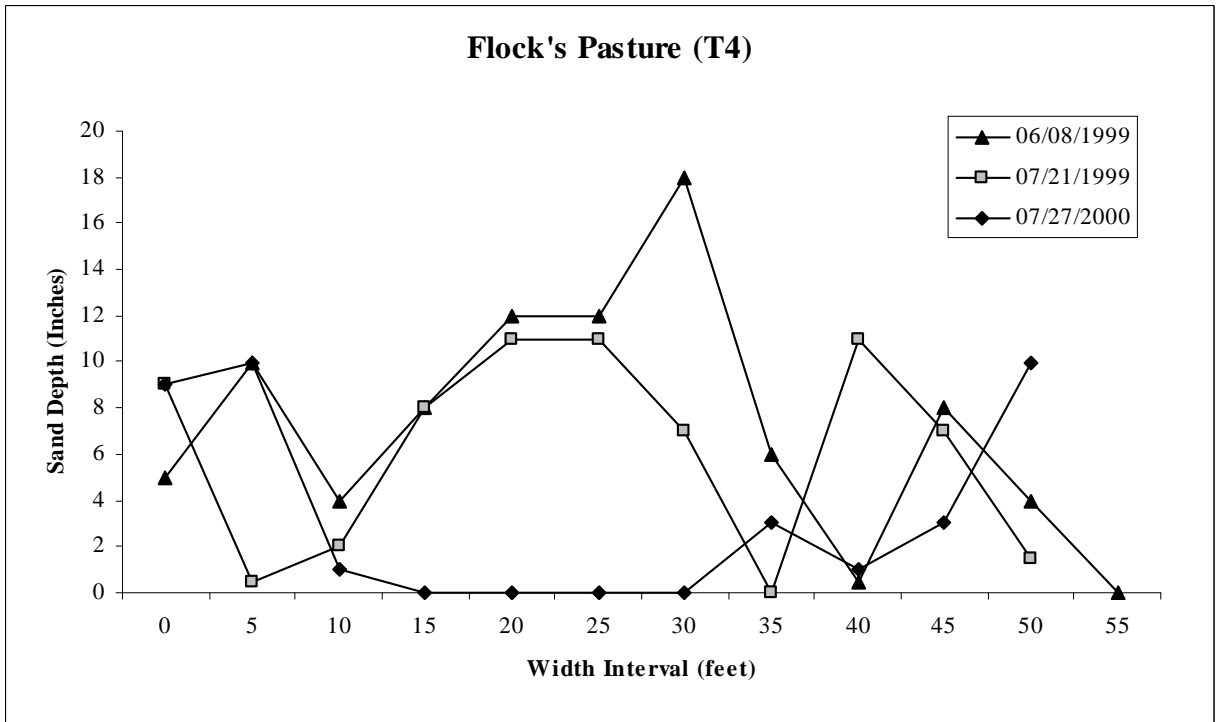
Sand depth cross-section of the Dowagiac River at Flock's pasture (T4).

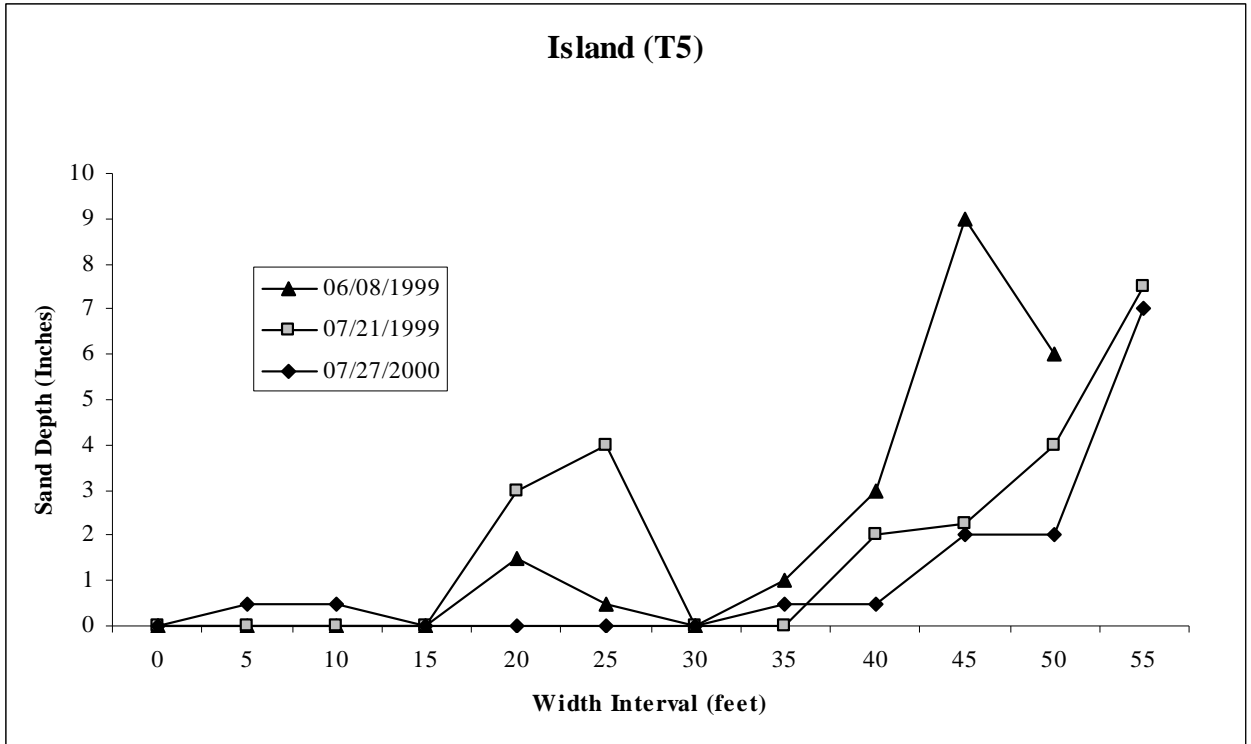
Sand depth cross-section of the Dowagiac River at the second island (T5).

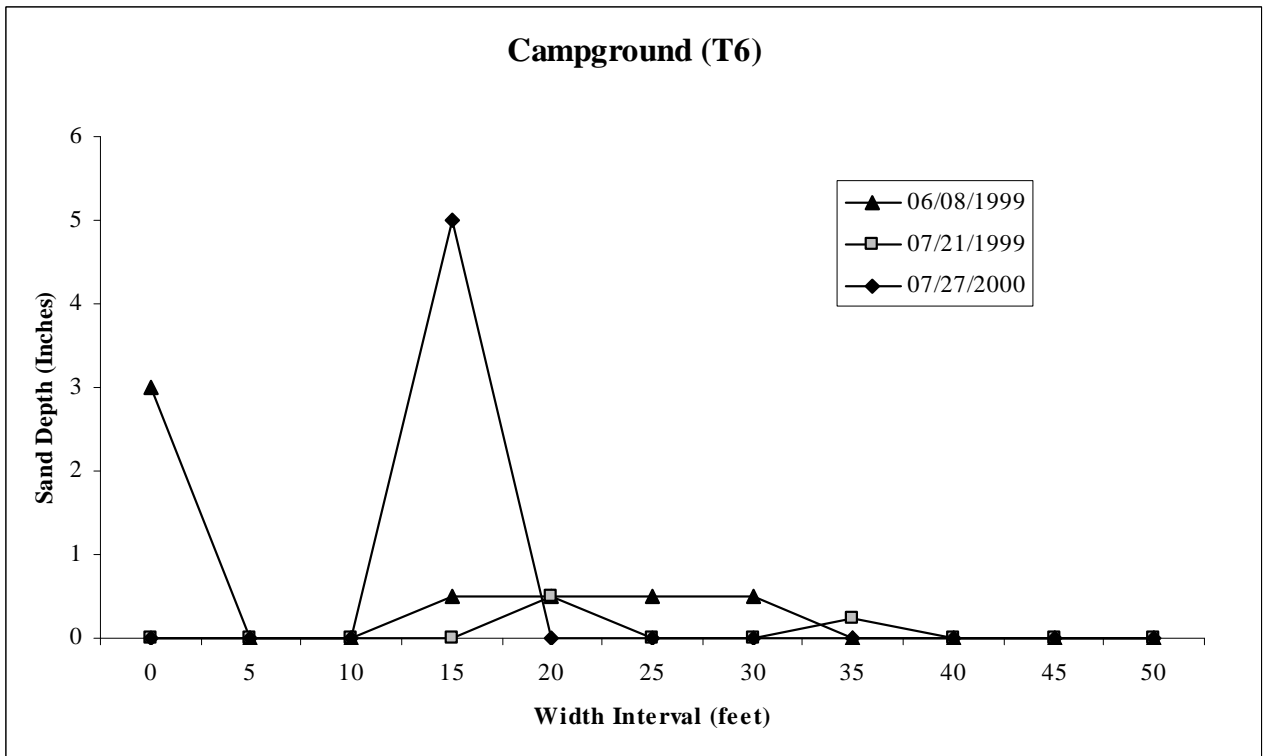
Sand depth cross-section of the Dowagiac River at the campground (T6).

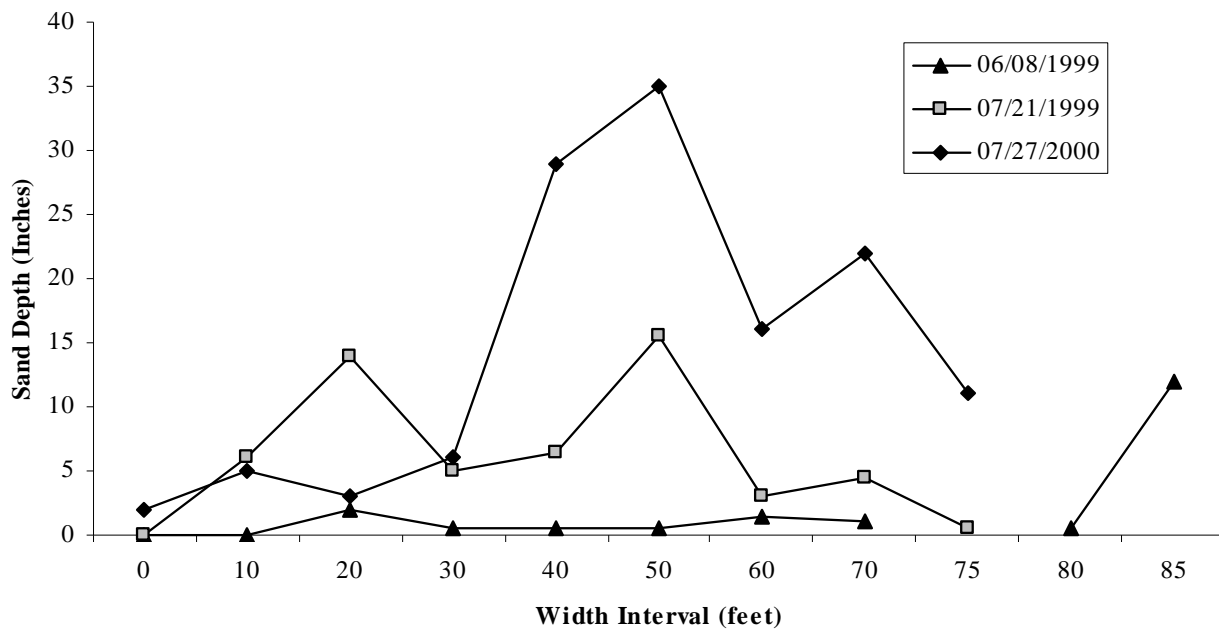
Canoe Livery (T7)

Sand depth cross-section of the Dowagiac River at the canoe livery (T7).
