THE APPLICATION OF LAND USE TO FISHERIES MANAGEMENT IN MICHIGAN

O. H. Clark
Michigan Department of Conservation
Lansing 13, Michigan

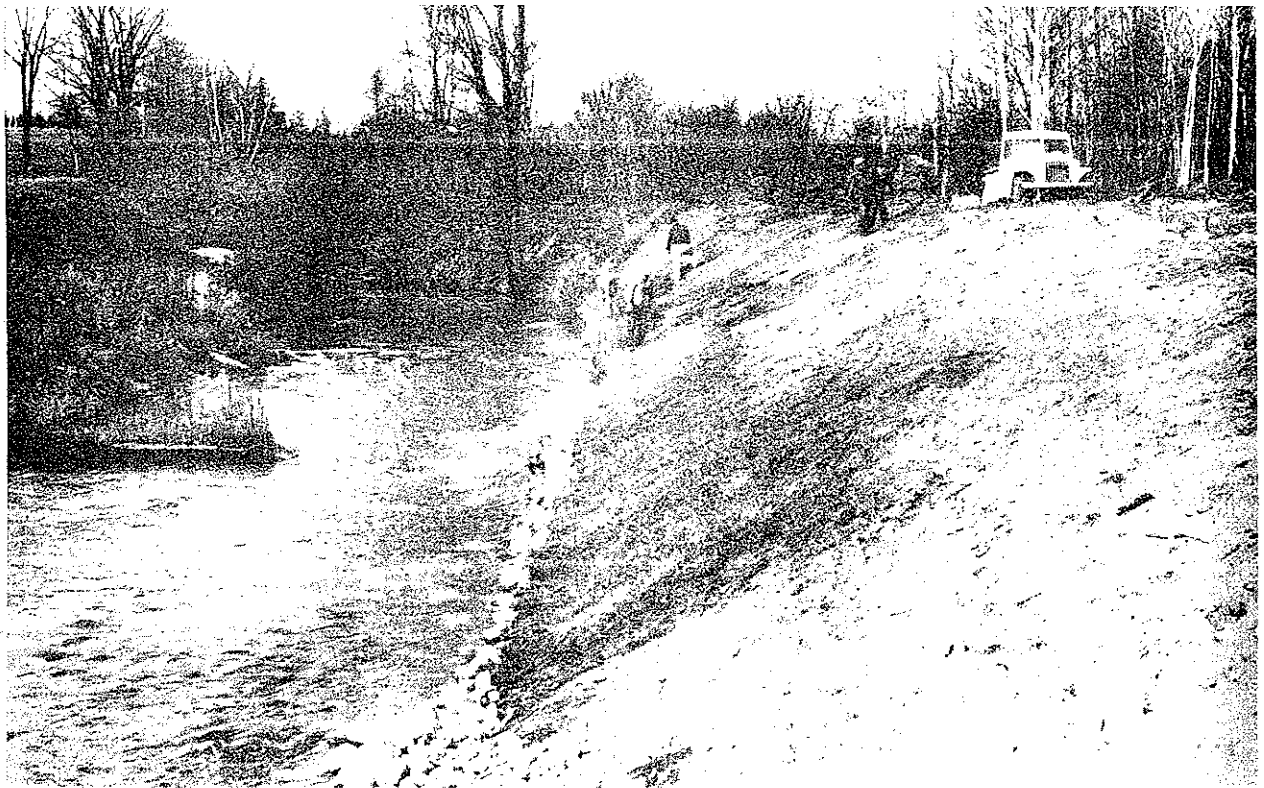
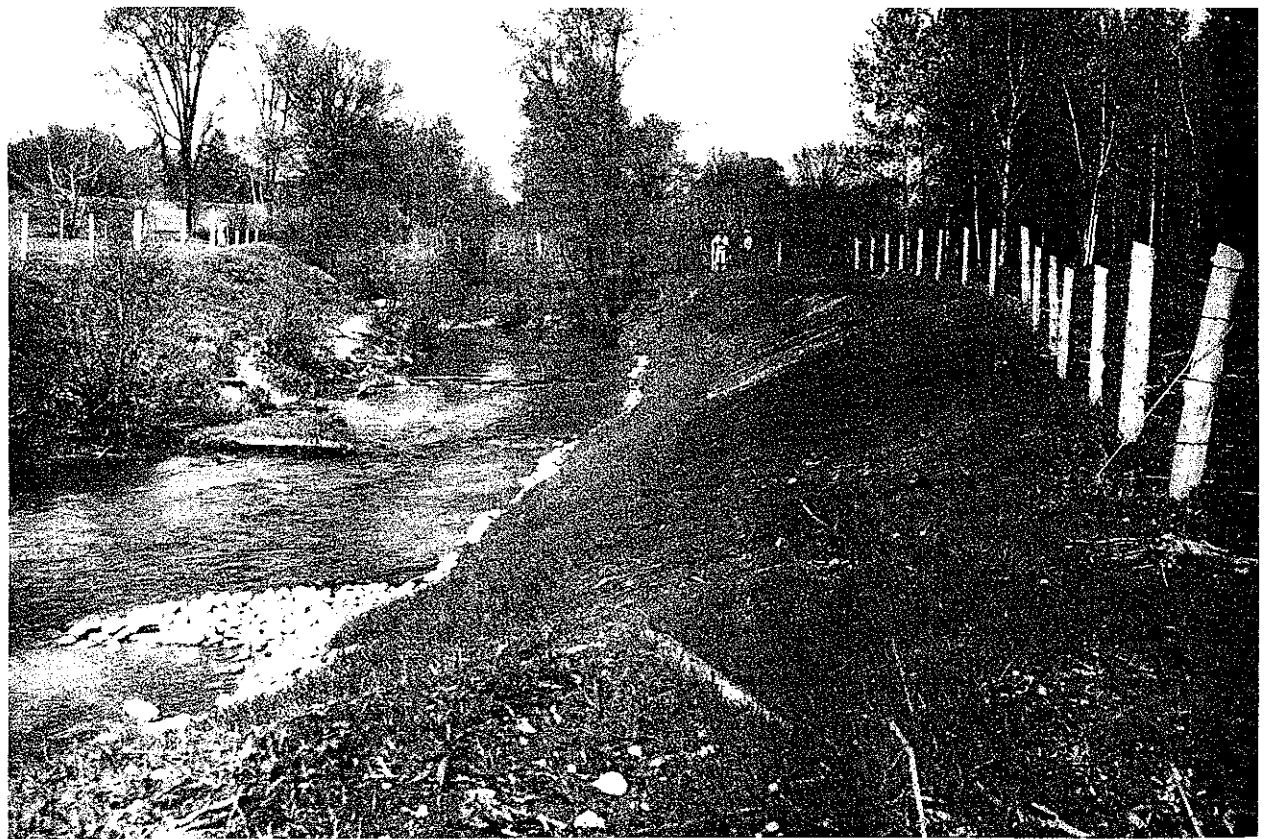
TOP: Stabilization of an eroding bank by reduction of slope, sodding, and riprap.
BOTTOM: Same stream section after completion, with fence to limit stock access.

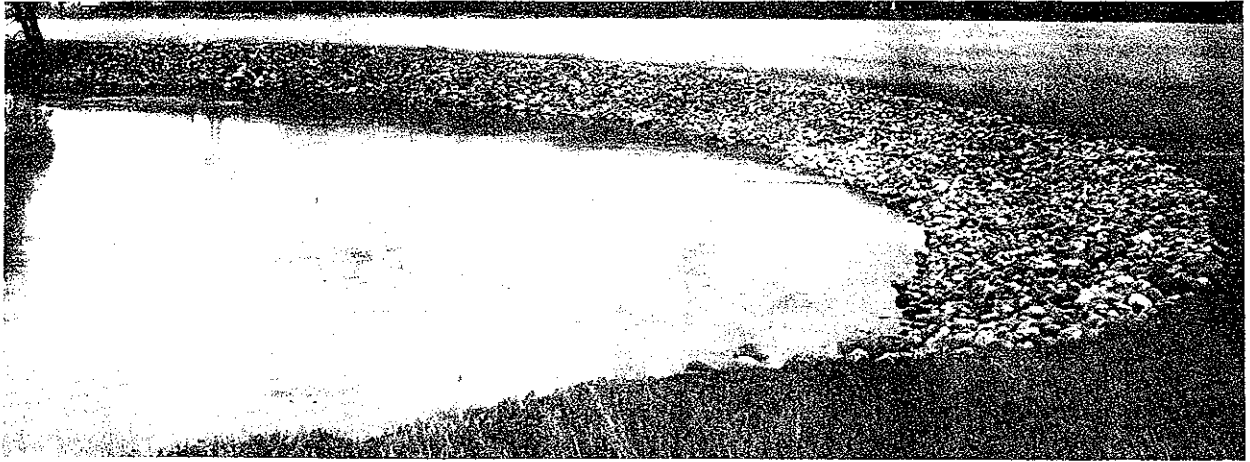
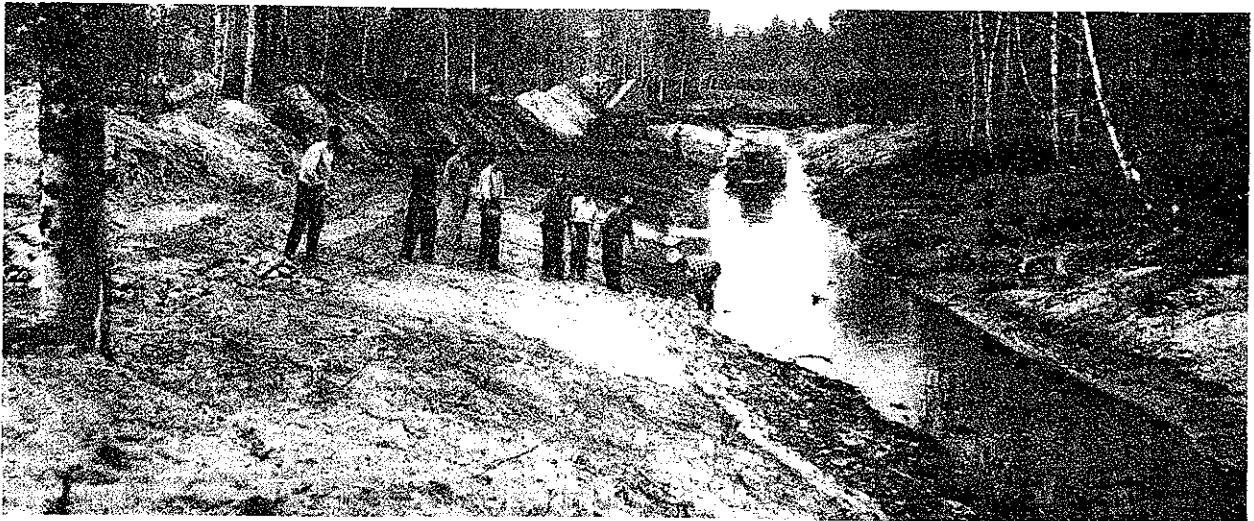
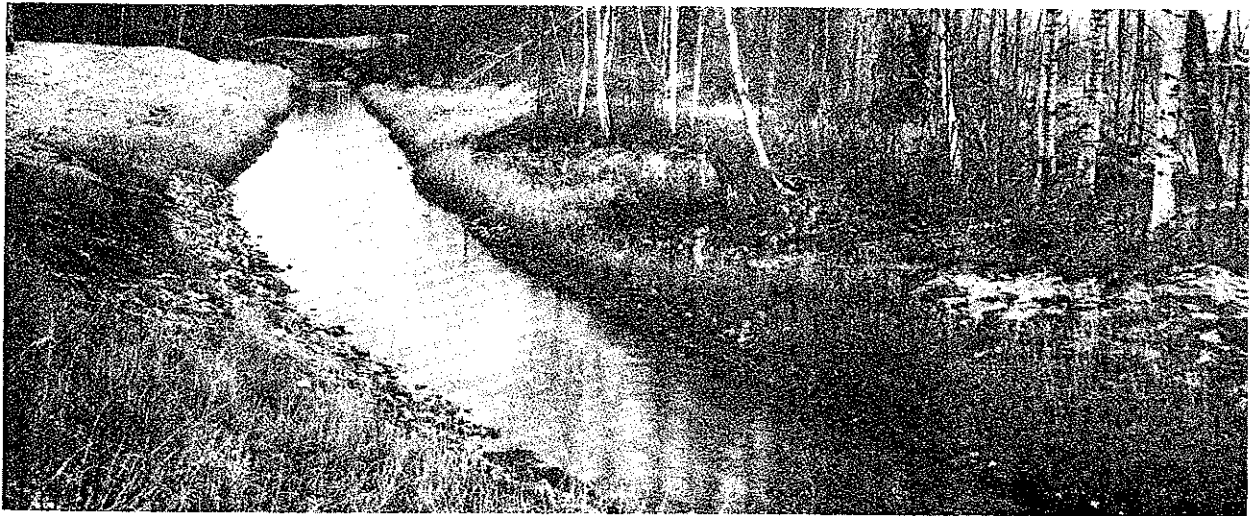
TOP: Control by riprap of an eroding bend in stream.
CENTER: Stream section in process of improvement.
BOTTOM: Same stream section after completion of improvement measures.

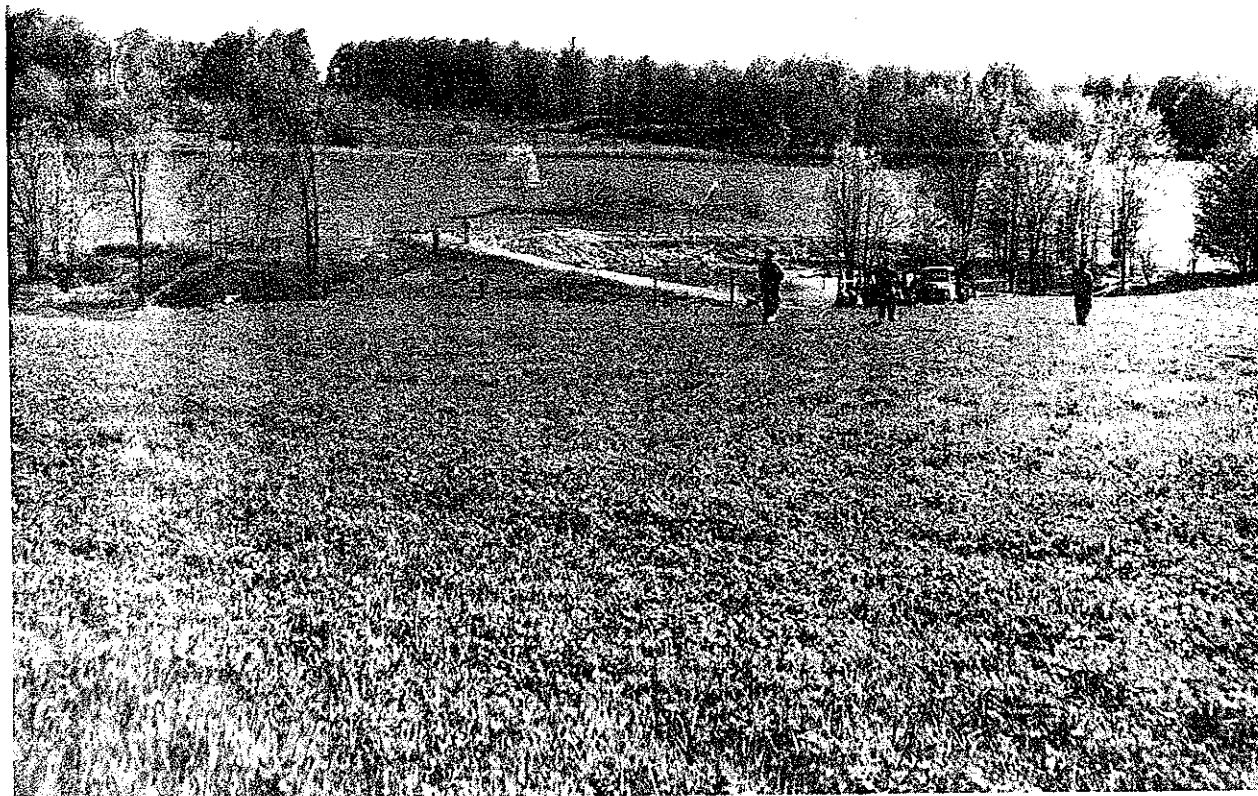
TOP: Headwater retention reservoir.

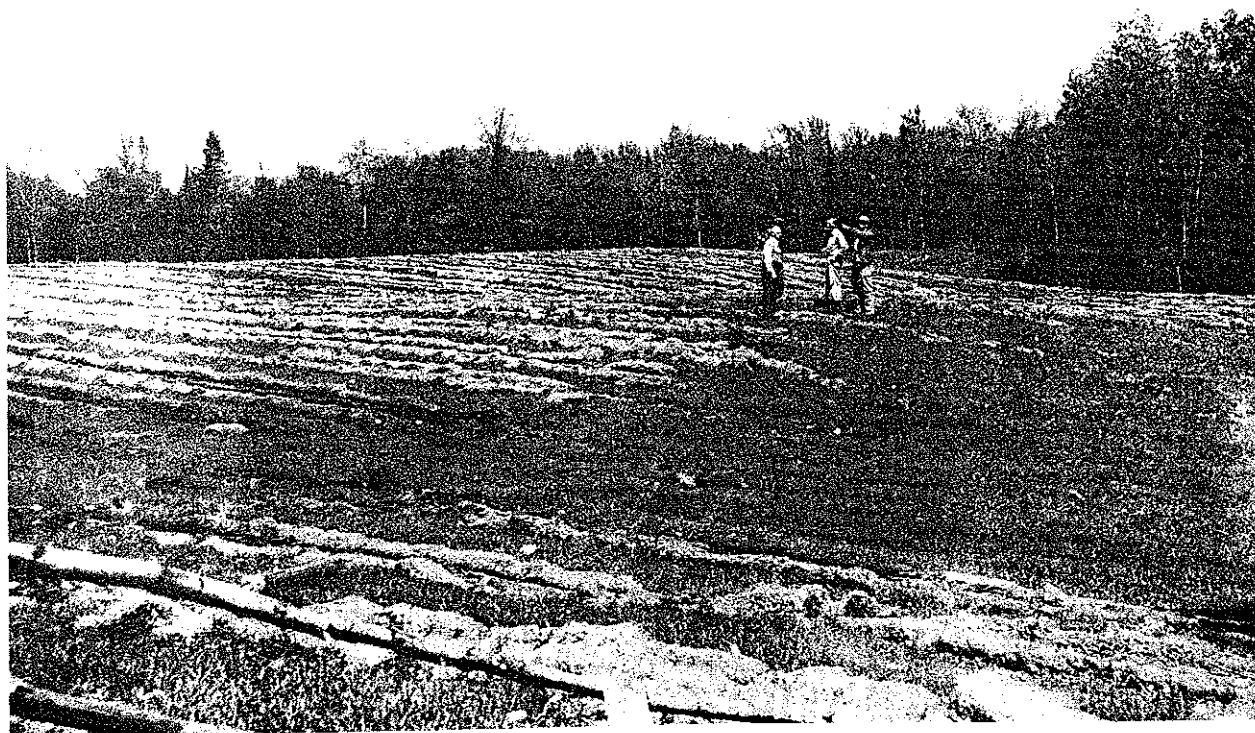
BOTTOM: Tree planting in cooperation with land owner to restrict run-off waters.

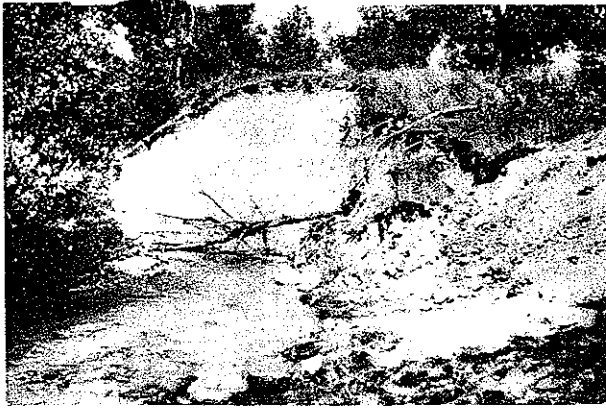
Bank before work.

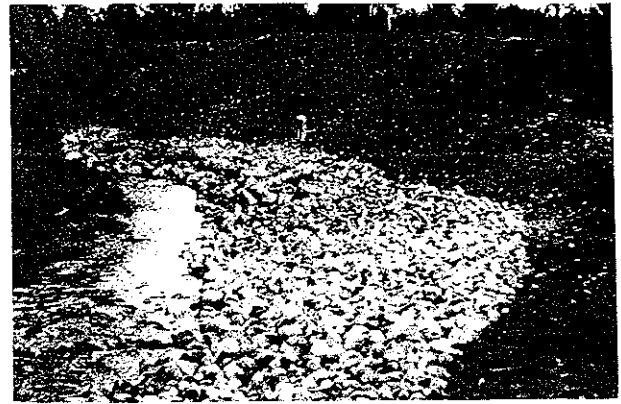
Same bank after stabilization.

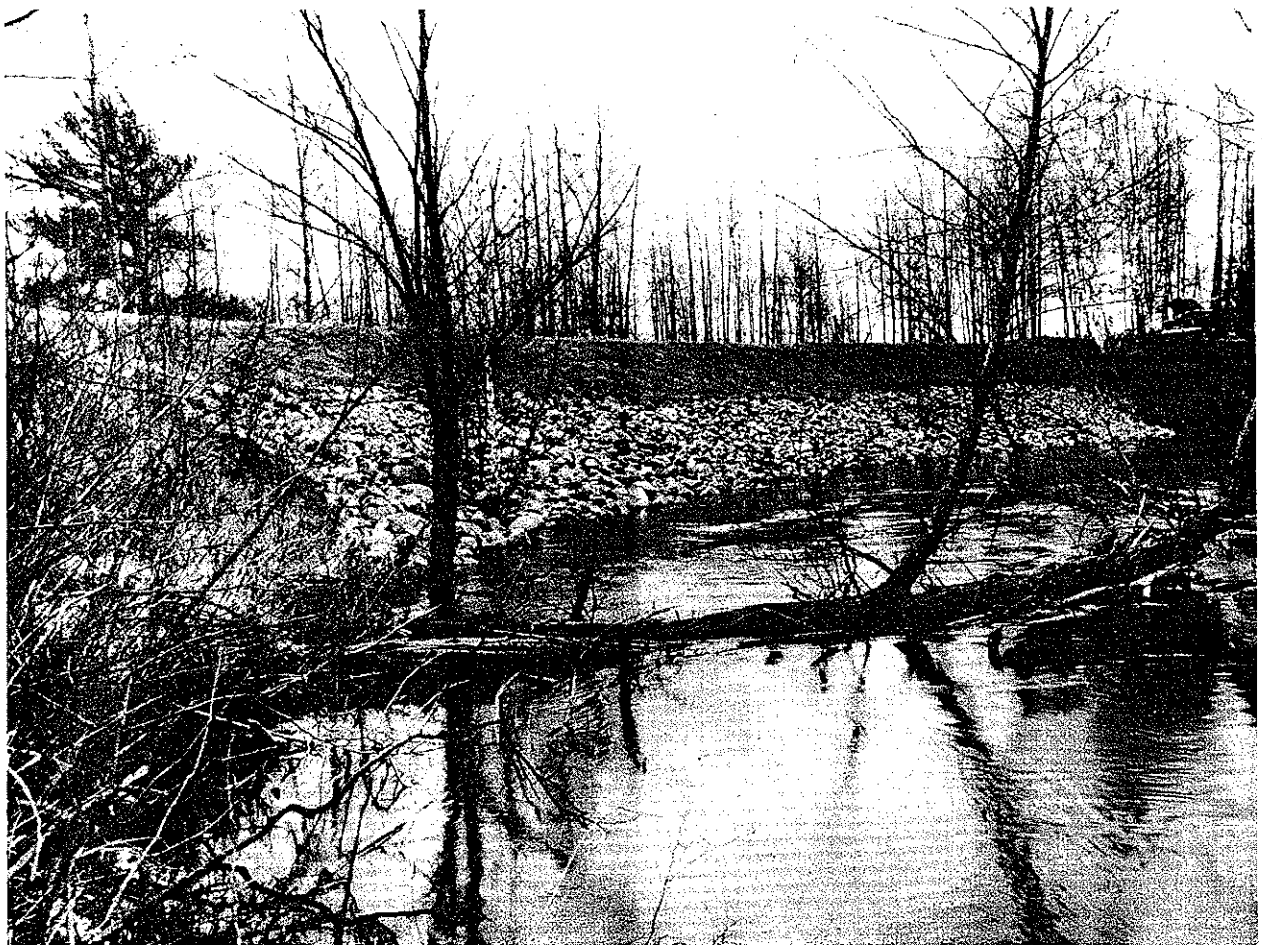
Bank controls.

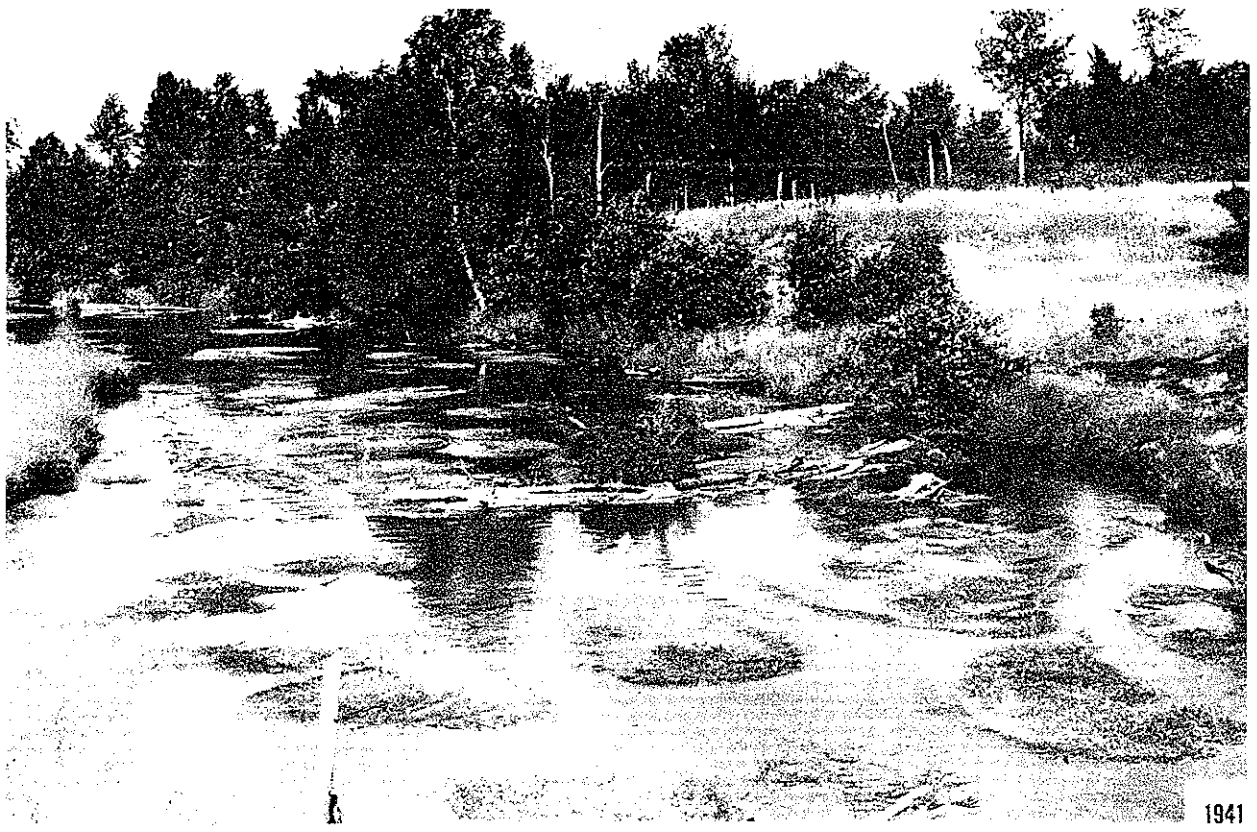
1941

The two photographs on the next page and the photograph on the following page show the effects of 11 years of stream improvement work. These photographs were taken in 1941, 1946, and 1952, respectively. Note the narrowing of the channel.

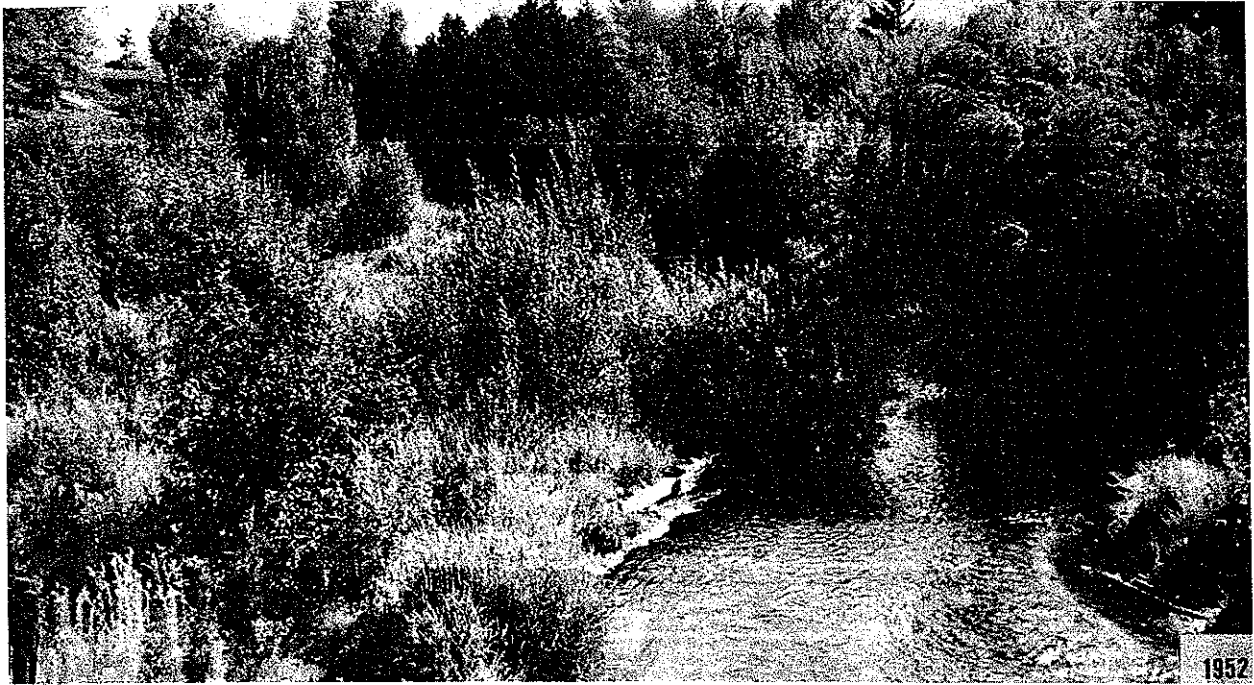
Third view (1952) of the same stream shown in the two preceding photographs.
