SmartBall® Dual Inspection Report

Prepared for
Enbridge

Pipeline Number:	Line 5
Pipeline Segment:	Mackinaw Straits West Leg
Launch Date:	March 7, 2017
Contact:	Sal Paonessa
Product:	Light Sweet Crude

Line 5 - Mackinaw Straits West Leg

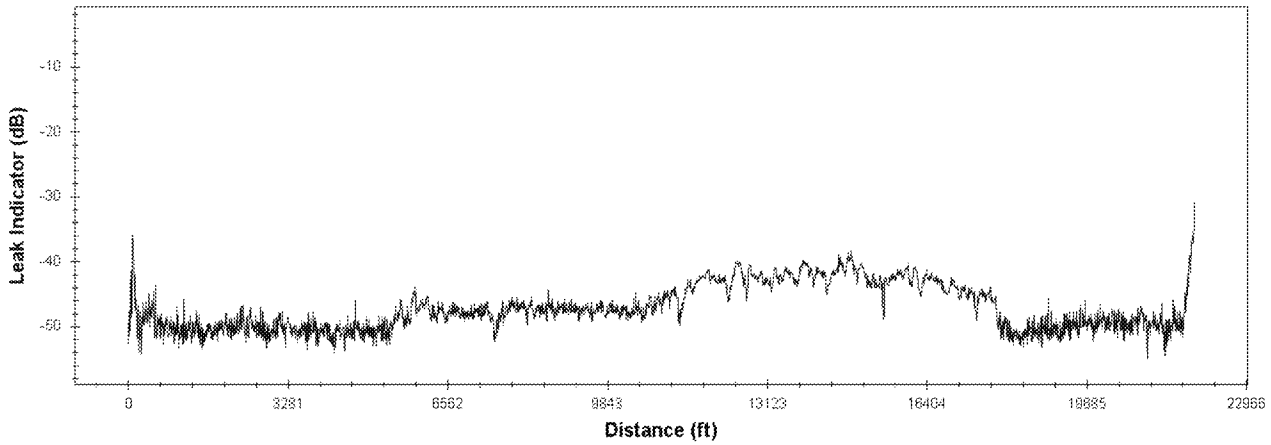
Figure 4.2A: Acoustic summary of the first SmartBall inspection versus Distance Traveled

For both inspections, East and West Legs respectively, external acoustic events have been identified which are not leak related, nor do they hinder the SmartBall's tool ability for leak detection. These acoustic events are present in all SmartBall inspections although with a different signal intensity in each case. Based on the transitory and varying nature of these events they would likely be identified as underwater currents making contact with the pipeline or ship traffic nearby.

It is important to note that this overview may contain anomalous spikes in the data. These spikes may have been caused by ambient noise around the pipeline from external sources such as pumps or nearby traffic. These sources of ambient noise are easily distinguishable from leaks or other points of interest upon further analysis by trained personnel.
