SmartBall® Dual Inspection Report

Prepared for
Enbridge

Pipeline Number:	Line 5
Pipeline Segment:	Mackinaw Straits East Leg
Launch Date:	March 8, 2017
Contact:	Sal Paonessa
Product:	Light Sweet Crude

Line 5 - Mackinaw Straits East Leg

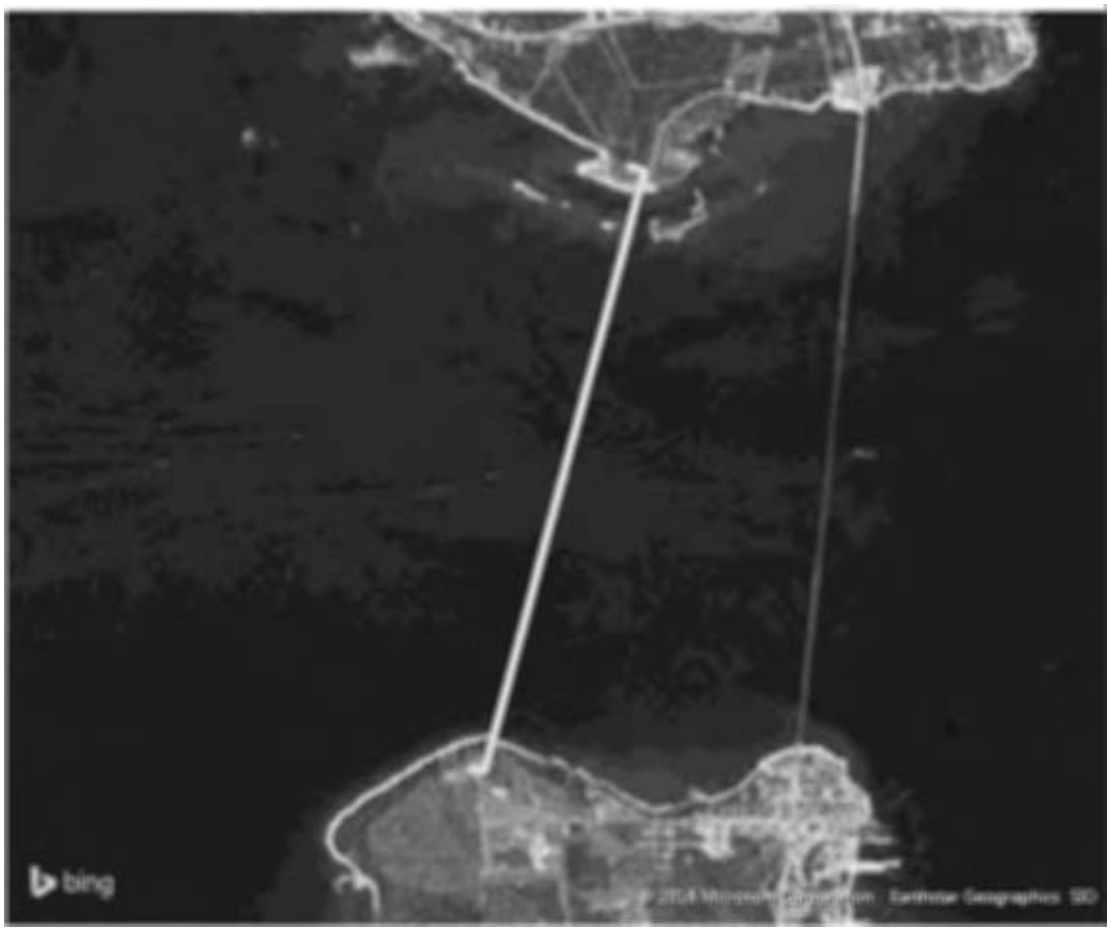
Figure 2.1: General layout of Line 5 - Mackinaw Straits East Leg

The approximate pipeline location and any anomalies detected by the SmartBall technology are shown in Figure 2.1.

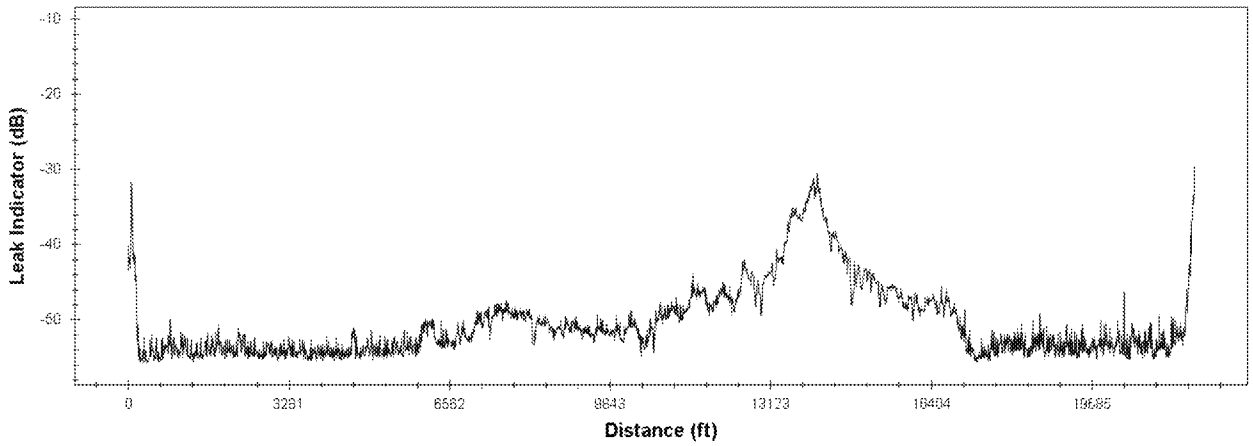
Figure 4.2A: Acoustic summary of the first SmartBall inspection versus Distance Traveled

For both inspections, East and West Legs respectively, external acoustic events have been identified which are not leak related, nor do they hinder the SmartBall's tool ability for leak detection. These acoustic events are present in all SmartBall inspections although with a different signal intensity in each case. Based on the transitory and varying nature of these events they would likely be identified as underwater currents making contact with the pipeline or ship traffic nearby.
