SmartBall® Dual Inspection Report

Pipeline Number:	Line 5
Pipeline Segment:	Mackinac Straits West Leg
Launch Date:	March 21, 2018
Contact:	Jeremy Ward
Product:	Light Sweet Crude

Line 5 Mackinac Straits West Leg

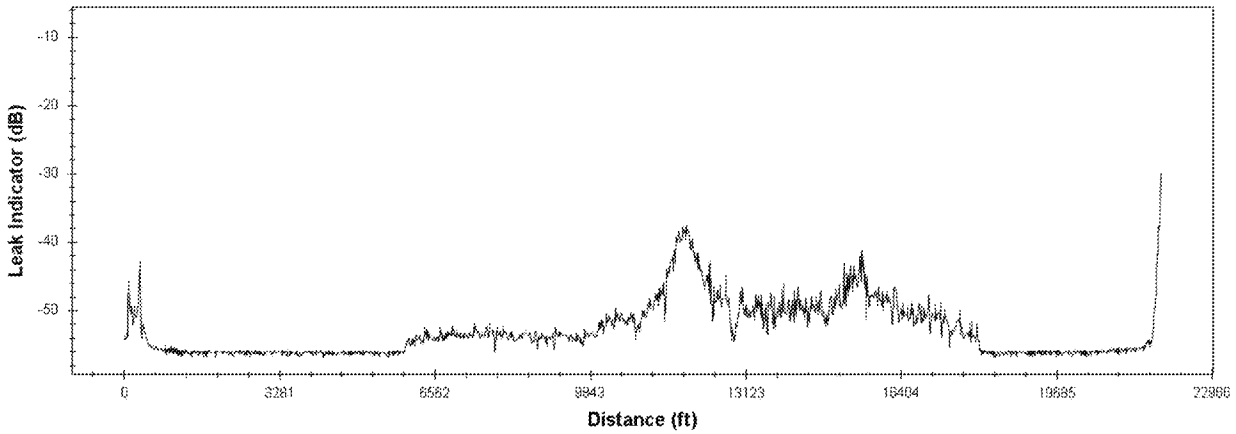
For both inspections, external transitory acoustic events were identified which are not leak related. These acoustic events may be present in SmartBall inspections although with a different signal intensity in each case, as depicted below in Figures 4.2A and 4.2B.

Figure 4.2A: Acoustic summary of the first SmartBall inspection versus Distance Traveled

It is important to note that this overview may contain anomalous spikes in the data. These spikes may have been caused by ambient noise around the pipeline from external sources such as pumps or nearby traffic. These sources of ambient noise are easily distinguishable from leaks or other points of interest upon further analysis by trained personnel.

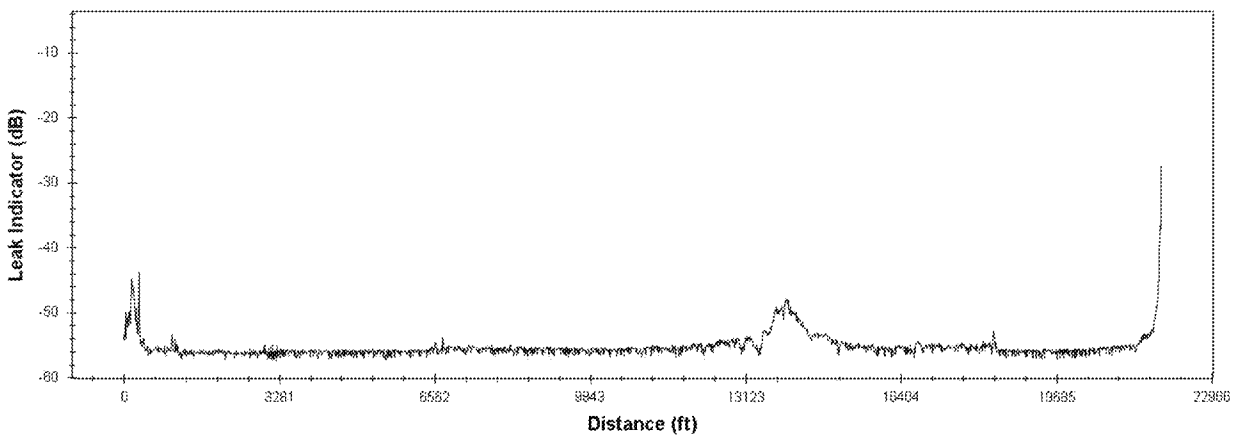
Figure 4.2B: Acoustic summary of the second SmartBall inspection versus Distance Traveled

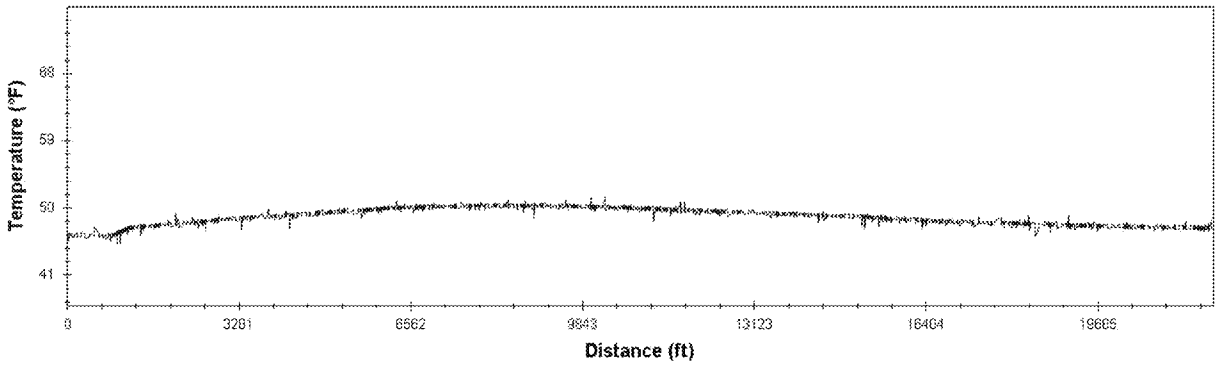
Figure 4.3A: Temperature Profile of the first SmartBall vs. Distance

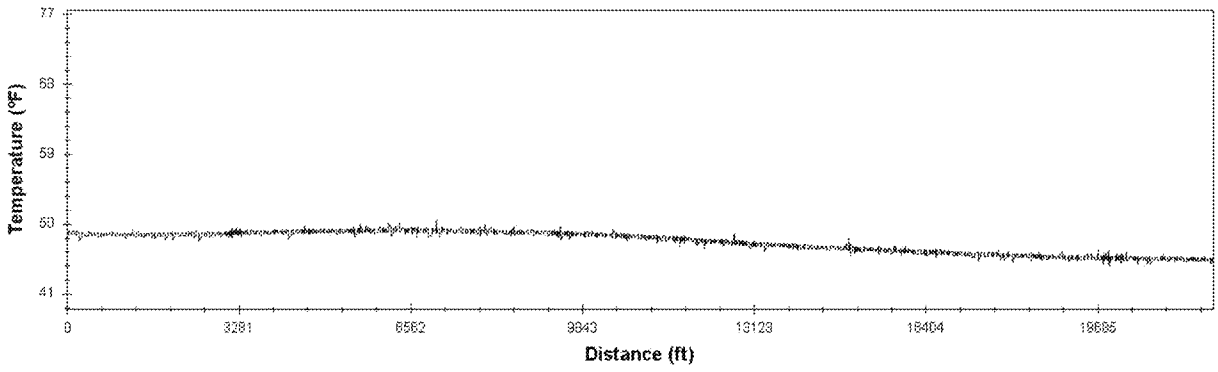
Figure 4.3B: Temperature Profile of the second SmartBall vs. Distance

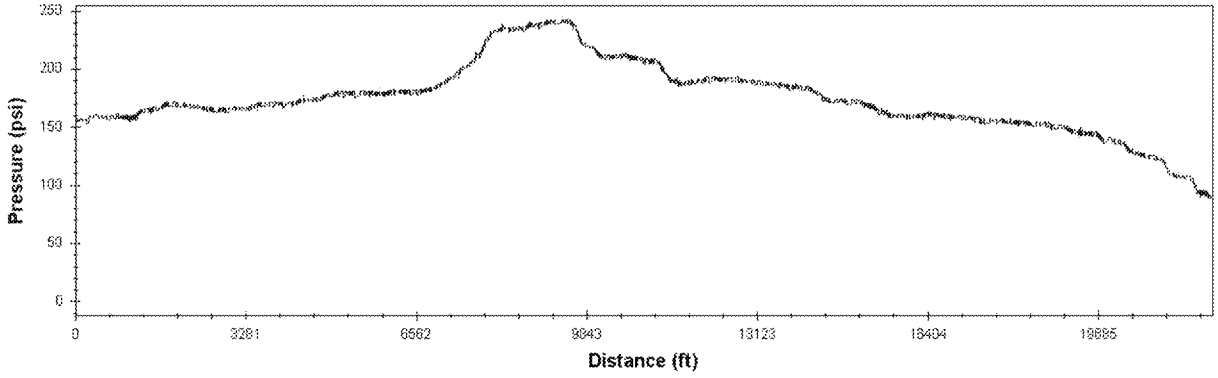
Figure 4.3C Pressure Profile of the first SmartBall vs. Distance

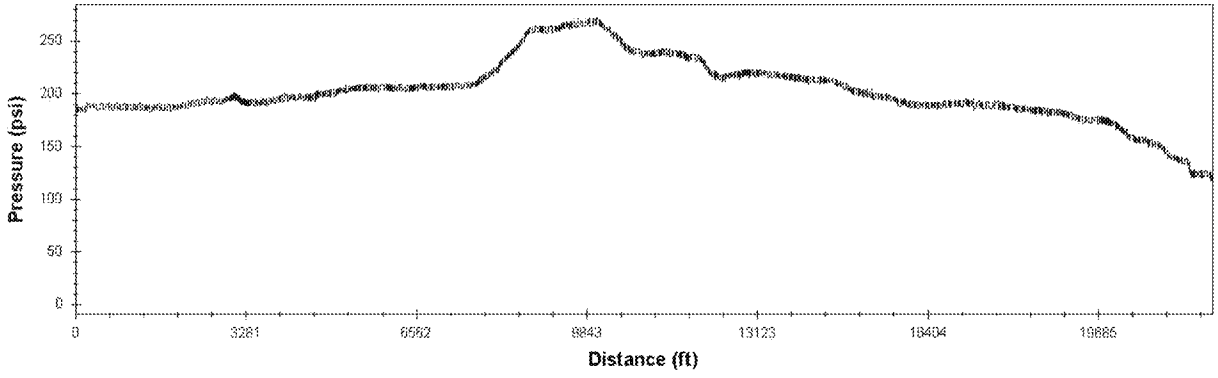
Figure 4.3D Pressure Profile of the second SmartBall vs. Distance
