SmartBall® Dual Inspection Report

Enbridge

Pipeline Number:	Line 5
Pipeline Segment:	Mackinac Straits West Leg
Launch Date:	April 18, 2018
Contact:	Jeremy Ward / Gurwinder Nagra
Product:	Light Sweet Crude

Line 5 Mackinac Straits West Leg

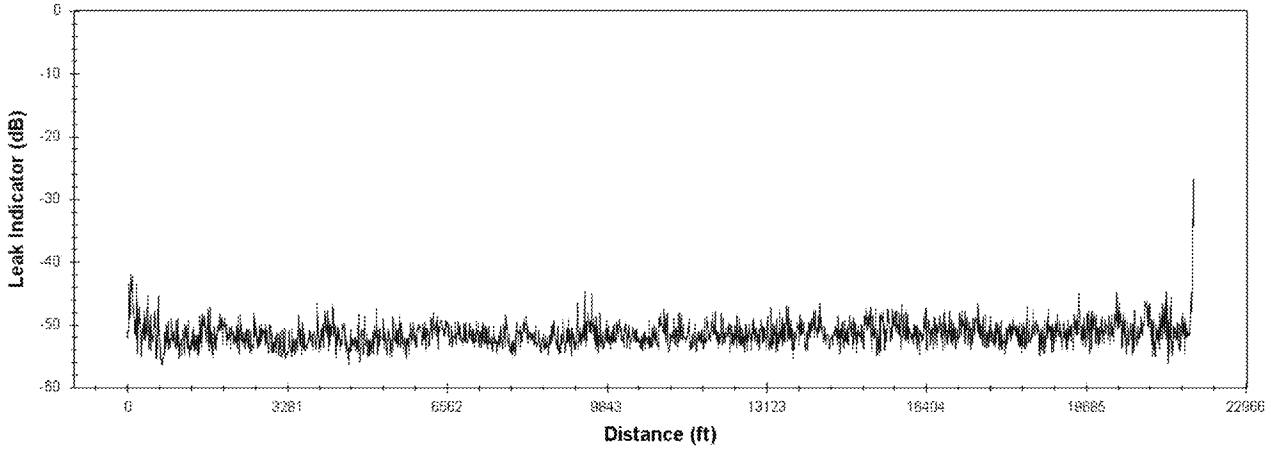
Figure 4.2A: Acoustic summary of the first SmartBall inspection versus Distance Traveled

It is important to note that this overview may contain anomalous spikes in the data. These spikes may have been caused by ambient noise around the pipeline from external sources such as pumps or nearby traffic. These sources of ambient noise are easily distinguishable from leaks or other points of interest upon further analysis by trained personnel.

Ambient noise generally occurs at a much lower frequency than the frequencies generated by a leak.
