SmartBall® Dual Inspection Report

Prepared for
Enbridge

Pipeline Number:	Line 5
Pipeline Segment:	Mackinac Straits East Leg
Launch Date:	September 18, 2018
Contact:	Jeremy Ward / Gurwinder Nagra
Product:	Light Sweet Crude

Line 5 Mackinac Straits East Leg

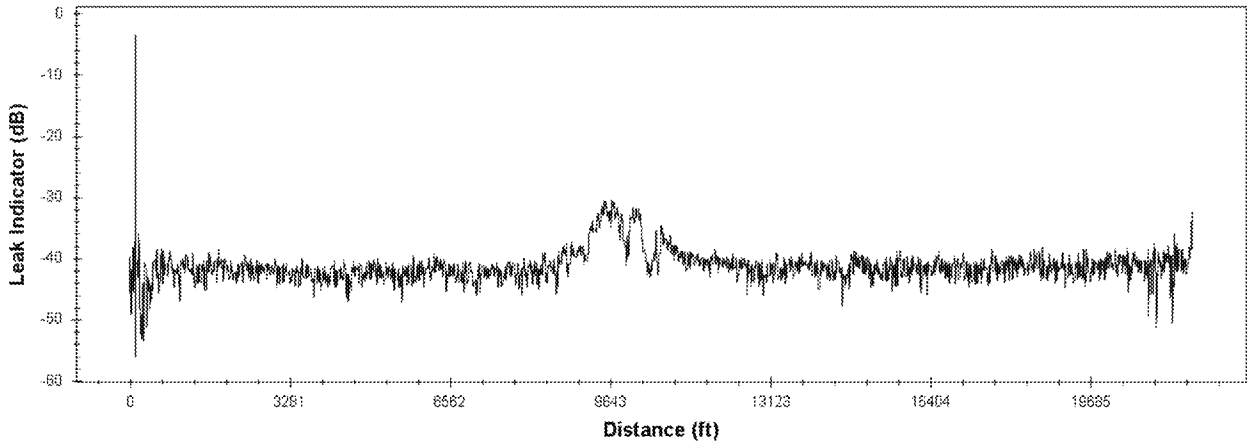
Figure 4.2A: Acoustic summary of the first SmartBall inspection versus Distance Traveled

It is important to note that this overview may contain anomalous spikes in the data. These spikes may have been caused by ambient noise around the pipeline from external sources such as pumps or nearby traffic. These sources of ambient noise are easily distinguishable from leaks or other points of interest upon further analysis by trained personnel.

Ambient noise generally occurs at a much lower frequency than the frequencies generated by a leak.

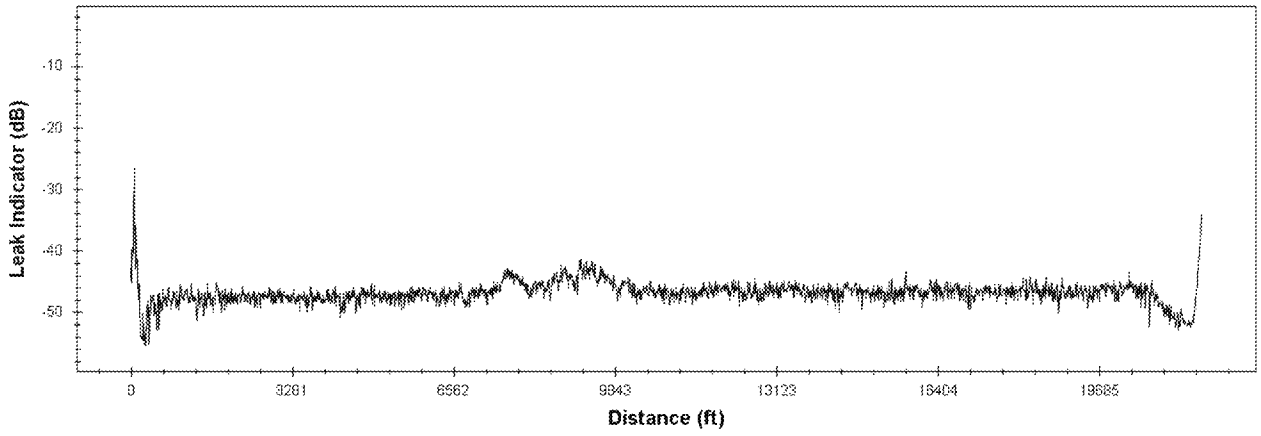
Figure 4.2B: Acoustic summary of the second SmartBall inspection versus Distance Traveled

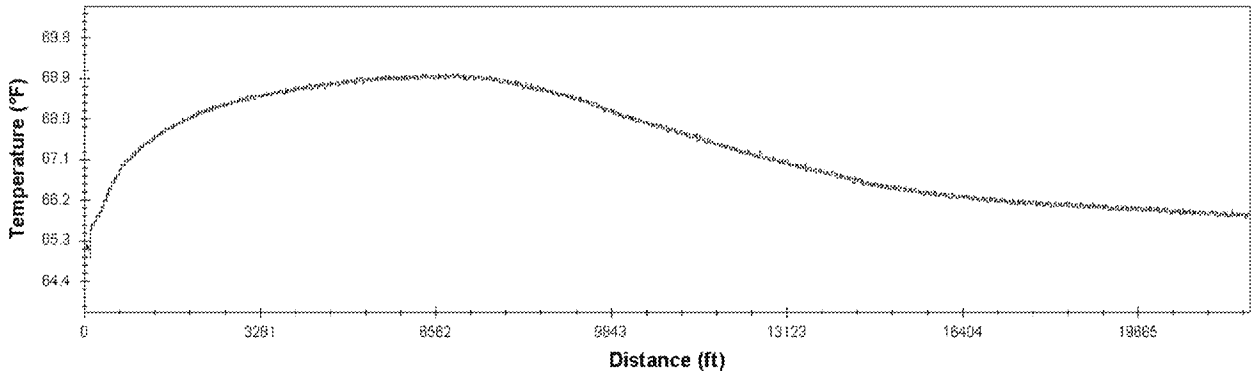
Figure 4.3A: Temperature Profile of the first SmartBall vs. Distance

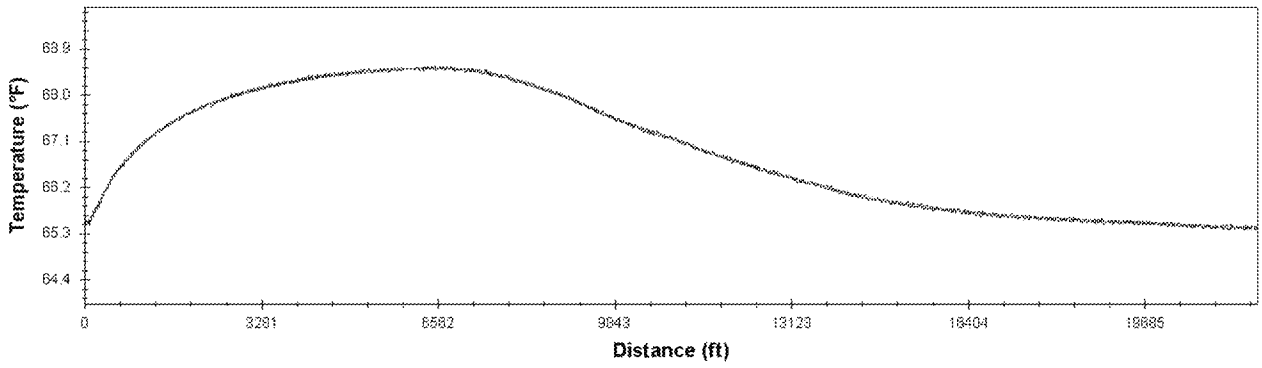
Figure 4.3B: Temperature Profile of the second SmartBall vs. Distance

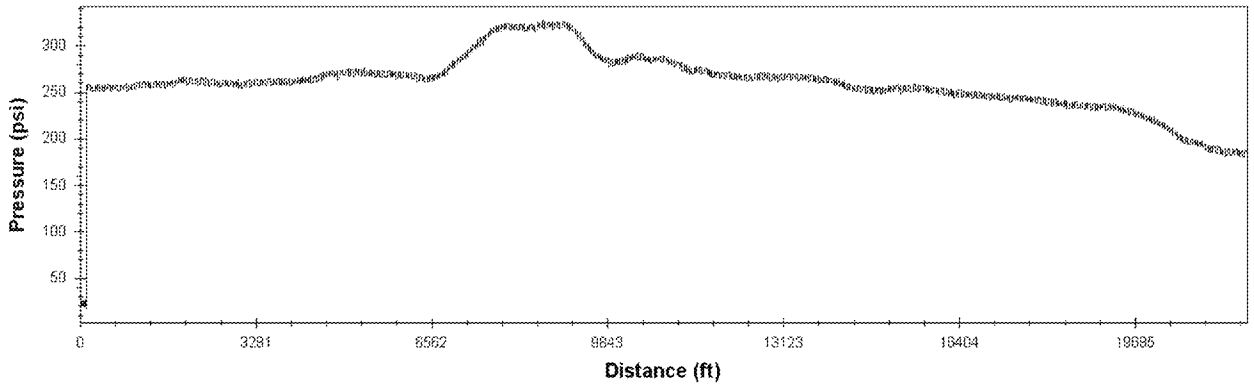
Figure 4.3C Pressure Profile of the first SmartBall vs. Distance

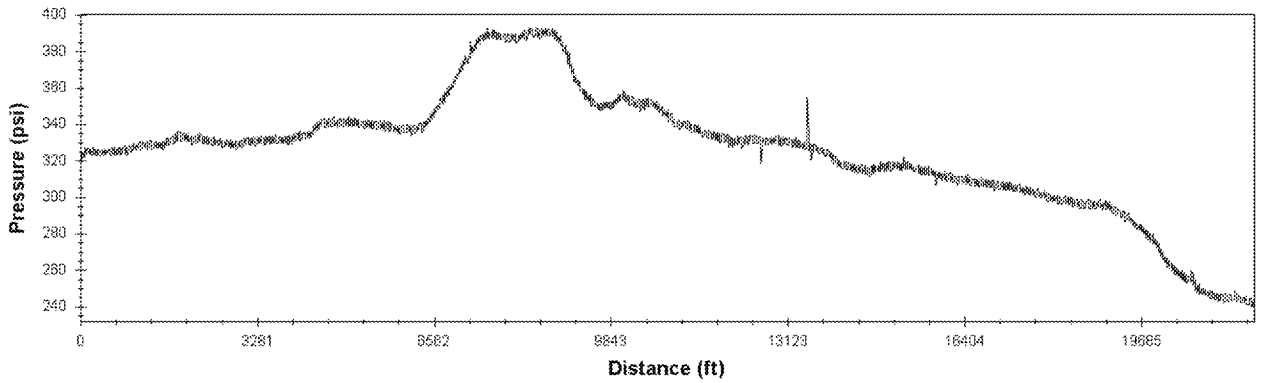
Figure 4.3D Pressure Profile of the second SmartBall vs. Distance
