SmartBall® Dual Inspection Report

Pipeline Number:	Enbridge Line 5
Pipeline Segment:	Mackinac Straits - East Leg
Launch Date:	July 22, 2019
Contact:	Jonathan Kwan / Jeremy Ward
Product:	Light Sweet Crude

Enbridge Line 5 Mackinac Straits - East Leg

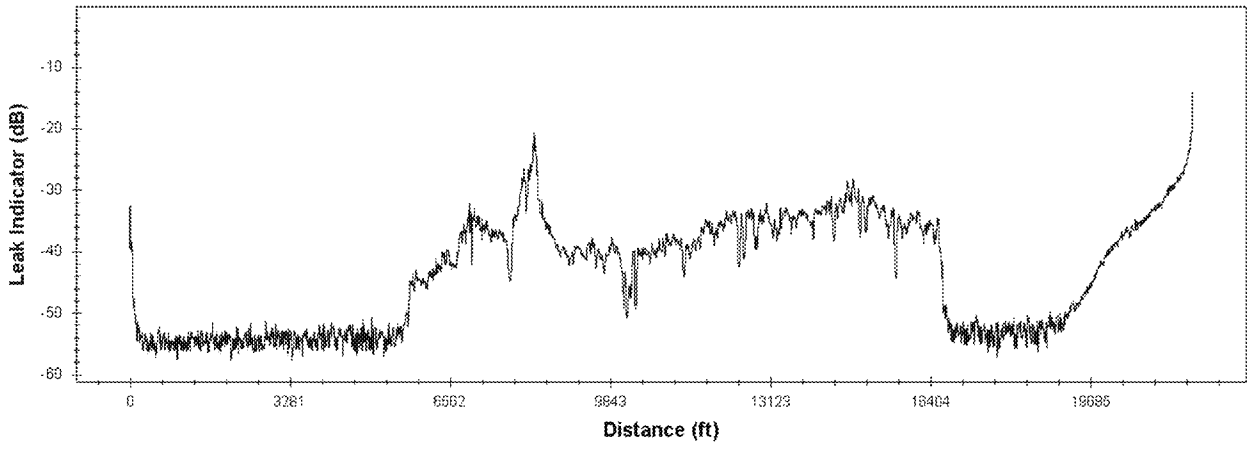
Figure 4.2A: Acoustic summary of the first SmartBall inspection versus Distance Traveled

Figures 4.2A and 4.2B show the acoustic profile of each inspection with respect to the position of each tool within the pipeline, as detected by the SmartBall technology. There is an acoustic signal along the pipeline section which indicates external activity possibly corresponding to drilling as discussed in the field summary delivery e-mail. This signature does not correspond to any leak pattern or leak acoustics.

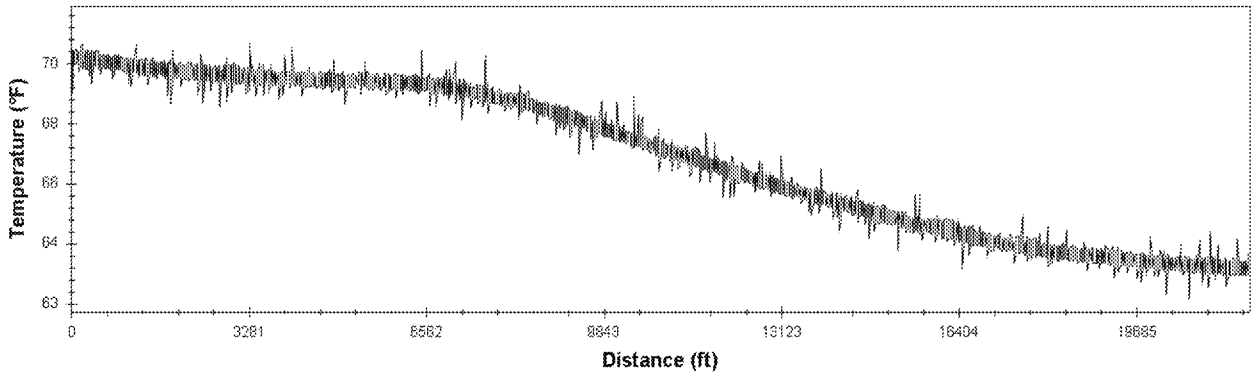
Figure 4.3A: Temperature Profile of the first SmartBall vs. Distance

Figures 4.3A and 4.3B show the corresponding plots of the temperature the first and second SmartBall tools experienced vs distance.
