SmartBall® Dual Inspection Report

Prepared for
Enbridge

Pipeline Number:	Line 5 Mackinac Straits
Pipeline Segment:	East Leg
Launch Date:	November 5, 2019
Contact:	Emils Muehlenbachs
Product:	Light Sweet Crude

Line 5 Mackinac Straits - East Leg

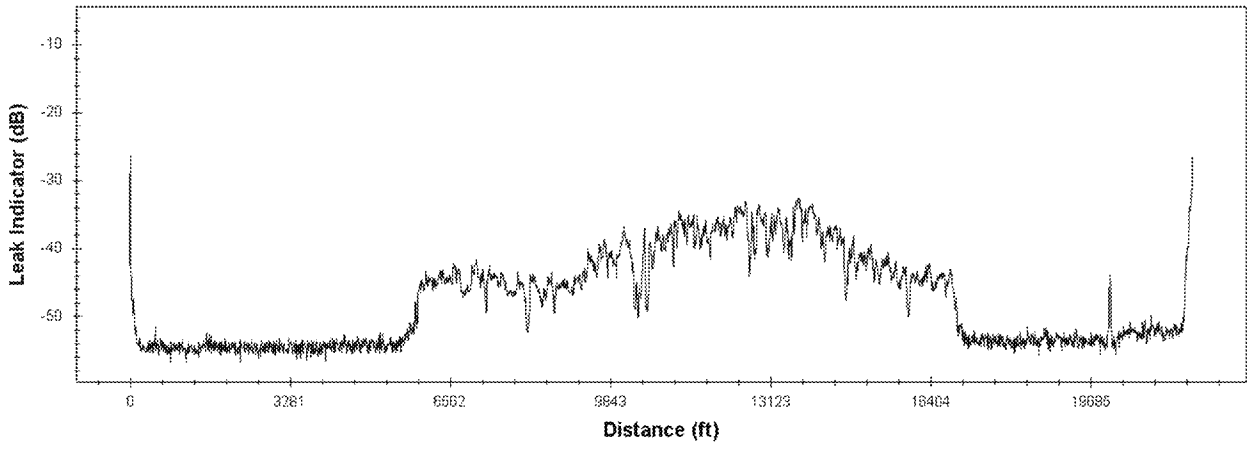
Figure 4.2A: Acoustic summary of the first SmartBall inspection versus Distance Traveled

Figures 4.2A and 4.2B show the acoustic profile of each inspection with respect to the position of each tool within the pipeline, as detected by the SmartBall technology. There is an acoustic signal along the pipeline section which indicates some type of external activity. This signature does not correspond to any leak pattern or leak acoustics.

It is important to note that this overview may contain anomalous spikes in the data. These spikes may have been caused by ambient noise around the pipeline from external sources such as pumps or nearby traffic. These sources of ambient noise are easily distinguishable from leaks or other points of interest upon further analysis by trained personnel.

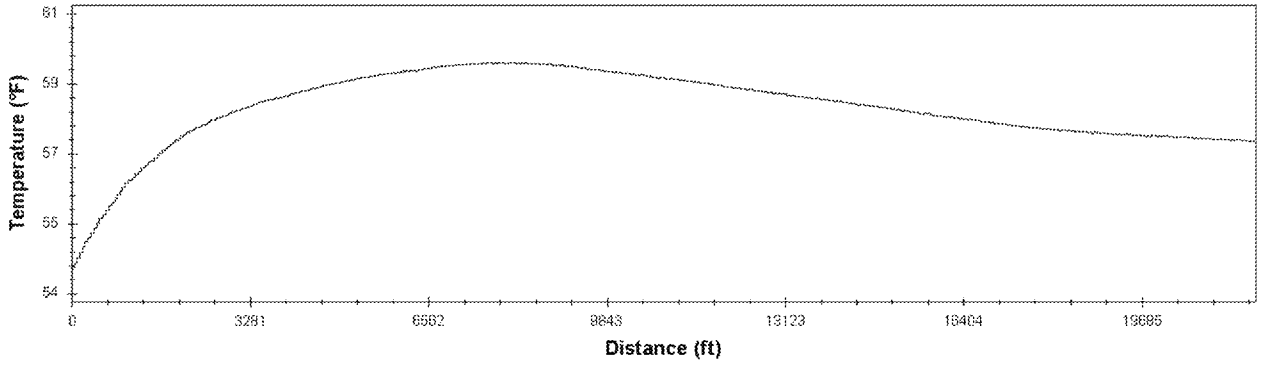
Figure 4.3A: Temperature Profile of the first SmartBall vs. Distance

Figures 4.3A and 4.3B show the corresponding plots of the temperature the first and second SmartBall tools experienced vs distance.

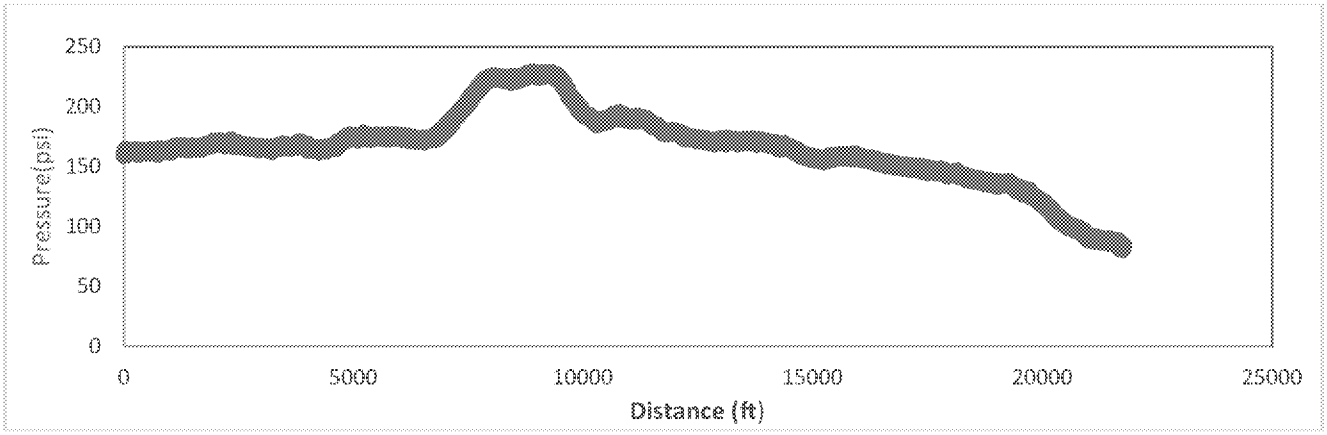
Figure 4.3D Pressure Profile of the second SmartBall vs. Distance

Figure 4.3C and 4.3D show the corresponding plots of the pressure the first and second SmartBall tools experienced vs distance.

The SmartBall tools were successfully launched and received. The tools recorded data throughout the entire length of the inspection. During this time the pressure inside the subject pipeline was recorded to be above 80 psi for the entire span of the inspected section. Acoustic anomalies resembling leaks were not found on the 20-inch Enbridge Line 5 Mackinac Straits - East Leg section, within the detection limits of the SmartBalls under the operating conditions at the time of the inspection. The data quality was not negatively affected by any surrounding noise, environmental factors, tool speed or otherwise. The data collected was of sufficient quality, and the SmartBall's proven minimum leak detection threshold of 0.03 gallons per minute is retained.
