MagneScan™ MFL 3
Inspection Report for
20 inch Crude Oil Pipeline

Enbridge Energy Limited Partnership

Line 5: 20" Straits of Mackinac - West Leg
Run Date: 27 August 2013

Contract Number: 436881_20B
Issue 1, 29 November 2013

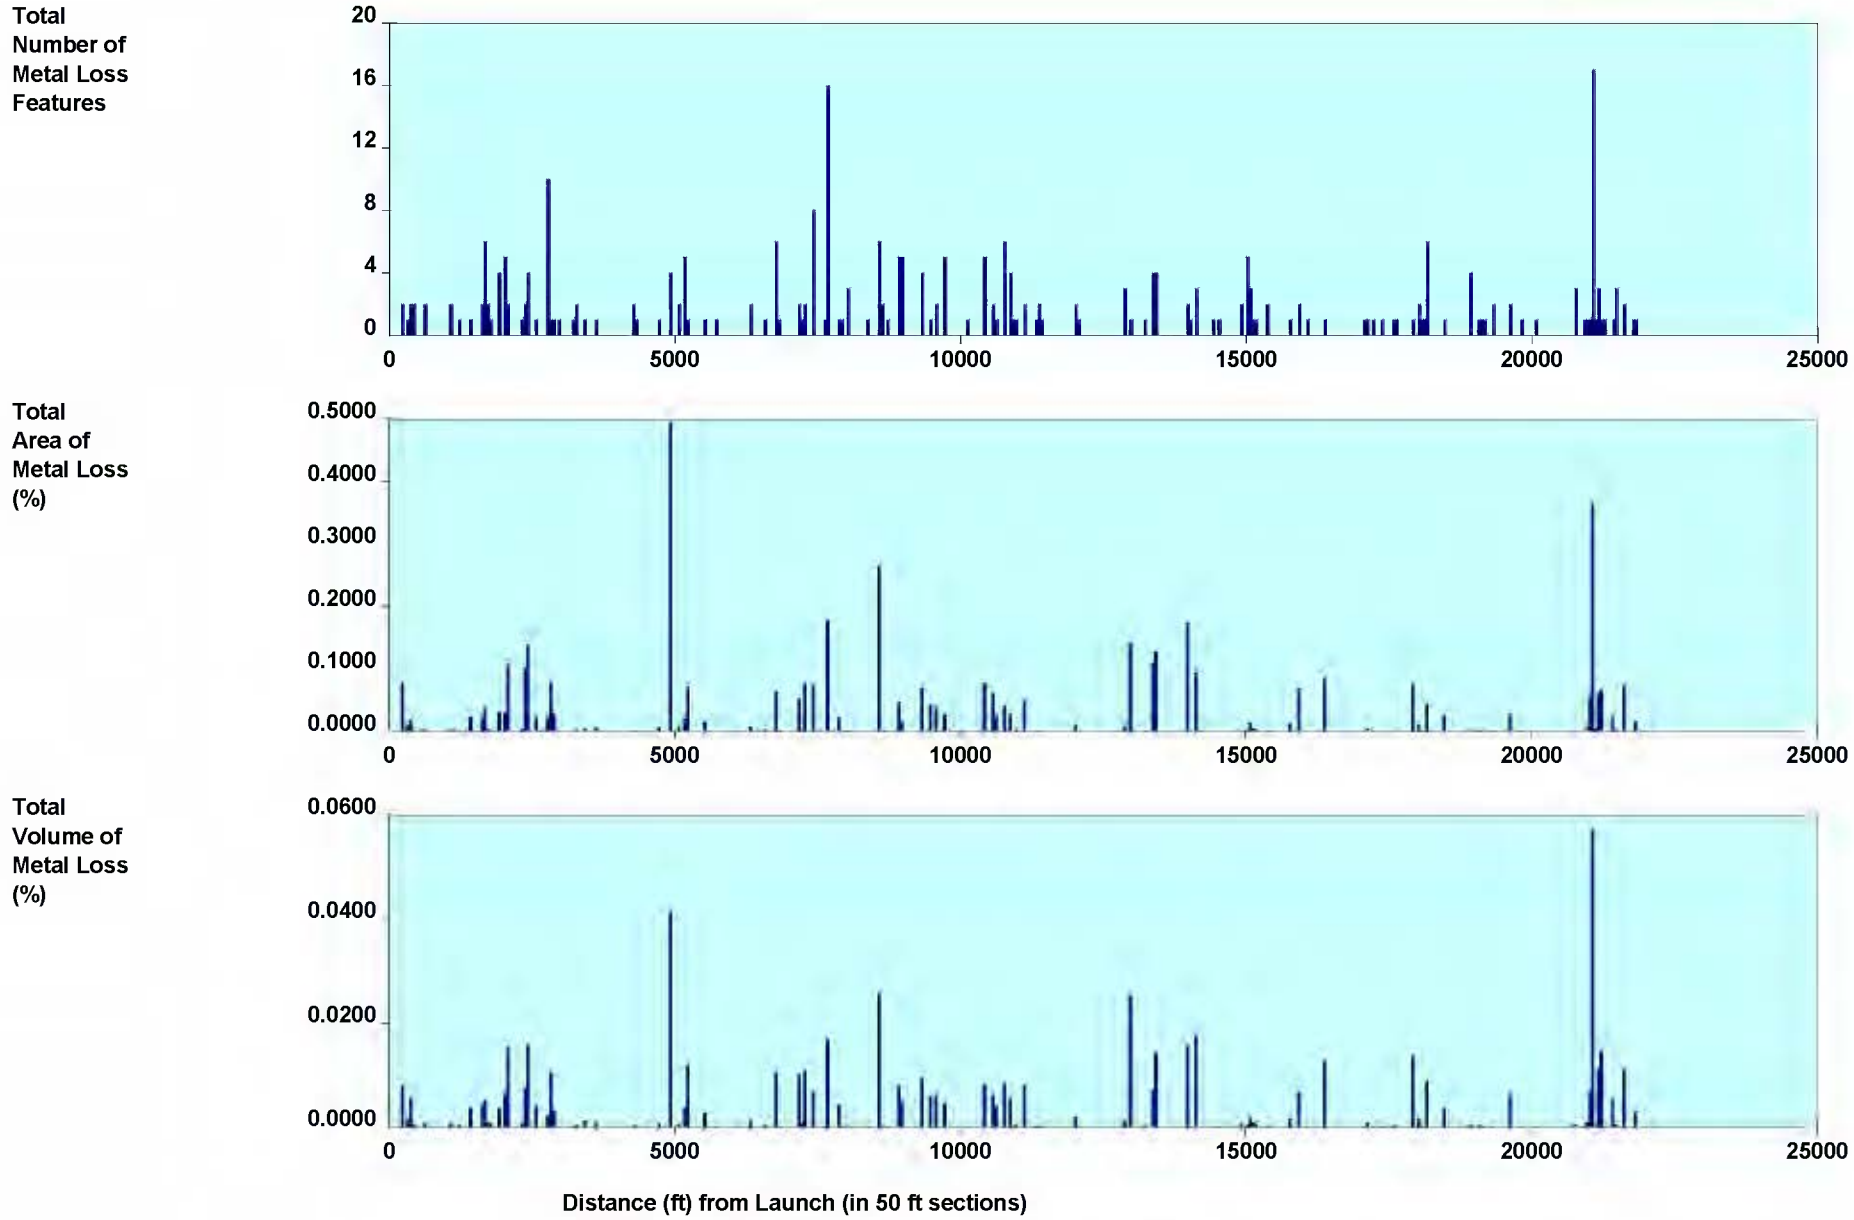
DEPTH BASED HISTOGRAM - ALL METAL LOSS

A total of 294 metal loss features have been detected on the inspection survey of which the deepest was 41%. These are distributed throughout the pipeline. Approximately 17% of the total number of spools have metal loss reported within them.

The majority of these are external and have the appearance of mill/manufacturing faults.
