SmartBall® Dual Inspection Report

Pipeline Number:	Line 5
Pipeline Segment:	Mackinaw Straits West Leg
Launch Date:	May 15, 2017
Contact:	Sal Paonessa
Product:	Light Sweet Crude

Line 5 Mackinaw Straits West Leg

HMUS-PJN000091-002	**Project Name:**	Line 5 Mackinaw Straits West Leg
Document Type:	SmartBall Report	Project Manager:	Cory Solyom

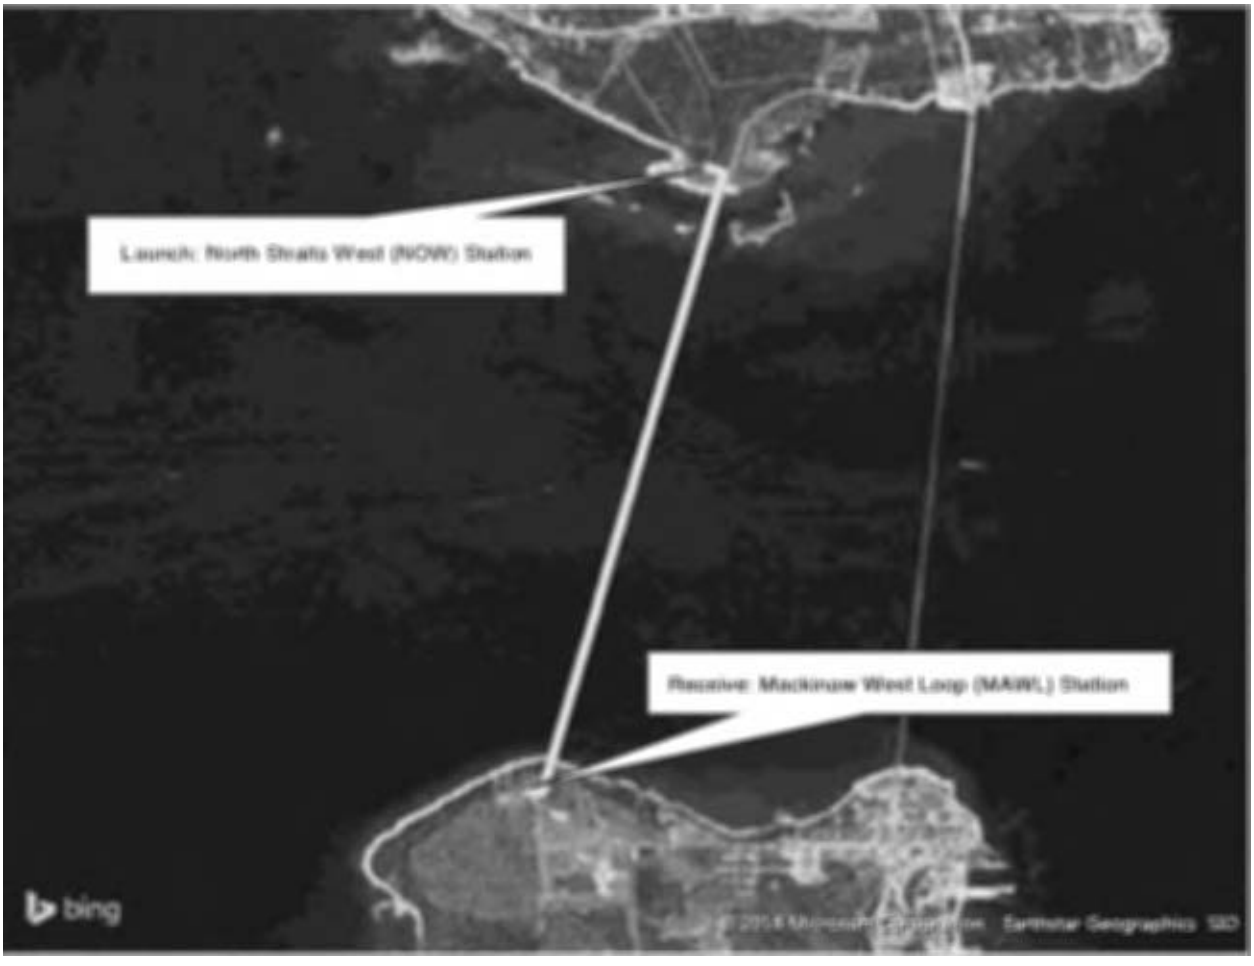
Figure 2.1: General layout of Line 5 Mackinaw Straits West Leg Section

The approximate pipeline location and any anomalies detected by the SmartBall technology are shown in Figure 2.1.

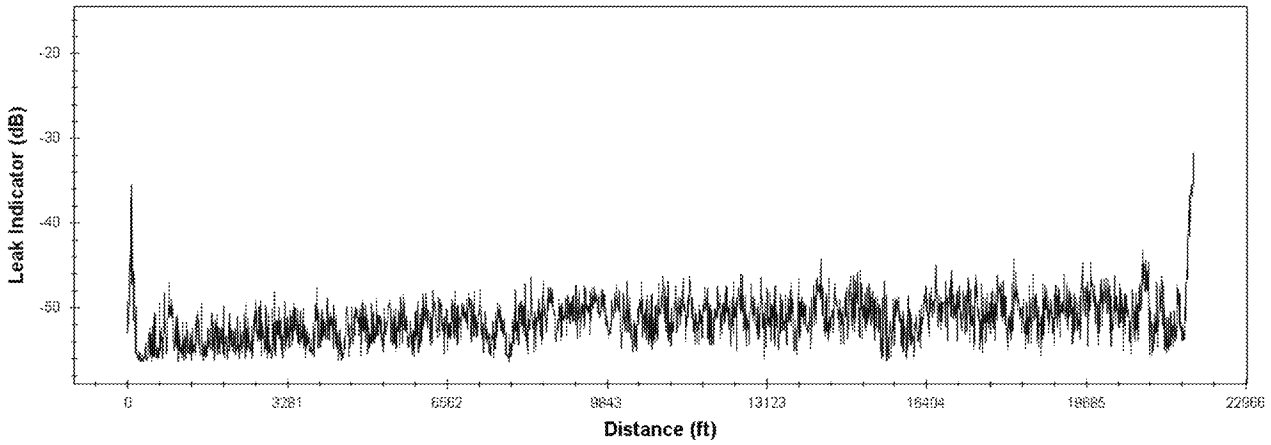
Figure 4.2A: Acoustic summary of the first SmartBall inspection versus Distance Traveled

Figures 4.2A and 4.2B show the acoustic profile of each inspection with respect to the position of each tool within the pipeline, as detected by the SmartBall technology.

It is important to note that this overview may contain anomalous spikes in the data. These spikes may have been caused by ambient noise around the pipeline from external sources such as pumps or nearby traffic. These sources of ambient noise are easily distinguishable from leaks or other points of interest upon further analysis by trained personnel.

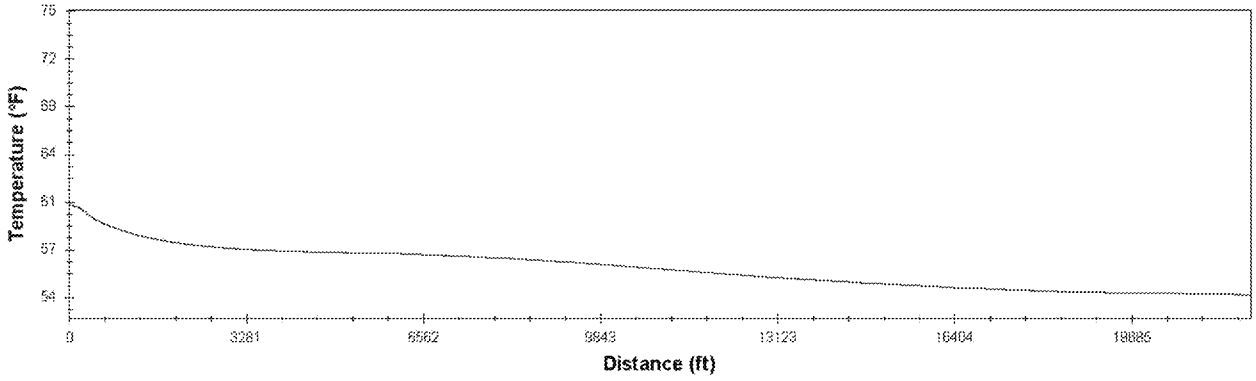
Figure 4.3A: Temperature Profile of the first SmartBall vs. Distance

Figures 4.3A and 4.3B show the corresponding plots of the temperature the first and second SmartBall tools experienced vs distance.

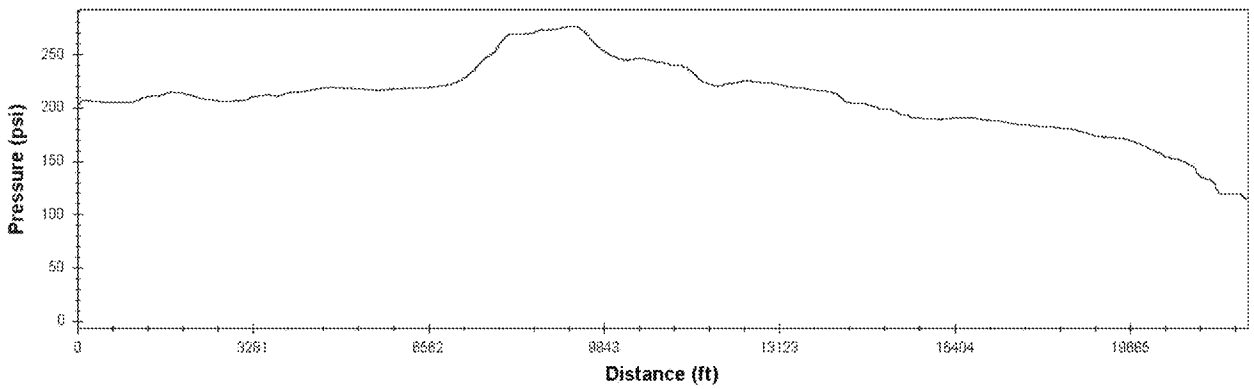
Figure 4.4A Pressure Profile of the first SmartBall vs. Distance

Figure 4.4A and 4.4B show the corresponding plots of the pressure measured by the first and second SmartBall tools experienced vs distance.
