SmartBall® Dual Inspection Report

Pipeline Number:	Line 5
Pipeline Segment:	Mackinaw Straits East Leg
Launch Date:	May 16, 2017
Contact:	Sal Paonessa
Product:	Light Sweet Crude

Line 5 Mackinaw Straits East Leg

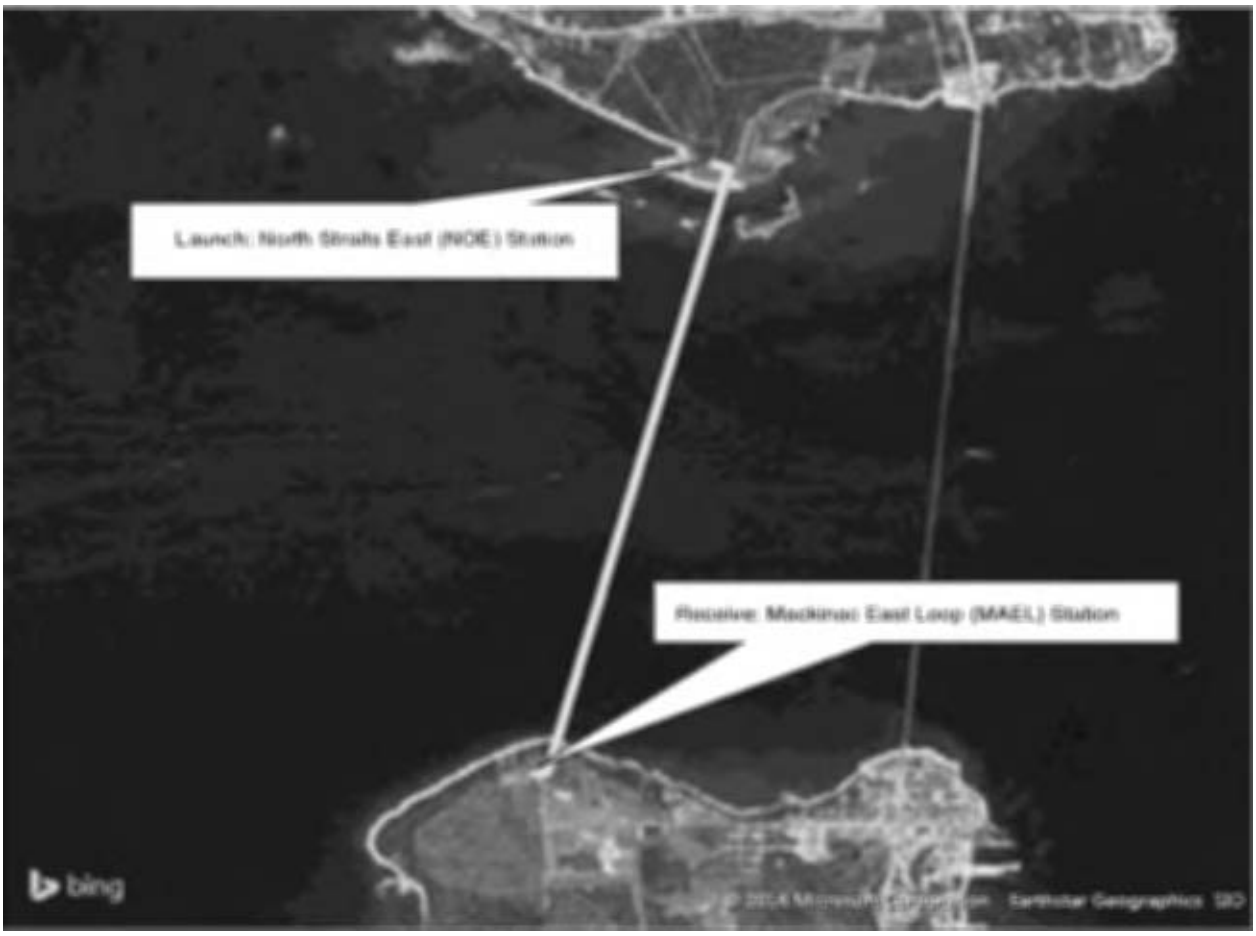
Figure 2.1: General layout of Line 5 Mackinaw Straits East Leg Section

The approximate pipeline location and any anomalies detected by the SmartBall technology are shown in Figure 2.1.

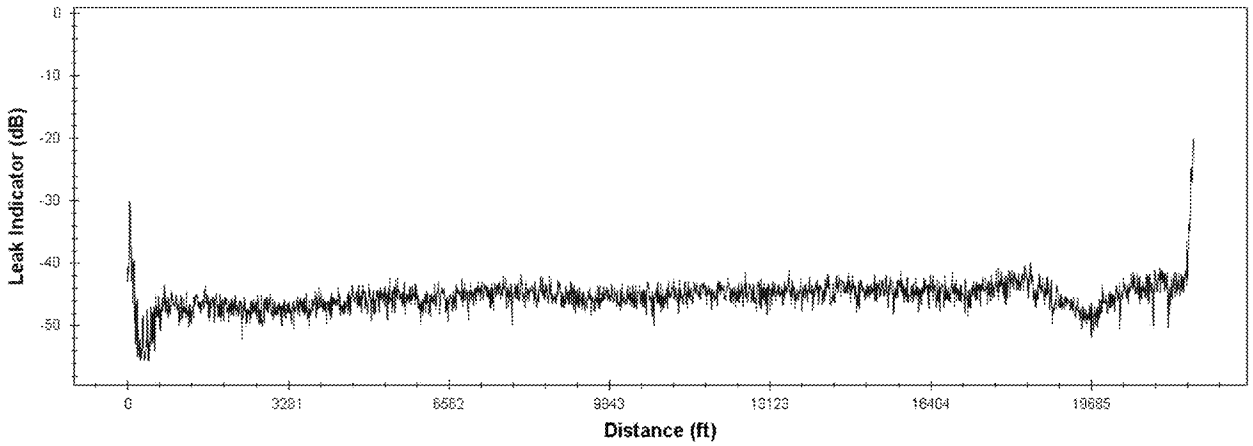
Figure 4.2A: Acoustic summary of the first SmartBall inspection versus Distance Traveled

Figures 4.2A and 4.2B show the acoustic profile of each inspection with respect to the position of each tool within the pipeline, as detected by the SmartBall technology.

It is important to note that this overview may contain anomalous spikes in the data. These spikes may have been caused by ambient noise around the pipeline from external sources such as pumps or nearby traffic. These sources of ambient noise are easily distinguishable from leaks or other points of interest upon further analysis by trained personnel.

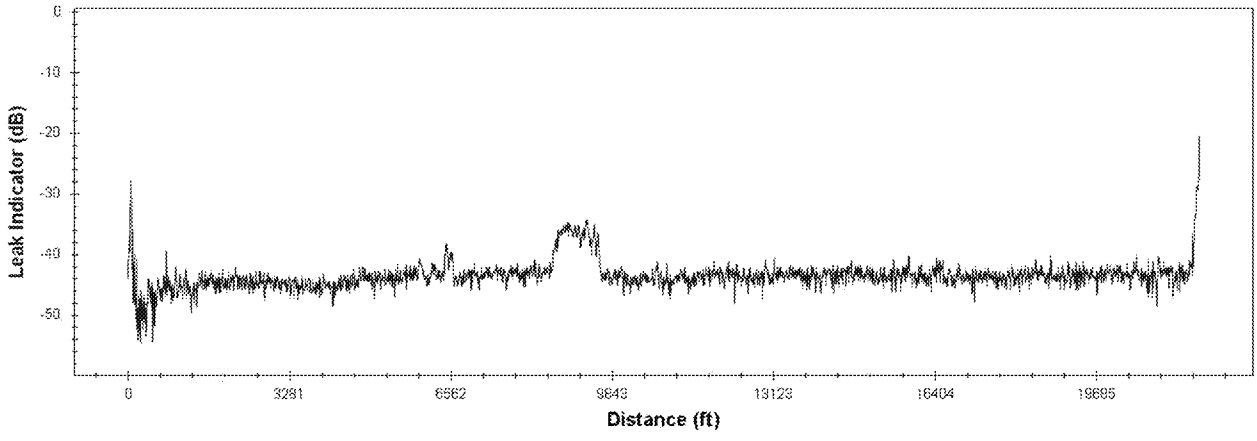
Figure 4.2B: Acoustic summary of the second SmartBall inspection versus Distance Traveled

For the second SmartBall inspection, an external acoustic event has been identified which is not leak related. These acoustic events may be present in SmartBall inspections although with a different signal intensity in each case. This same event was not detected in the first SmartBall inspection which indicates a transitory nature for this acoustic event.

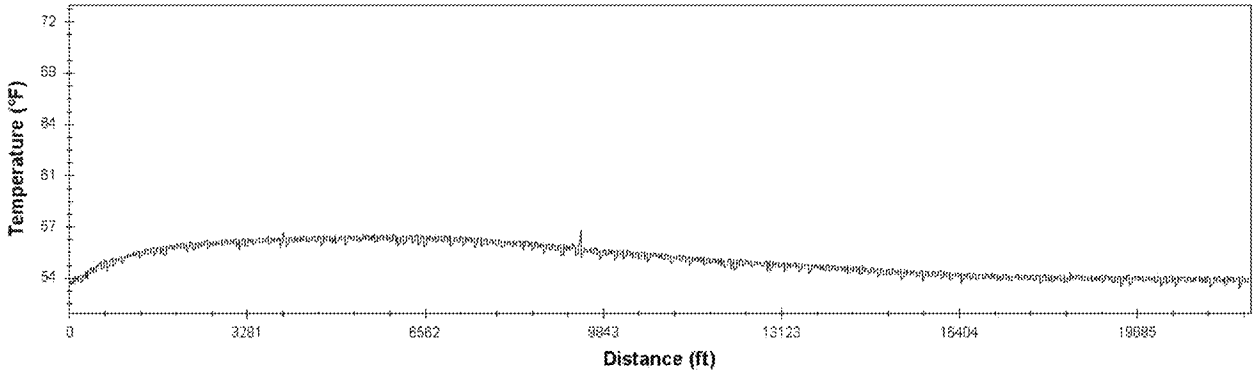
Figure 4.3A: Temperature Profile of the first SmartBall vs. Distance

Figures 4.3A and 4.3B show the corresponding plots of the temperature the first and second SmartBall tools experienced vs distance.

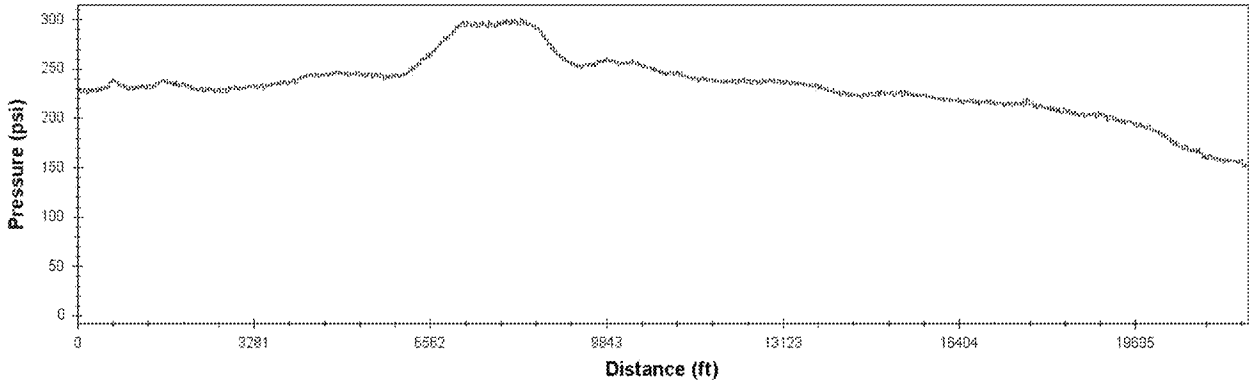
Figure 4.4A Pressure Profile of the first SmartBall vs. Distance

Figure 4.4A and 4.4B show the corresponding plots of the pressure measured by the first and second SmartBall tools experienced vs distance.
