SmartBall® Dual Inspection Report

Enbridge

Pipeline Number:	Line 5
Pipeline Segment:	Mackinaw Straits West Leg
Launch Date:	August 1, 2017
Contact:	Sal Paonessa
Product:	Light Sweet Crude

Line 5 Mackinaw Straits West Leg

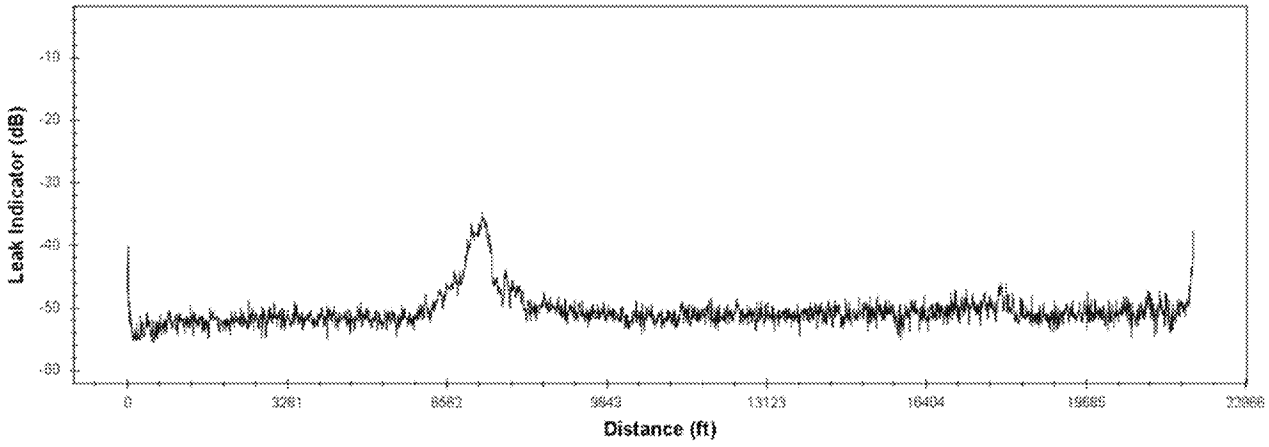
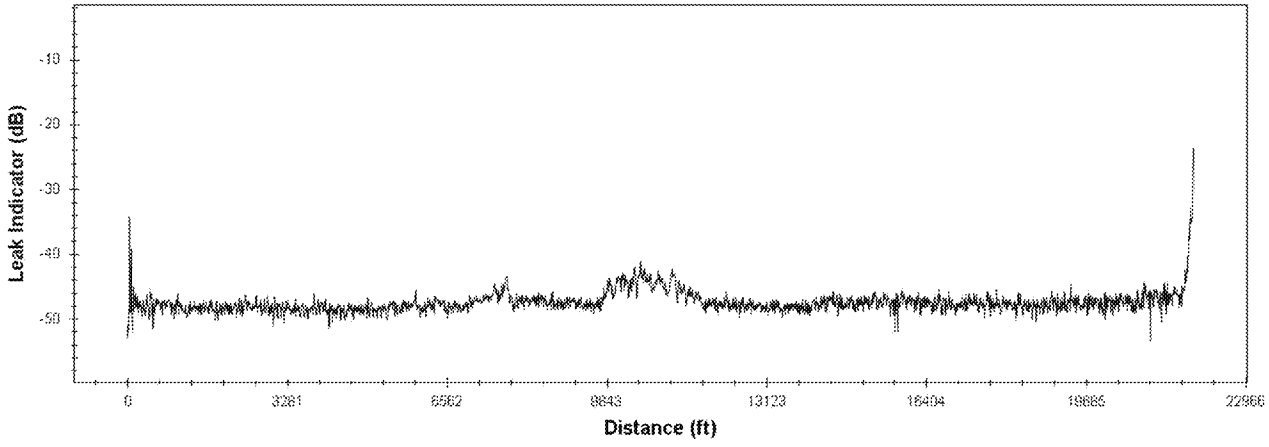
For both inspections, external transitory acoustic events were identified which are not leak related. These acoustic events may be present in SmartBall inspections although with a different signal intensity in each case, as depicted below in Figures 4.2A and 4.2B.

It is important to note that this overview may contain anomalous spikes in the data. These spikes may have been caused by ambient noise around the pipeline from external sources such as pumps or nearby traffic. These sources of ambient noise are easily distinguishable from leaks or other points of interest upon further analysis by trained personnel.
