SmartBall® Dual Inspection Report

Enbridge

Pipeline Number:	Line 5
Pipeline Segment:	Mackinac Straits East Leg
Launch Date:	October 24, 2017
Contact:	Sal Paonessa
Product:	Light Sweet Crude

Line 5 Mackinac Straits East Leg

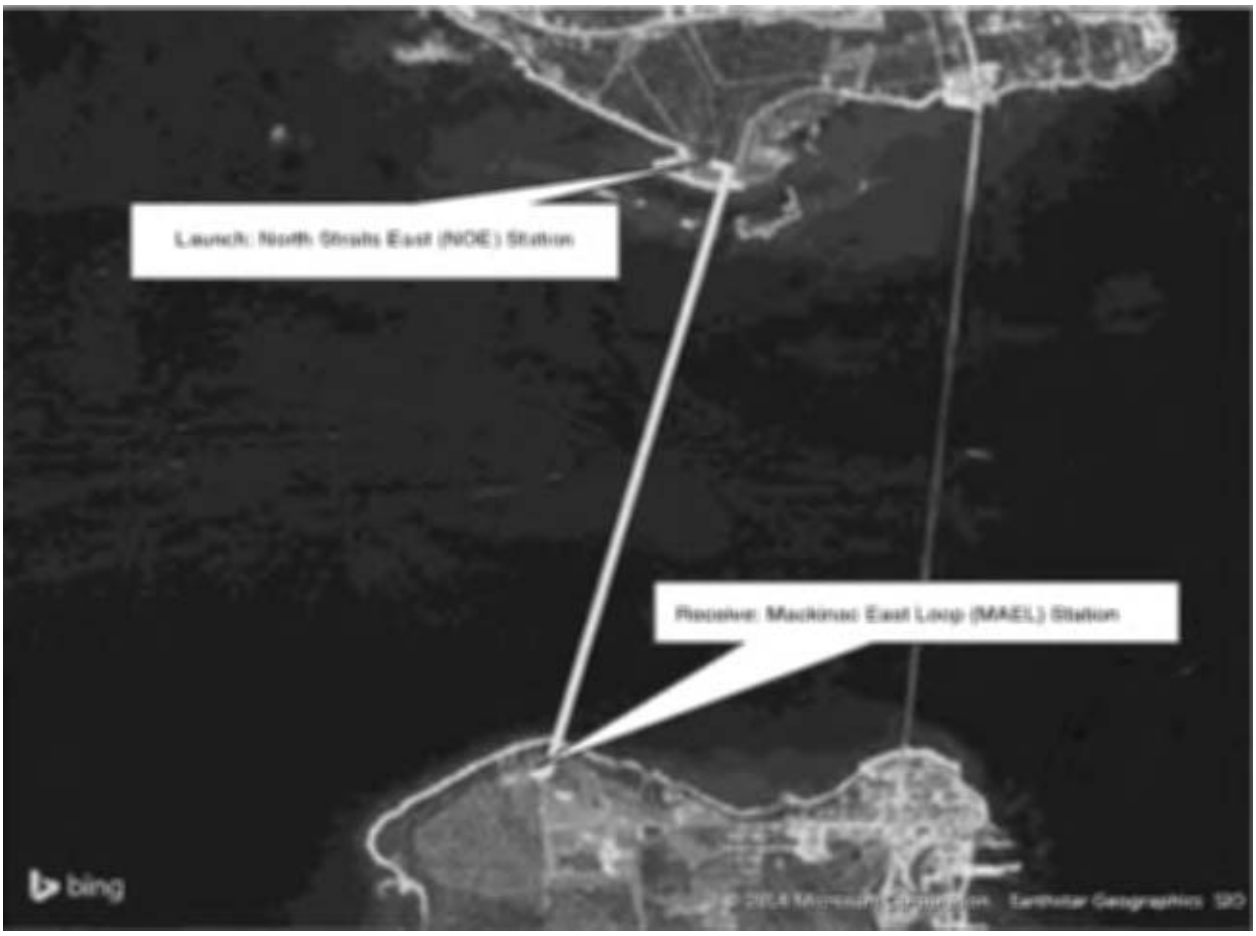
Figure 2.1: General layout of Line 5 Mackinac Straits East Leg

The approximate pipeline location and any anomalies detected by the SmartBall technology are shown in Figure 2.1.

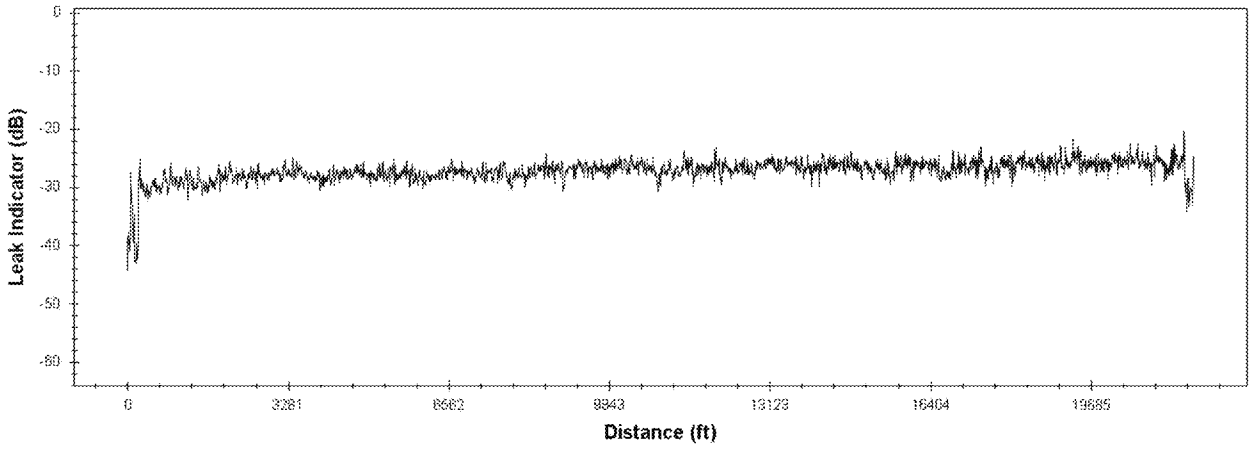
Figure 4.2A: Acoustic summary of the first SmartBall inspection versus Distance Traveled

Figures 4.2A and 4.2B show the acoustic profile of each inspection, SmartBall 1 and SmartBall 2, with respect to the position of each tool within the pipeline, as detected by the SmartBall technology.

It is important to note that this overview may contain anomalous spikes in the data. These spikes may have been caused by ambient noise around the pipeline from external sources such as pumps or nearby traffic. These sources of ambient noise are easily distinguishable from leaks or other points of interest upon further analysis by trained personnel.

Ambient noise generally occurs at a much lower frequency than the frequencies generated by a leak.

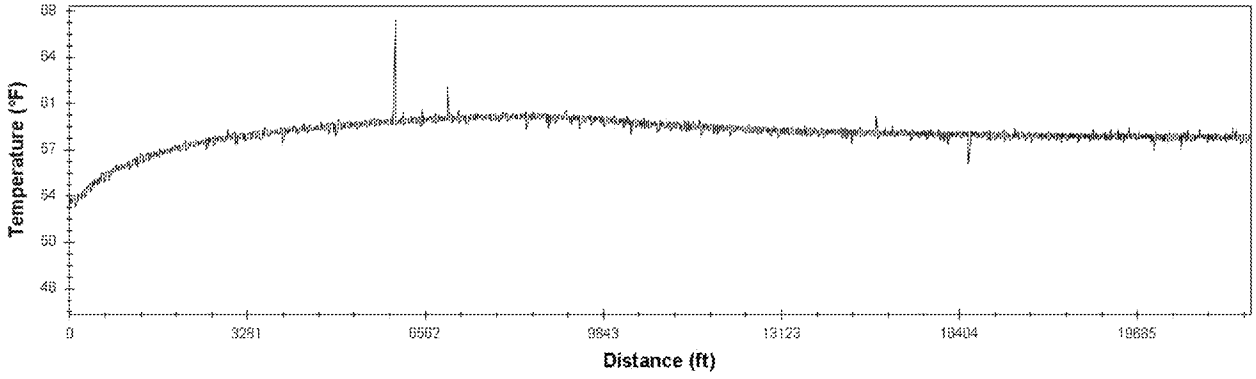
Figure 4.3A: Temperature Profile of the first SmartBall vs. Distance

Figures 4.3A and 4.3B show the corresponding plots of the temperature the first and second SmartBall tools experienced vs distance.

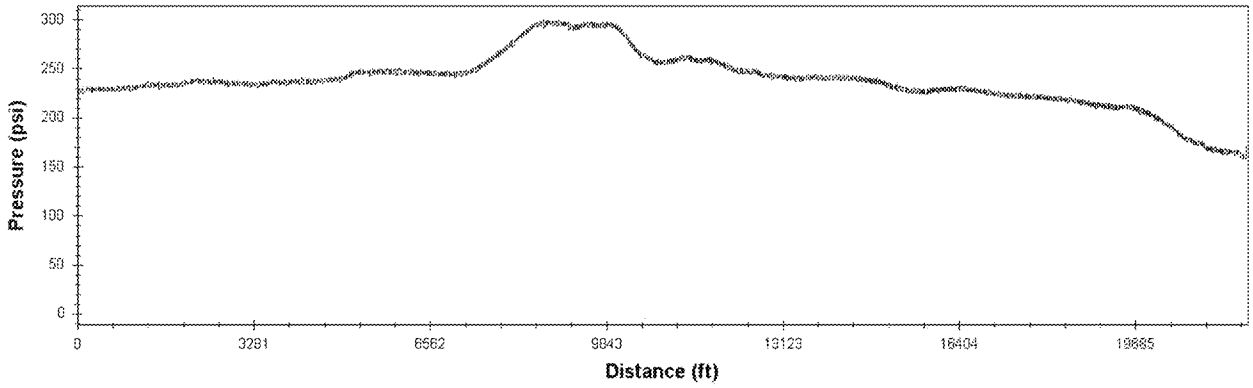
Figure 4.3C Pressure Profile of the first SmartBall vs. Distance

Figure 4.3C and 4.3D show the corresponding plots of the pressure the first and second SmartBall tools experienced vs distance.
