SmartBall® Dual Inspection Report

Pipeline Number:	Line 5
Pipeline Segment:	Mackinac Straits West Leg
Launch Date:	October 24, 2017
Contact:	Sal Paonessa
Product:	Light Sweet Crude

Line 5 Mackinac Straits West Leg

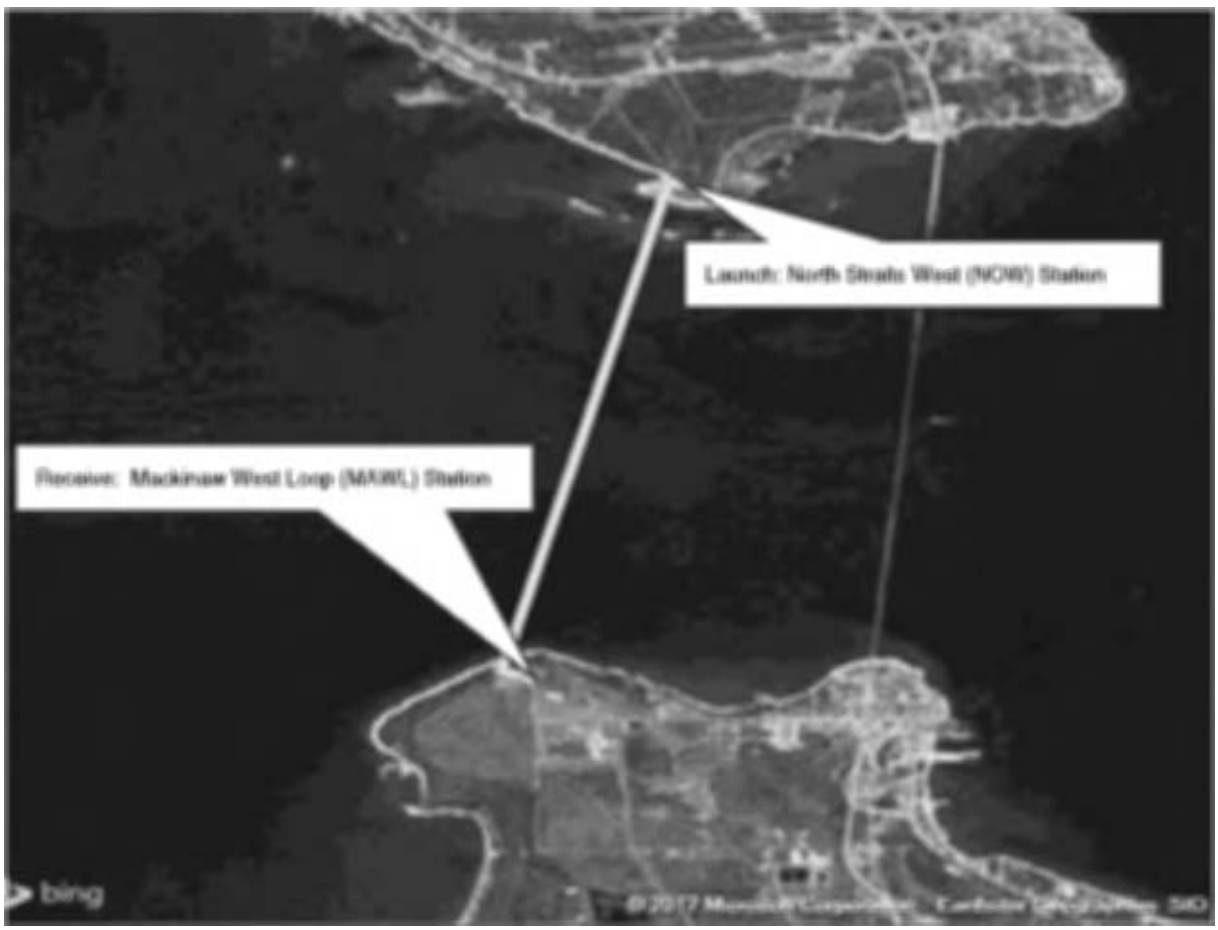
Figure 2.1: General layout of Line 5 Mackinac Straits West Leg

The approximate pipeline location and any anomalies detected by the SmartBall technology are shown in Figure 2.1.

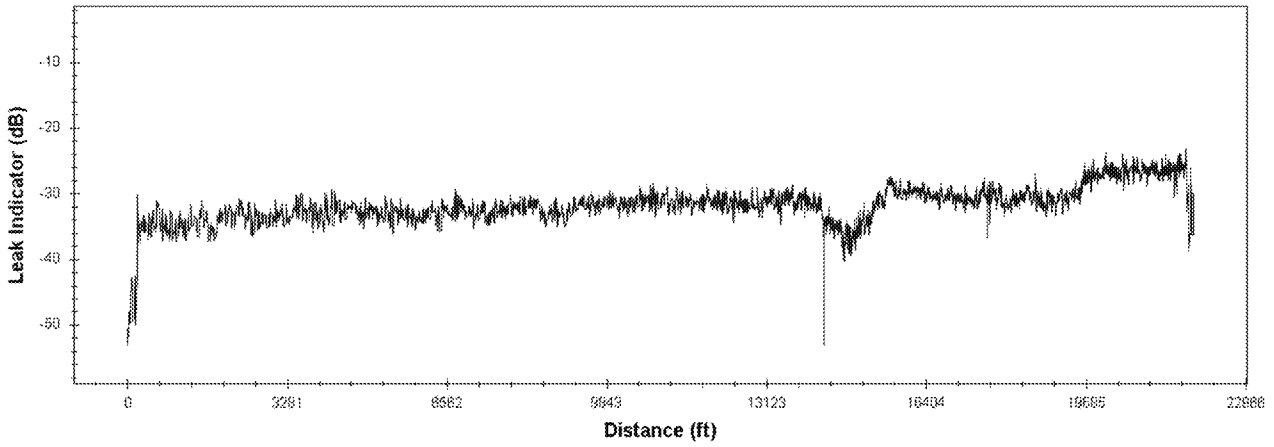
Figure 4.2A: Acoustic summary of the first SmartBall inspection versus Distance Traveled

Figures 4.2A and 4.2B show the acoustic profile of each inspection, SmartBall 1 and SmartBall 2, with respect to the position of each tool within the pipeline, as detected by the SmartBall technology.

It is important to note that this overview may contain anomalous spikes in the data. These spikes may have been caused by ambient noise around the pipeline from external sources such as pumps or nearby traffic. These sources of ambient noise are easily distinguishable from leaks or other points of interest upon further analysis by trained personnel.

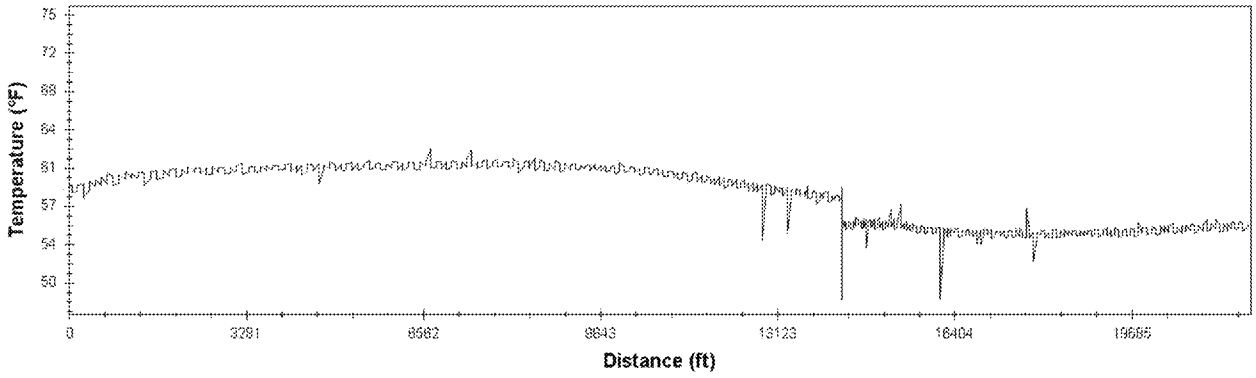
Figure 4.3A: Temperature Profile of the first SmartBall vs. Distance

The jogs in the temperature and pressure data observed in Figures 4.3A and 4.3C are caused by the line being shut down during the inspection.

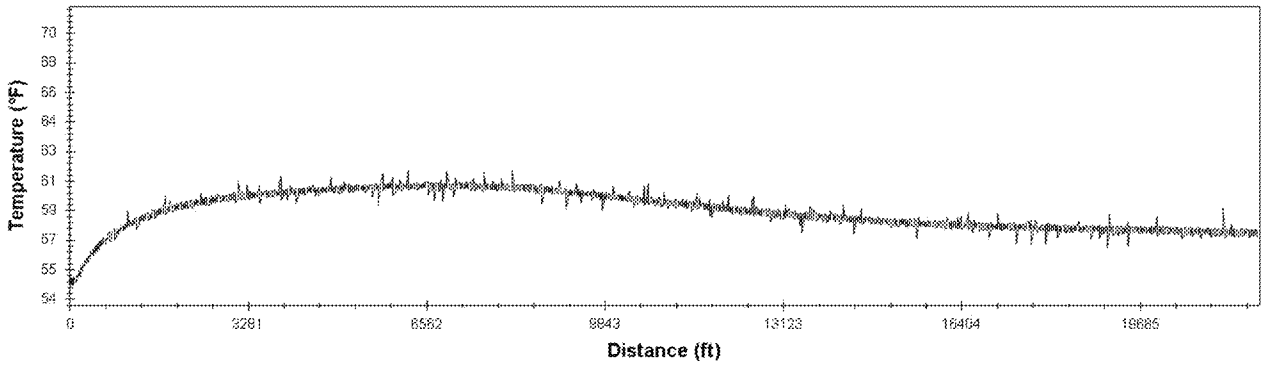
Figure 4.3B: Temperature Profile of the second SmartBall vs. Distance

Figures 4.3A and 4.3B show the corresponding plots of the temperature the first and second SmartBall tools experienced vs distance.

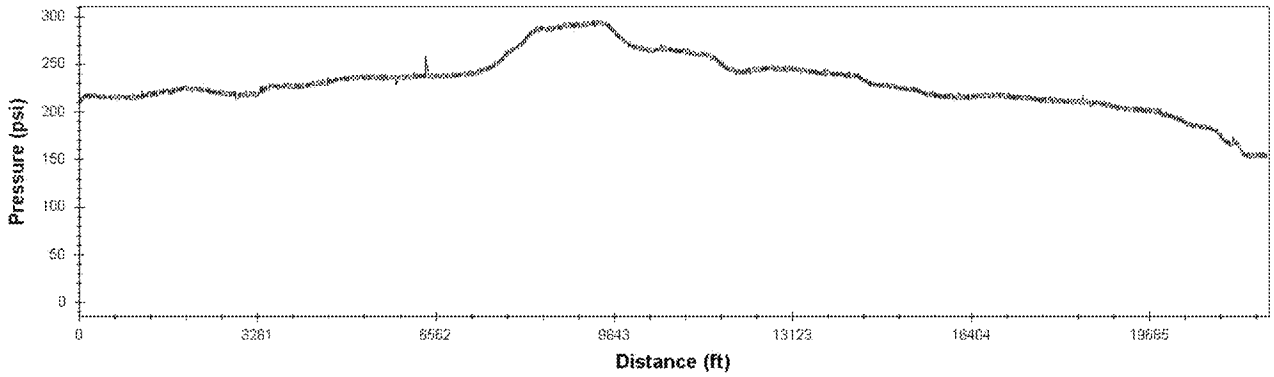
Figure 4.3D Pressure Profile of the second SmartBall vs. Distance

Figure 4.3C and 4.3D show the corresponding plots of the pressure the first and second SmartBall tools experienced vs distance.
