SmartBall® Dual Inspection Report

Prepared for
Enbridge

Enbridge Line 5 Mackinac Straits - East Leg

HMUS-PJN000223-001	**Project Name:**	Enbridge Line 5 Mackinac Straits - East Leg
Document Type:	SmartBall Report	**Project Manager:**	Cory Solyom

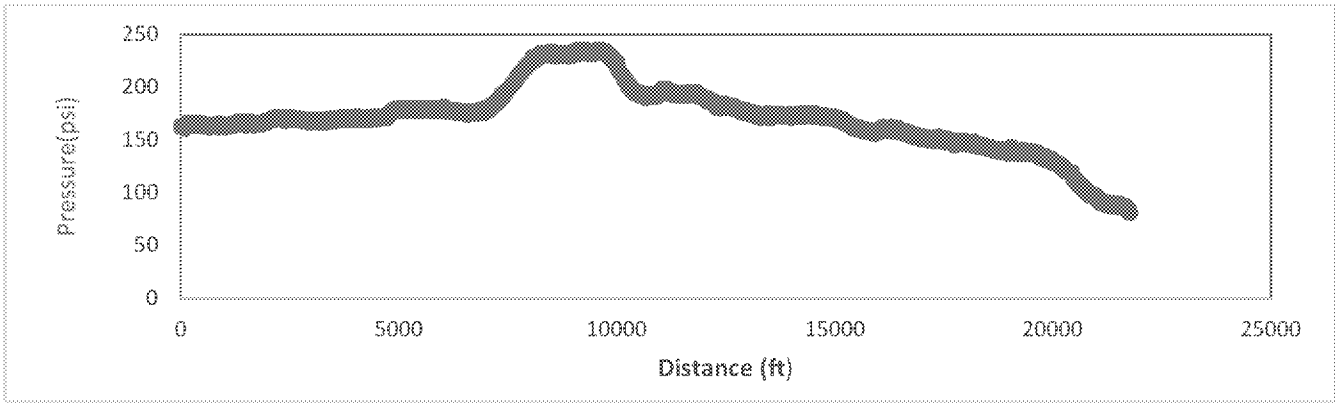
Figure 4.3C Pressure Profile of the first SmartBall vs. Distance

The SmartBall tools were successfully launched and received. The tools recorded data throughout the entire length of the inspections. During this time the pressure inside the subject pipeline was recorded to be above 81 psi for the entire span of the inspected section. Acoustic anomalies resembling leaks were not found on the 20-inch Enbridge Line 5 Mackinac Straits - East Leg section, within the detection limits of the SmartBalls under the operating conditions at the time of the inspection. The data quality was not negatively affected by any surrounding noise, environmental factors, tool speed or otherwise. The data collected was of sufficient quality, and the SmartBall's proven minimum leak detection threshold of 0.03 gallons per minute is retained.
