SmartBall® Dual Inspection Report

Prepared for
Enbridge

Pipeline Number:	Enbridge Line 5
Pipeline Segment:	Mackinac Straits West Leg
Launch Date:	February 19, 2019
Contact:	Jeremy Ward / Jonathan Kwan
Product:	Light Sweet Crude

Enbridge Line 5 Mackinac Straits West Leg

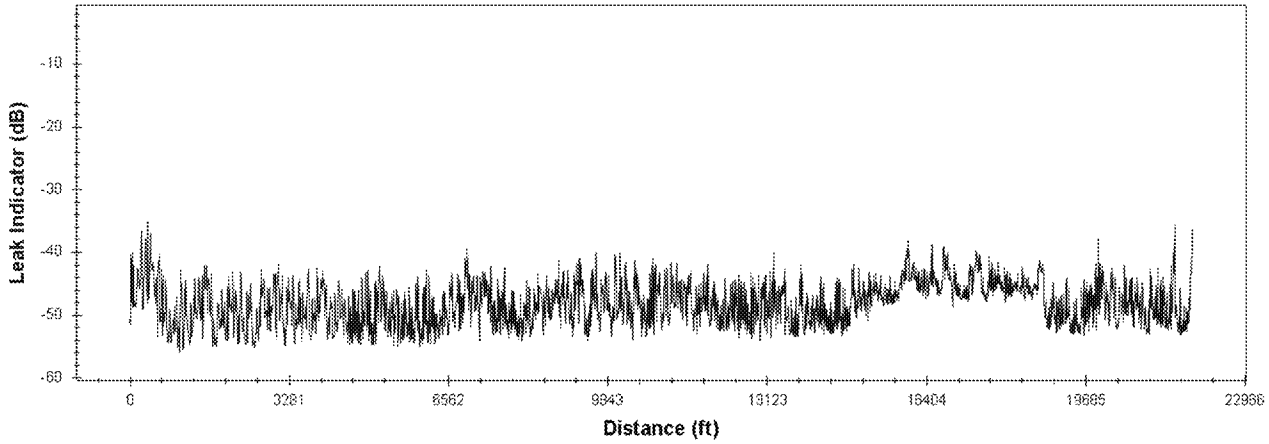
Figure 4.2A: Acoustic summary of the first SmartBall inspection versus Distance Traveled

The data collected by both SmartBall tools was internally peer reviewed to verify that all acoustic anomalies were detected and accurately classified. There were no acoustic anomalies resembling leaks. This indicated that there were no leaks within the detection limits of the SmartBall technology present in the pipeline under the operating conditions at the time of the inspections.

It is important to note that this overview may contain anomalous spikes in the data. These spikes may have been caused by ambient noise around the pipeline from external sources such as pumps or nearby traffic. These sources of ambient noise are easily distinguishable from leaks or other points of interest upon further analysis by trained personnel.

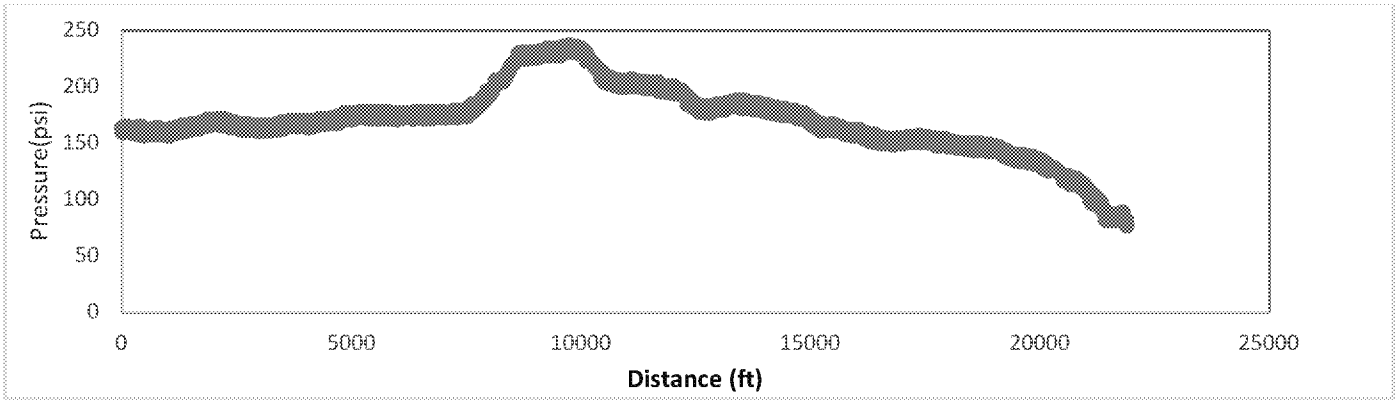
Figure 4.3D Pressure Profile of the second SmartBall vs. Distance

The SmartBall tools were successfully launched and received. The tools recorded data throughout the entire length of the inspection. During this time the pressure inside the subject pipeline was recorded to be above 77 psi for the entire span of the inspected section. Acoustic anomalies resembling leaks were not found on the 20-Inch Enbridge Line 5 Mackinac Straits West Leg section, within the detection limits of the SmartBalls under the operating conditions at the time of the inspection. The data quality was not negatively affected by any surrounding noise, environmental factors, tool speed or otherwise. The data collected was of sufficient quality, and the SmartBall's proven minimum leak detection threshold of 0.03 gallons per minute is retained.
