SmartBall® Dual Inspection Report

Enbridge

Pipeline Number:	Line 5
Pipeline Segment:	Mackinac Straits East Leg
Launch Date:	April 18, 2018
Contact:	Jeremy Ward / Gurwinder Nagra
Product:	Light Sweet Crude

Line 5 Mackinac Straits East Leg

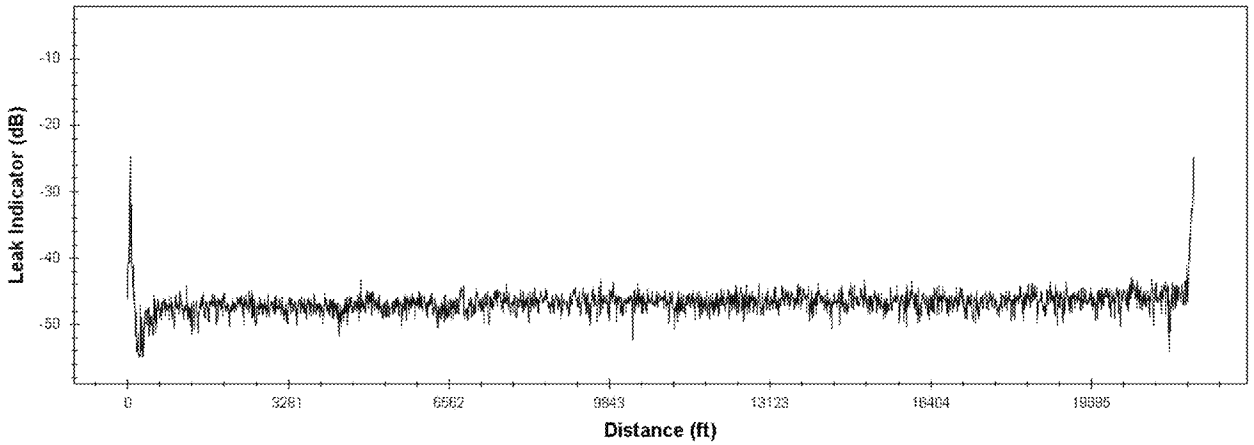
Figure 4.2A: Acoustic summary of the first SmartBall inspection versus Distance Traveled

Figures 4.2A and 4.2B show the acoustic profile of each inspection with respect to the position of each tool within the pipeline, as detected by the SmartBall technology.

It is important to note that this overview may contain anomalous spikes in the data. These spikes may have been caused by ambient noise around the pipeline from external sources such as pumps or nearby traffic. These sources of ambient noise are easily distinguishable from leaks or other points of interest upon further analysis by trained personnel.

Ambient noise generally occurs at a much lower frequency than the frequencies generated by a leak.

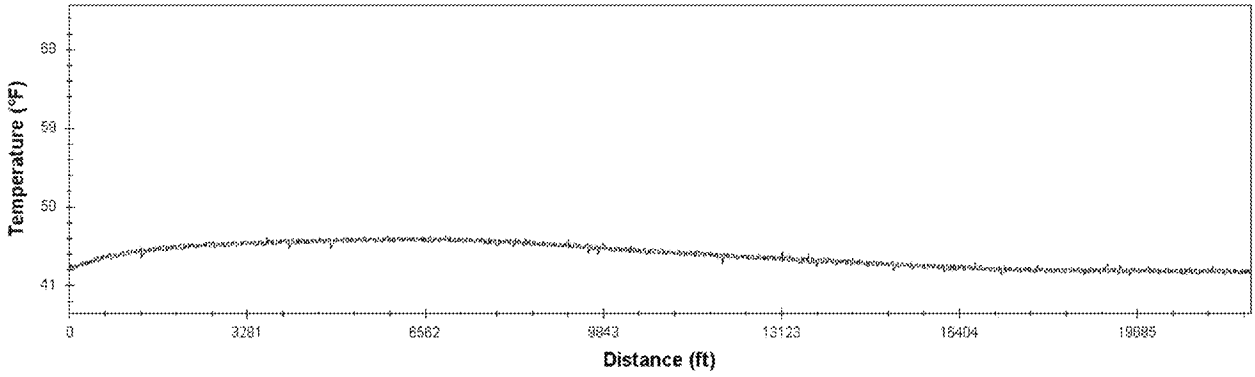
Figure 4.3A: Temperature Profile of the first SmartBall vs. Distance

Figure 4.3A shows the corresponding plots of the temperature the first SmartBall tool experienced vs distance.

No temperature and pressure profile is available for the second SmartBall possibly due to a failure in the temperature and pressure sensors for this tool.

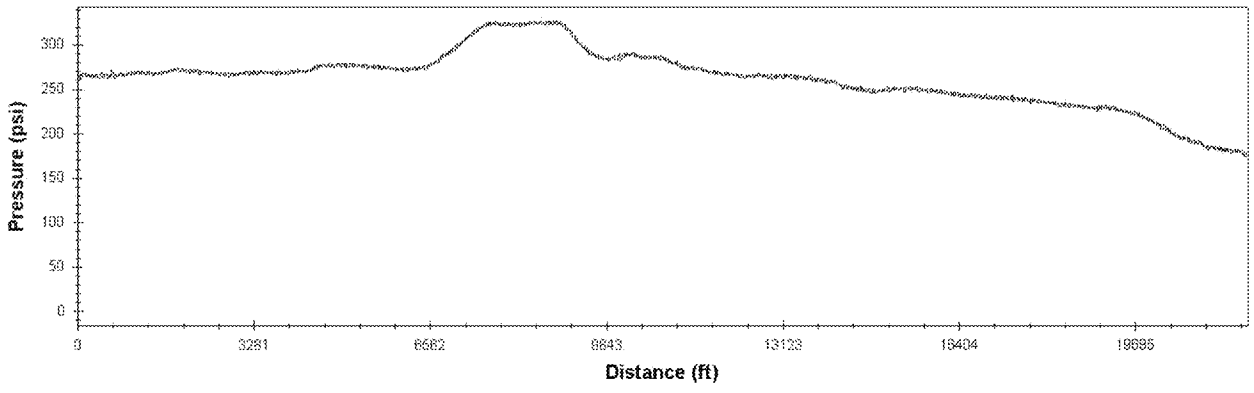
Figure 4.3B Pressure Profile of the first SmartBall vs. Distance

Figure 4.3B shows the corresponding plot of the pressure the first SmartBall tool experienced vs distance.
