SmartBall® Dual Inspection Report

Prepared for
Enbridge

Pipeline Number:	Enbridge Line 5
Pipeline Segment:	Mackinac Straits West Leg
Launch Date:	May 7, 2019
Contact:	Jeremy Ward / Jonathan Kwan
Product:	Light Sweet Crude

Enbridge Line 5 Mackinac Straits West Leg

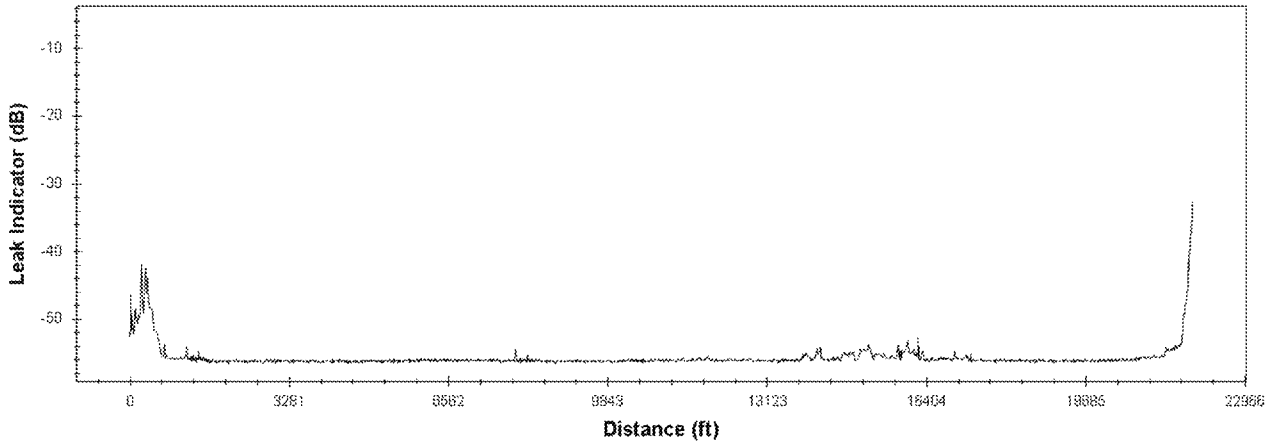
Figure 4.2A: Acoustic summary of the first SmartBall inspection versus Distance Traveled

It is important to note that this overview may contain anomalous spikes in the data. These spikes may have been caused by ambient noise around the pipeline from external sources such as pumps or nearby traffic. These sources of ambient noise are easily distinguishable from leaks or other points of interest upon further analysis by trained personnel.

Ambient noise generally occurs at a much lower frequency than the frequencies generated by a leak.

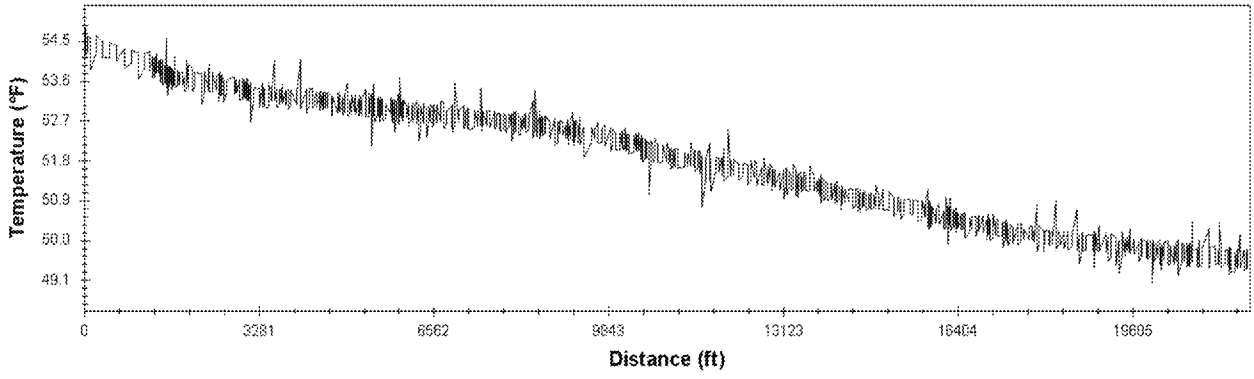
Figure 4.3A: Temperature Profile of the first SmartBall vs. Distance

Figures 4.3A and 4.3B show the corresponding plots of the temperature the first and second SmartBall tools experienced vs distance.

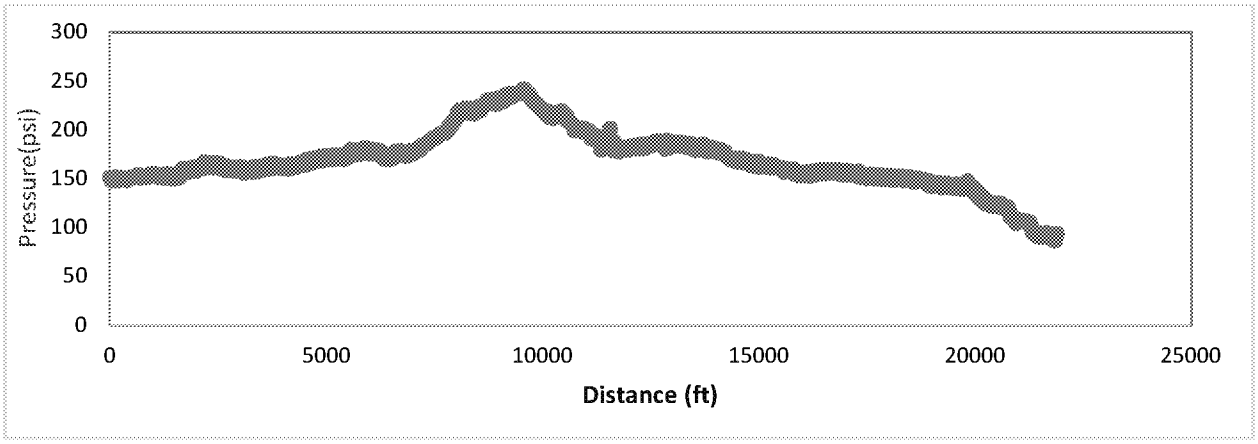
Figure 4.3C Pressure Profile of the first SmartBall vs. Distance

The SmartBall tools were successfully launched and received. The tools recorded data throughout the entire length of the inspection. During this time the pressure inside the subject pipeline was recorded to be above 100 psi for the entire span of the inspected section. Acoustic anomalies resembling leaks were not found on the 20-inch Enbridge Line 5 Mackinac Straits West leg section, within the detection limits of the SmartBalls under the operating conditions at the time of the inspection. The data quality was not negatively affected by any surrounding noise, environmental factors, tool speed or otherwise. The data collected was of sufficient quality, and the SmartBall's proven minimum leak detection threshold of 0.03 gallons per minute is retained.
