SmartBall® Dual Inspection Report

Prepared for
Enbridge

Pipeline Number:	Line 5
Pipeline Segment:	Mackinac Straits West Leg
Launch Date:	September 18, 2018
Contact:	Jeremy Ward / Gurwinder Nagra
Product:	Light Sweet Crude

Line 5 Mackinac Straits West Leg

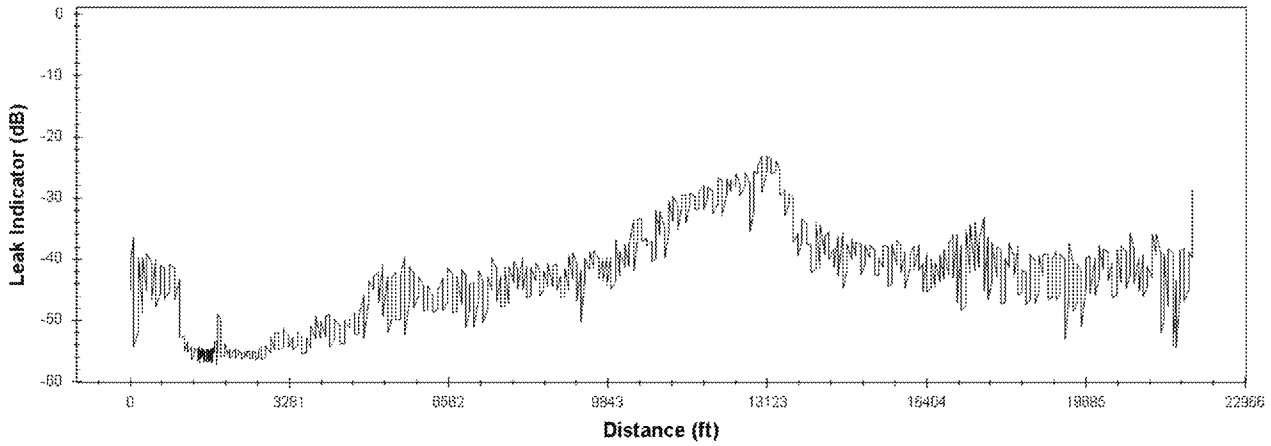
Figure 4.2A: Acoustic summary of the first SmartBall inspection versus Distance Traveled

It is important to note that this overview may contain anomalous spikes in the data. These spikes may have been caused by ambient noise around the pipeline from external sources such as pumps or nearby traffic. These sources of ambient noise are easily distinguishable from leaks or other points of interest upon further analysis by trained personnel.

Ambient noise generally occurs at a much lower frequency than the frequencies generated by a leak.

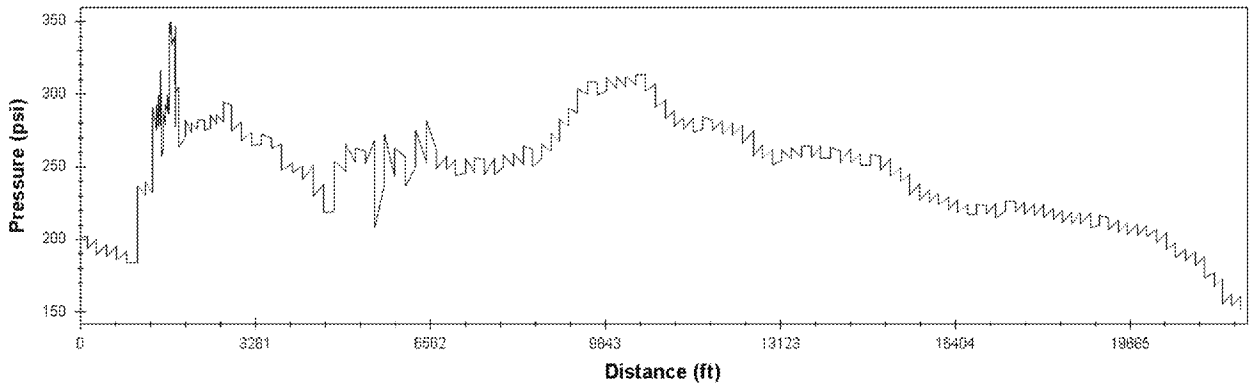
Figure 4.3C Pressure Profile of the first SmartBall vs. Distance

The SmartBall tools were successfully launched and received. The tools recorded data throughout the entire length of the inspection. During this time the pressure inside the subject pipeline was recorded to be above 159 psi for the entire span of the inspected section. Acoustic anomalies resembling leaks were not found on the Enbridge Line 5 Mackinac Straits West Leg section, within the detection limits of the SmartBalls under the operating conditions at the time of the inspection. The data quality was not negatively affected by any surrounding noise, environmental factors, tool speed or otherwise. The data collected was of sufficient quality, and the SmartBall's proven minimum leak detection threshold of 0.03 gallons per minute is retained.
