SmartBall® Dual Inspection Report

Prepared for
Enbridge

Pipeline Number:	Line 5
Pipeline Segment:	Mackinac Straits West Leg
Launch Date:	November 7, 2018
Contact:	Jeremy Ward / Gurwinder Nagra
Product:	Light Sweet Crude

Line 5 Mackinac Straits West Leg

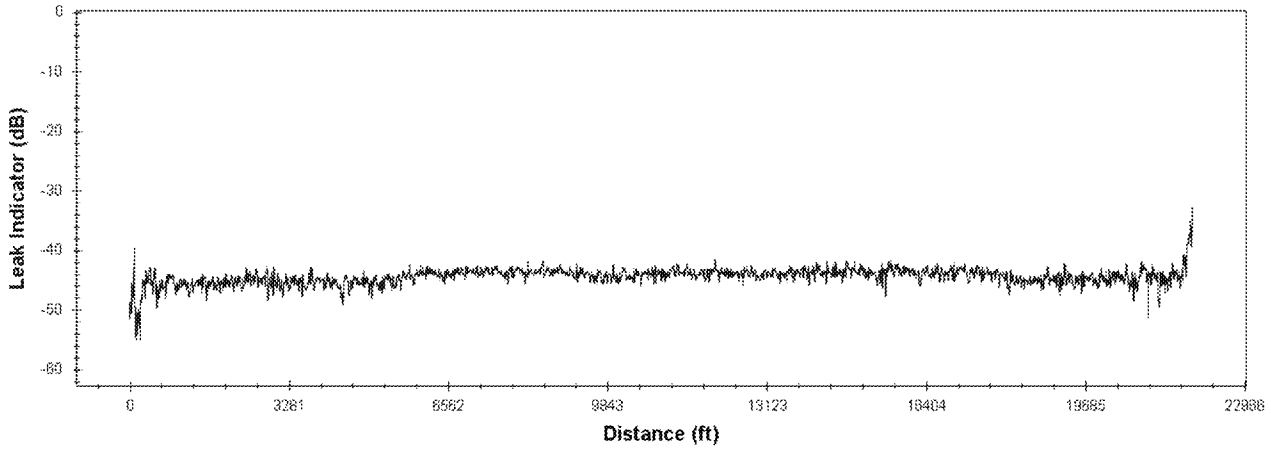
Figure 4.2A: Acoustic summary of the first SmartBall inspection versus Distance Traveled

It is important to note that this overview may contain anomalous spikes in the data. These spikes may have been caused by ambient noise around the pipeline from external sources such as pumps or nearby traffic. These sources of ambient noise are easily distinguishable from leaks or other points of interest upon further analysis by trained personnel.

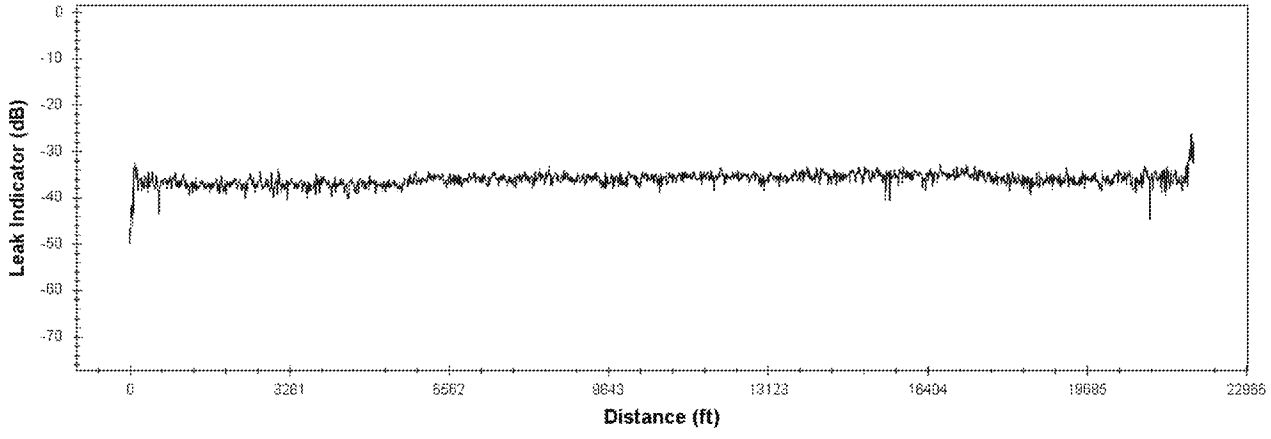
Figure 4.2B: Acoustic summary of the second SmartBall inspection versus Distance Traveled

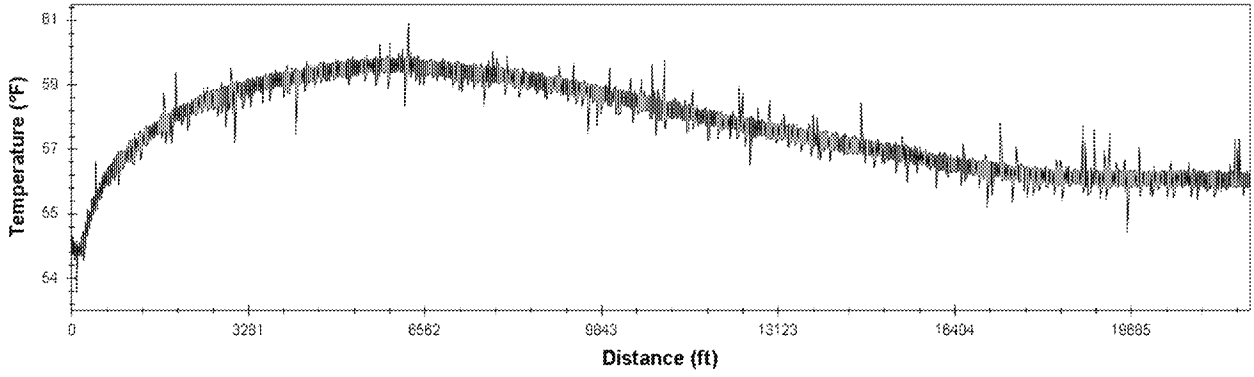
Figure 4.3A: Temperature Profile of the first SmartBall vs. Distance

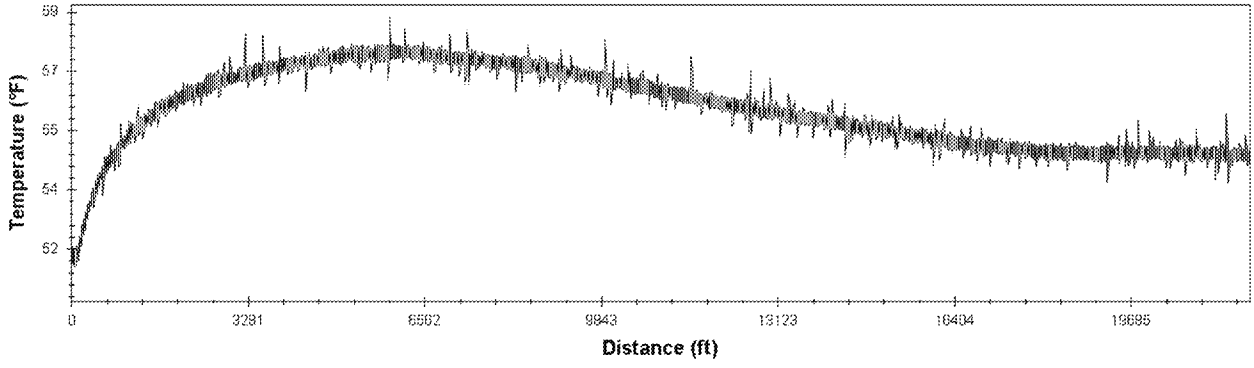
Figure 4.3B: Temperature Profile of the second SmartBall vs. Distance

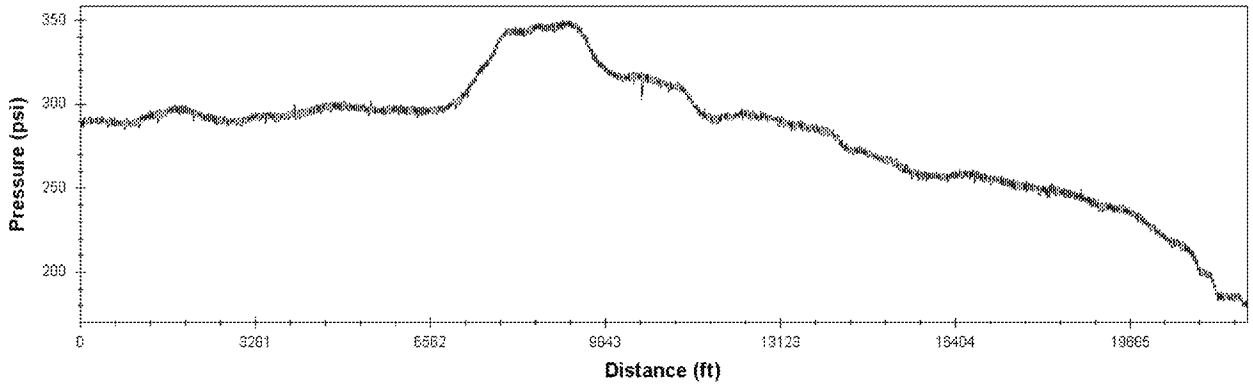
Figure 4.3C Pressure Profile of the first SmartBall vs. Distance

The SmartBall tools were successfully launched and received. The tools recorded data throughout the entire length of the inspection. During this time the pressure inside the subject pipeline was recorded to be above 193 psi for the entire span of the inspected section. Acoustic anomalies resembling leaks were not found on the 20-Inch Enbridge Line 5 Mackinac Straits West Leg section, within the detection limits of the SmartBalls under the operating conditions at the time of the inspection. The data quality was not negatively affected by any surrounding noise, environmental factors, tool speed or otherwise. The data collected was of sufficient quality, and the SmartBall's proven minimum leak detection threshold of 0.03 gallons per minute is retained.

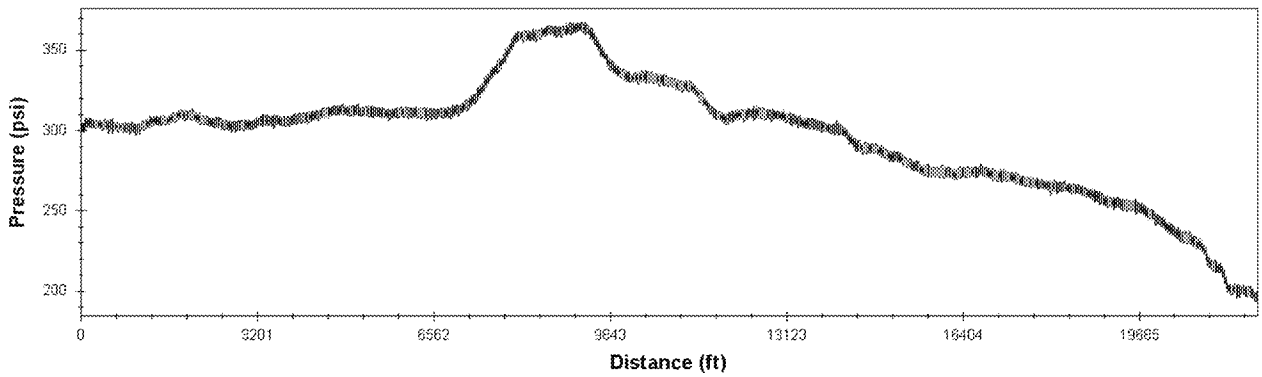
Figure 4.3D Pressure Profile of the second SmartBall vs. Distance
