MagneScan™
Inspection Report for
20 inch Crude Oil Pipeline

Enbridge Energy Limited Partnership

Line 5: 20" West North Straits to
West Mackinaw (WNO-WMA)
Run Date: 21 March 2018

Work Order Number: WPI-1267560-18
Contract Number: 30554
Project Number: 450634_20B
Issue 1, 19 June 2018

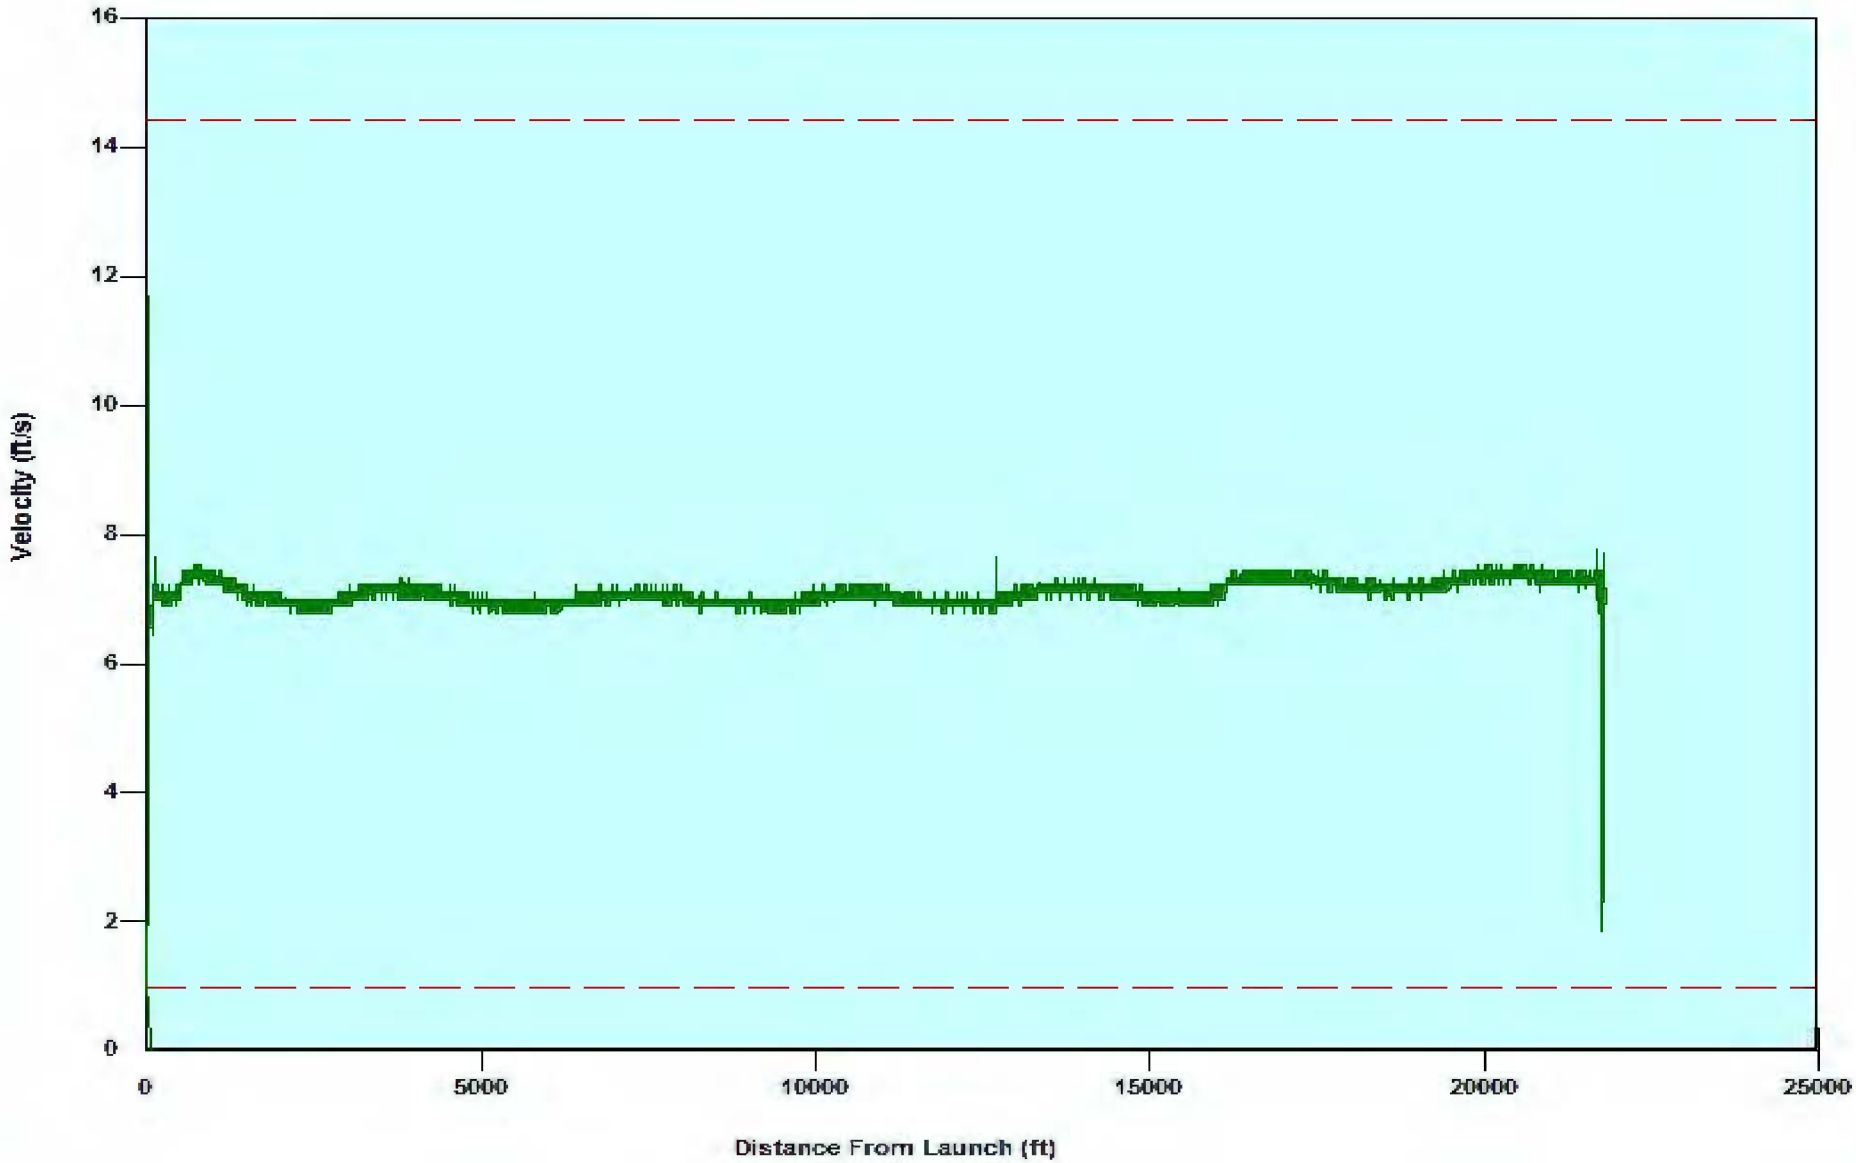
VELOCITY PLOT

The inspection vehicle did not exceed the specified maximum velocity during the inspection survey.

The inspection vehicle's average velocity during the inspection run was 7.1 ft/s.

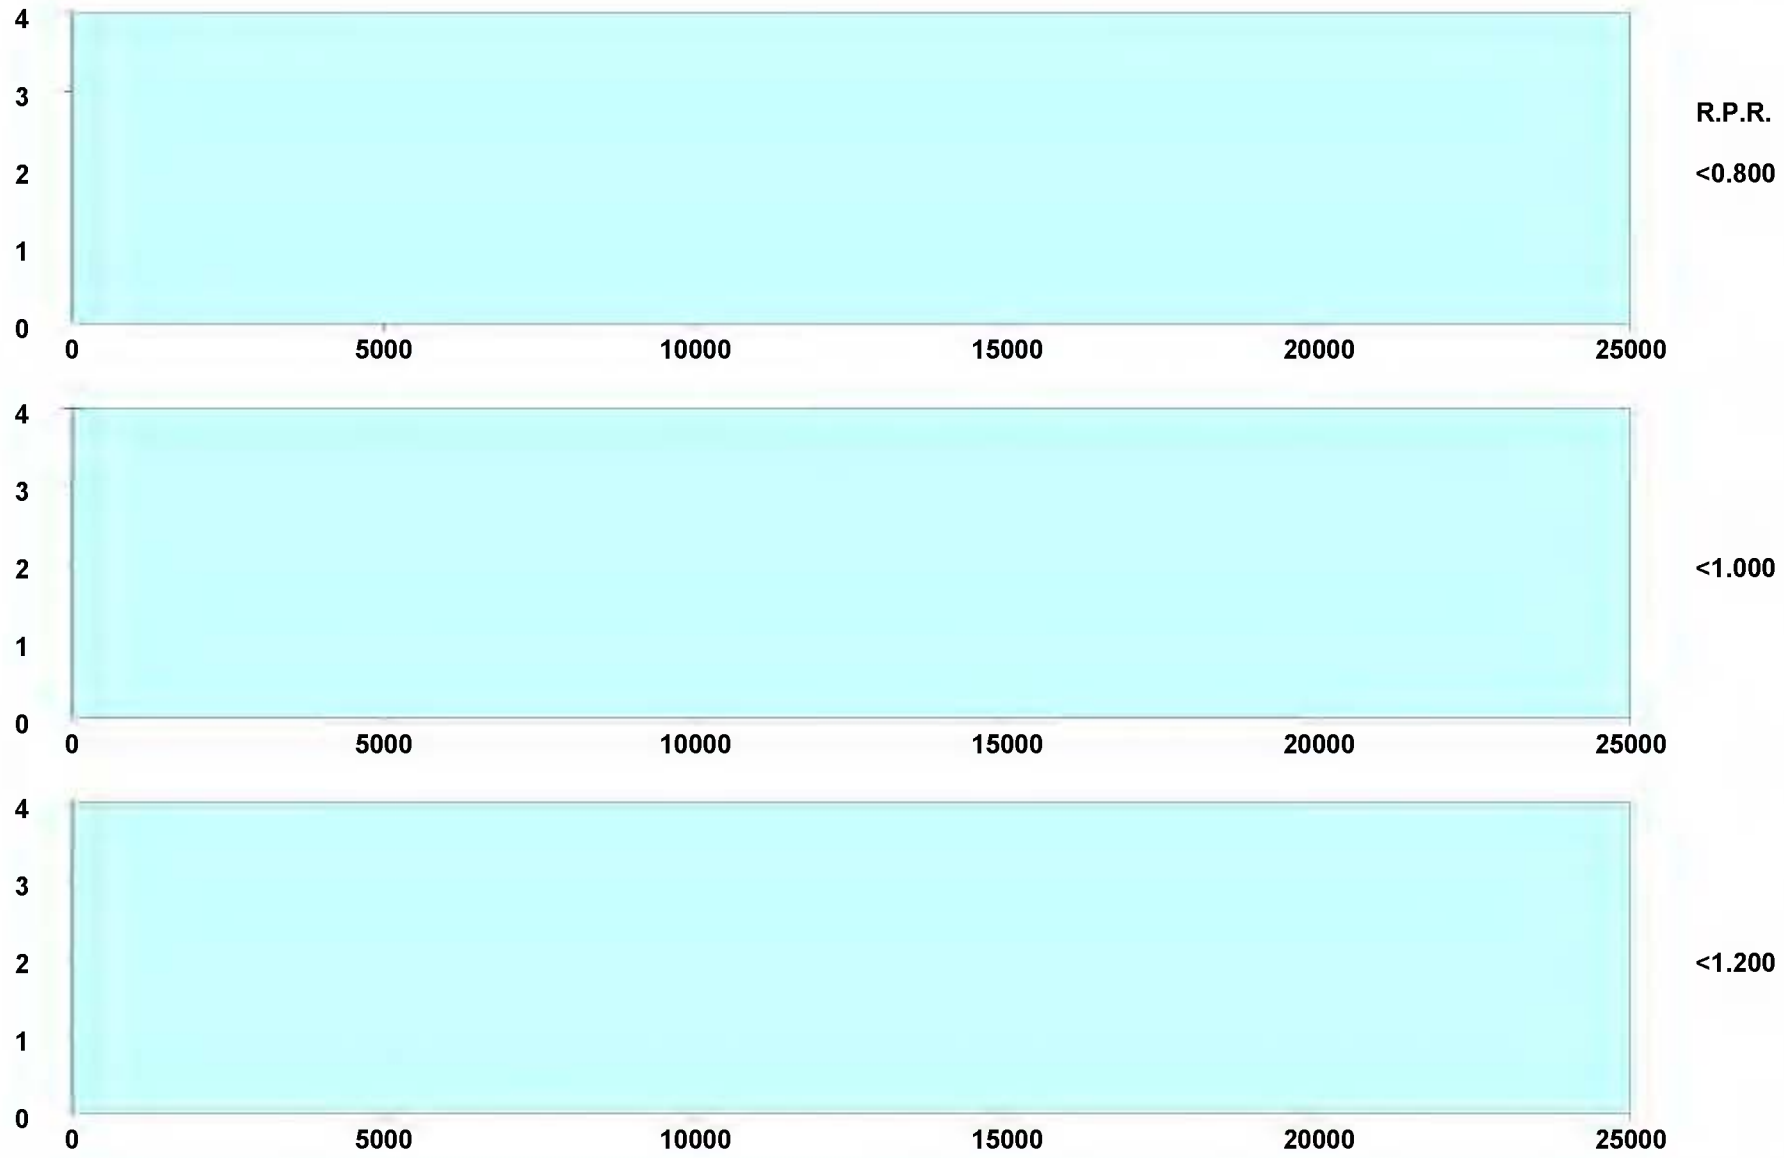
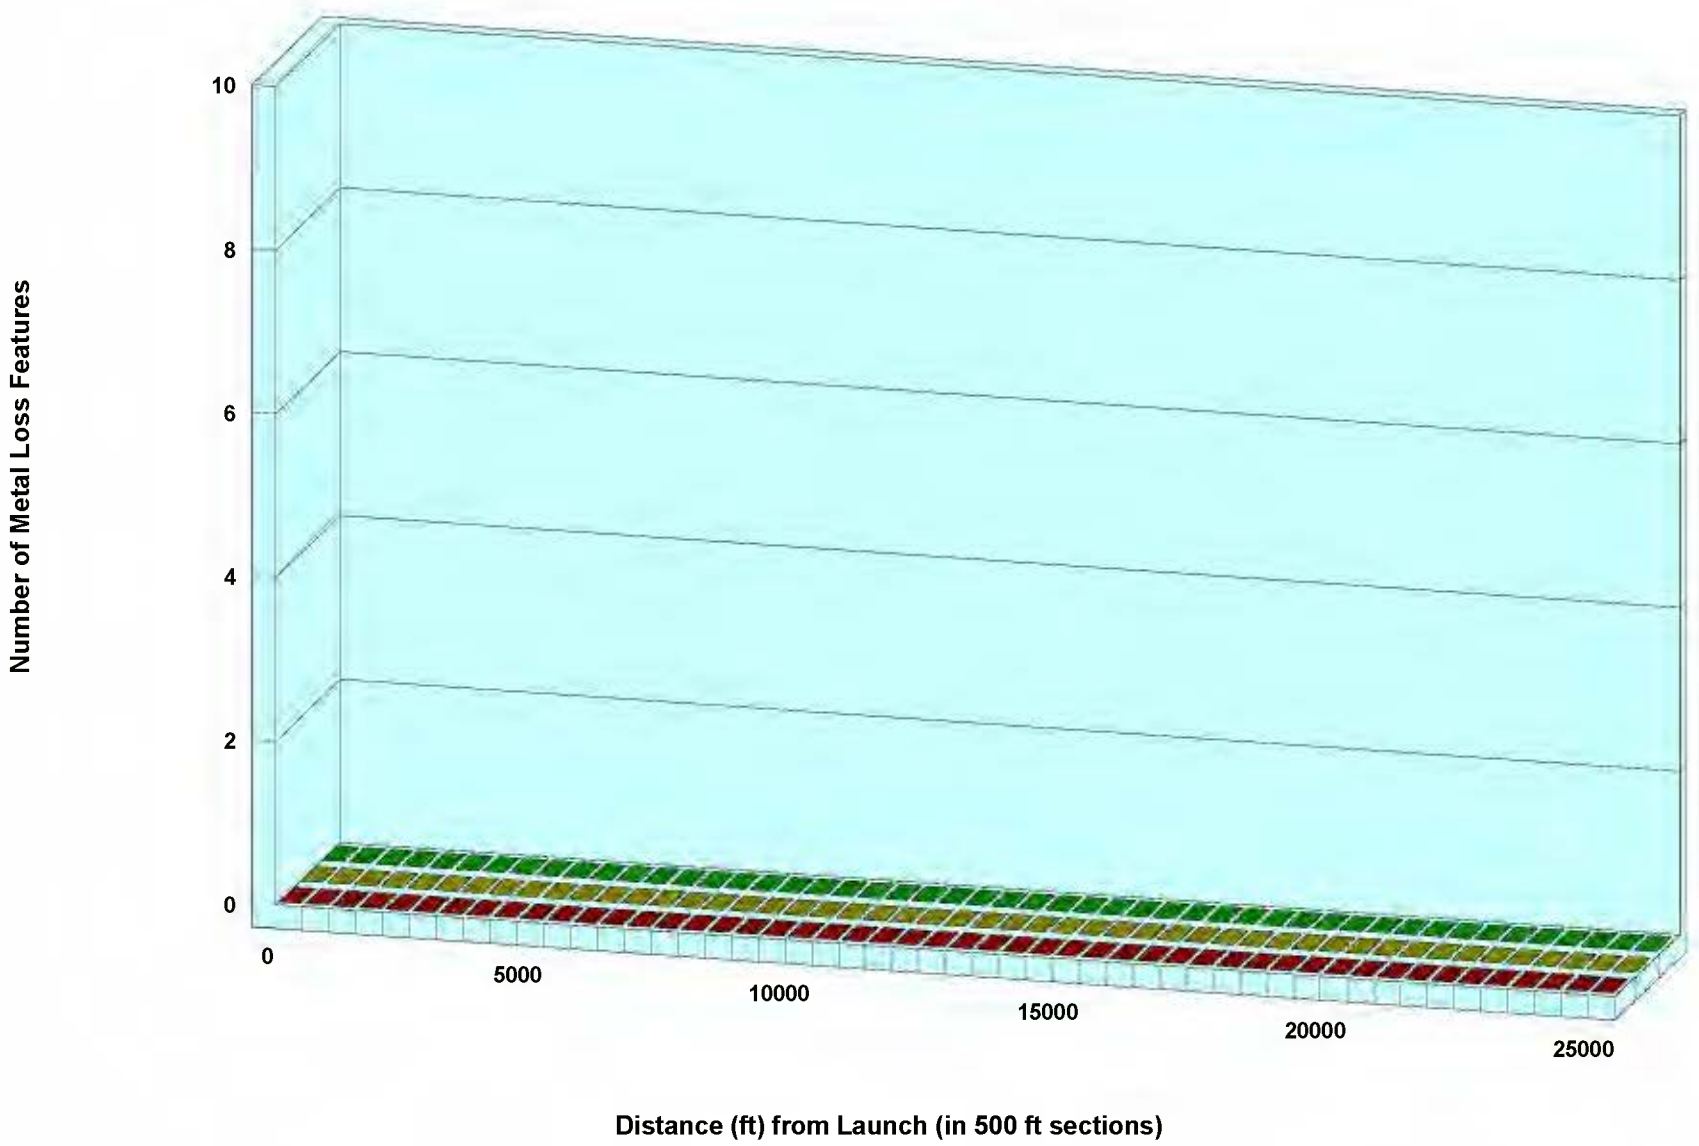
PRESSURE BASED HISTOGRAM

0 metal loss features with RPR values <0.800

0 metal loss features with RPR values <1.000

0 metal loss features with RPR values <1.200

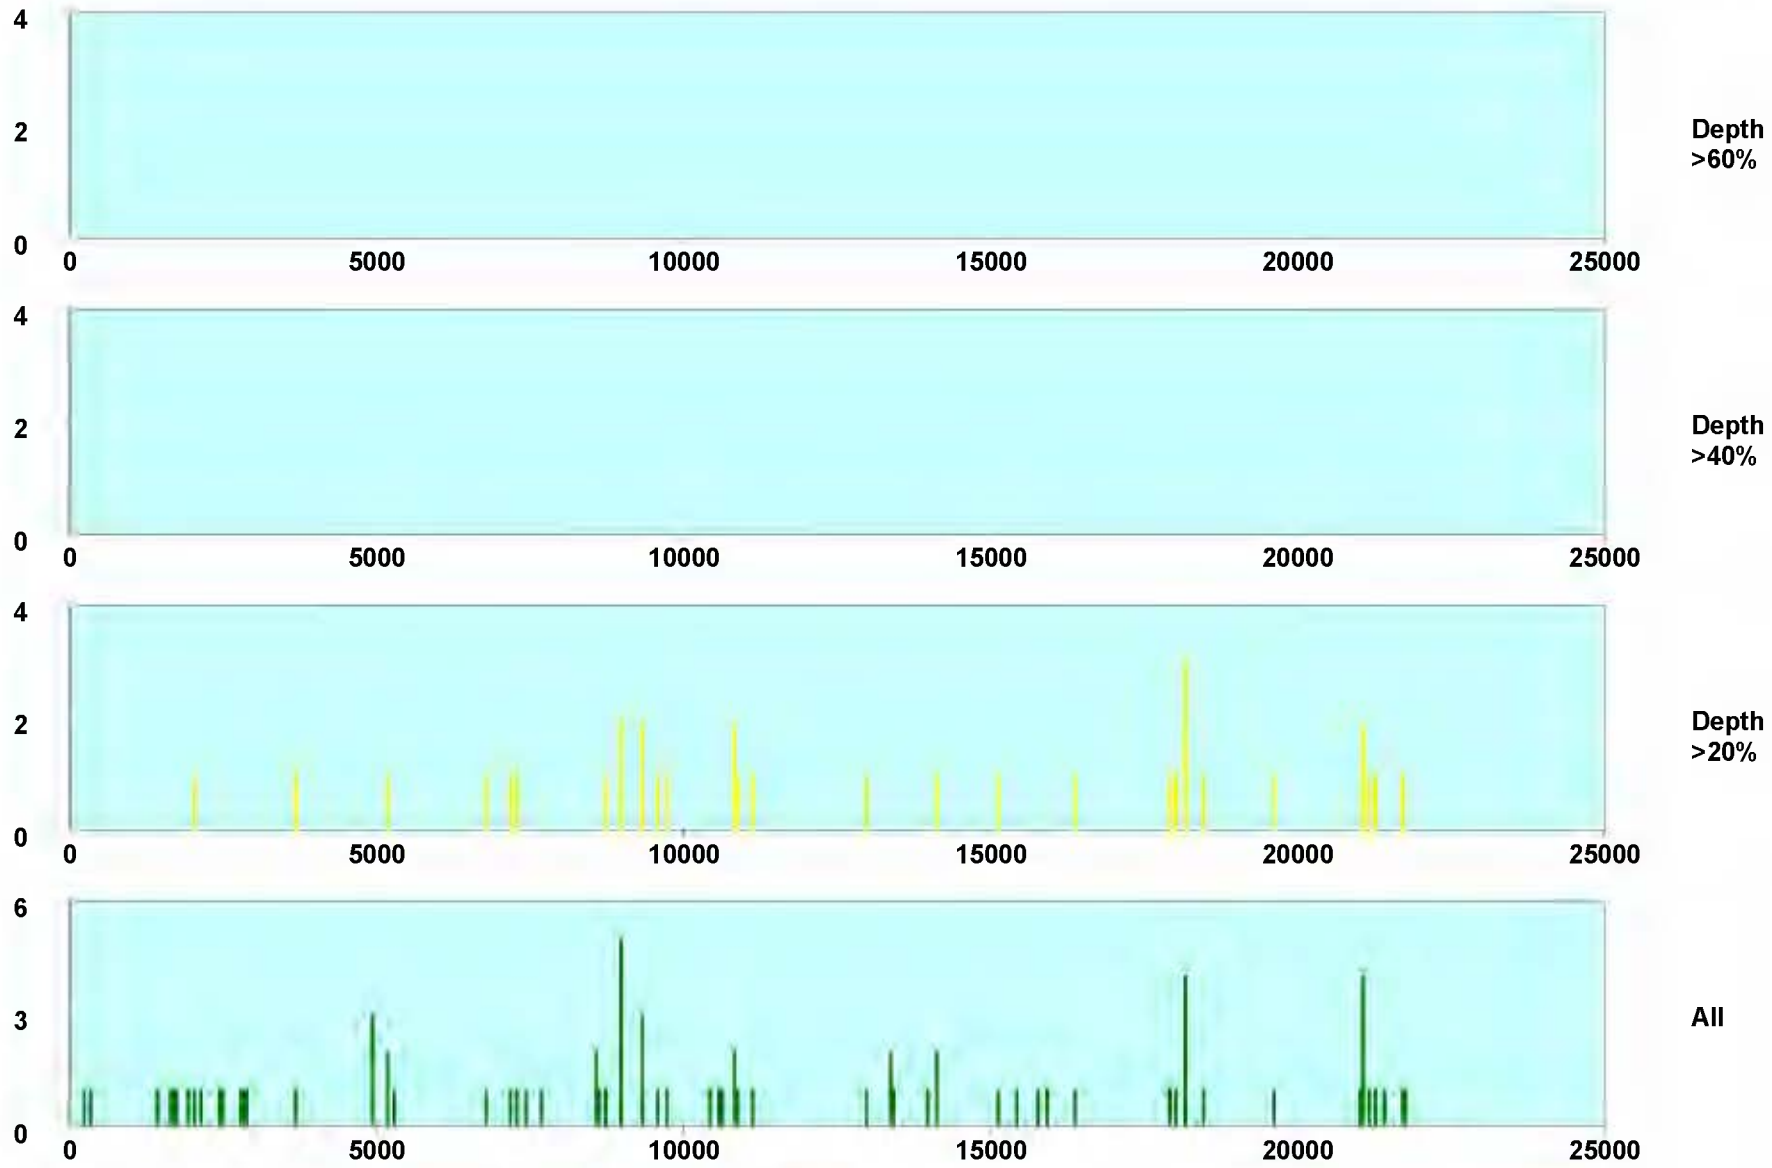
DEPTH BASED HISTOGRAM
Axial Length > 3t
Line 5: 20" West North Straits to West Mackinaw (WNO-WMA)

77 metal loss features with a predicted length > 3t.
Of these:

44	have a predicted peak depth of ≤ 20%t.
33	have a predicted peak depth of > 20%t and ≤ 40%t.
0	have a predicted peak depth of > 40%t and ≤ 60%t.
0	have a predicted peak depth of > 60%t.
