Geometric ILI Summary Document

Line 5 ENO-EMA March 2018 BH Geopig

Effective Date: <6/13/2018>

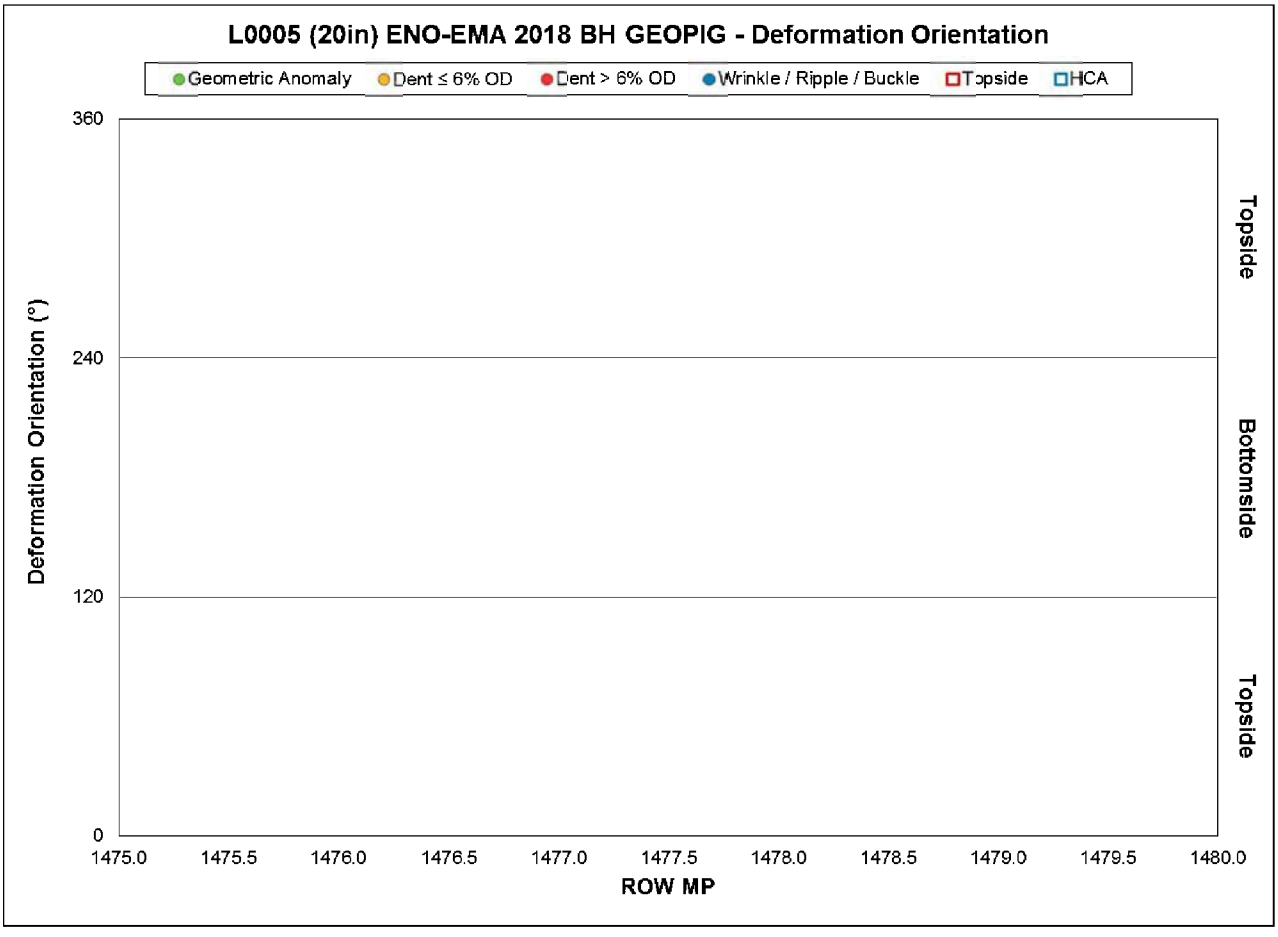
Figure 1 Orientation of all reported deformation features on the pipeline system based on the 2018 Geopig program.

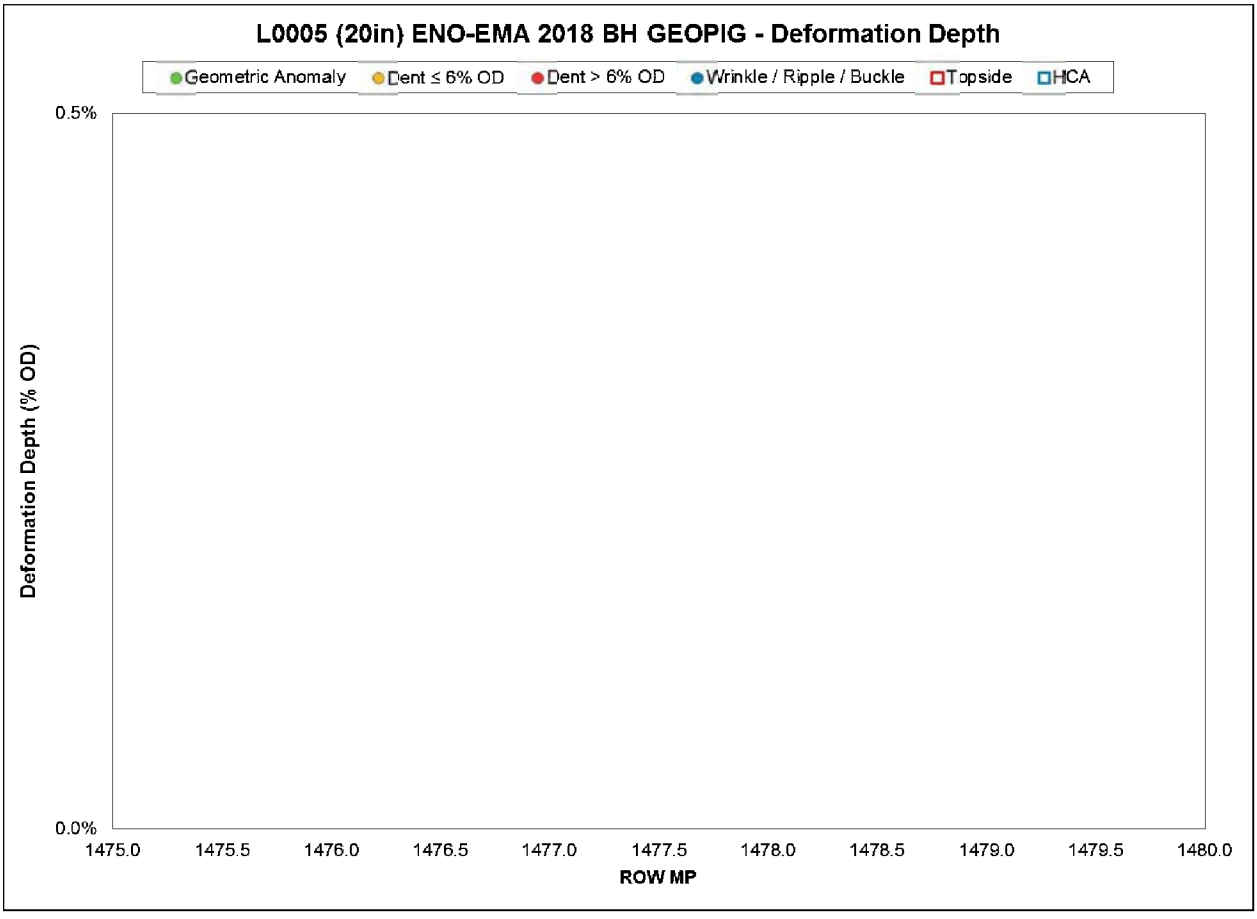
Figure 2 Depth of all reported deformation features on the pipeline system based on the 2018 Geopig program.

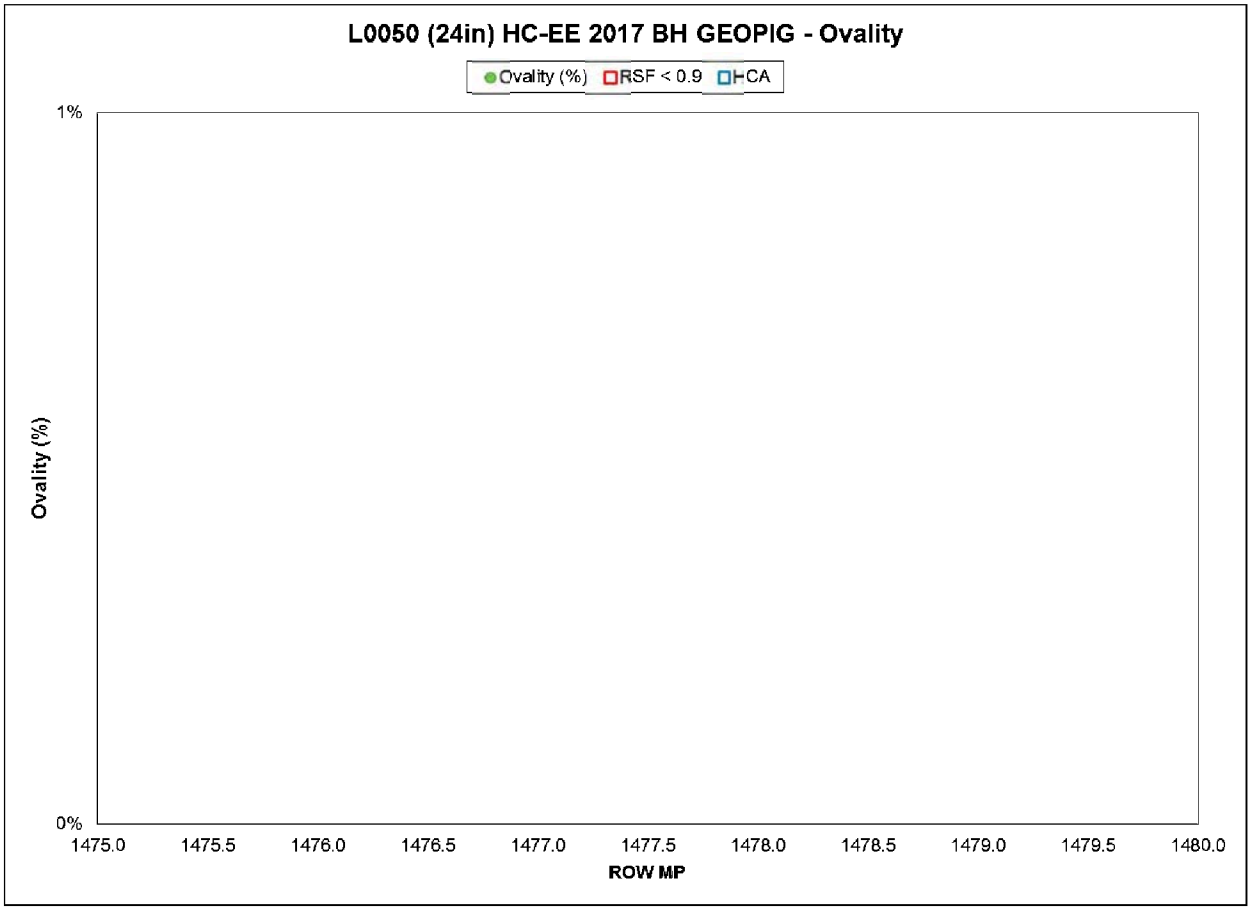
Figure 3 Severity ranking of all reported ovality features on the pipeline system based on the 2018 Geopig program.
