**MagneScan™**
Inspection Report for
20 inch Crude Oil Pipeline

# Enbridge Energy Limited Partnership

Line 5: 20" East North Straits to
East Mackinaw (ENO-EMA)
Run Date: 20 March 2018

Work Order Number: WPI-1267560-18
Contract Number: 30553
Project Number: 450634_20A
Issue 1, 18 June 2018

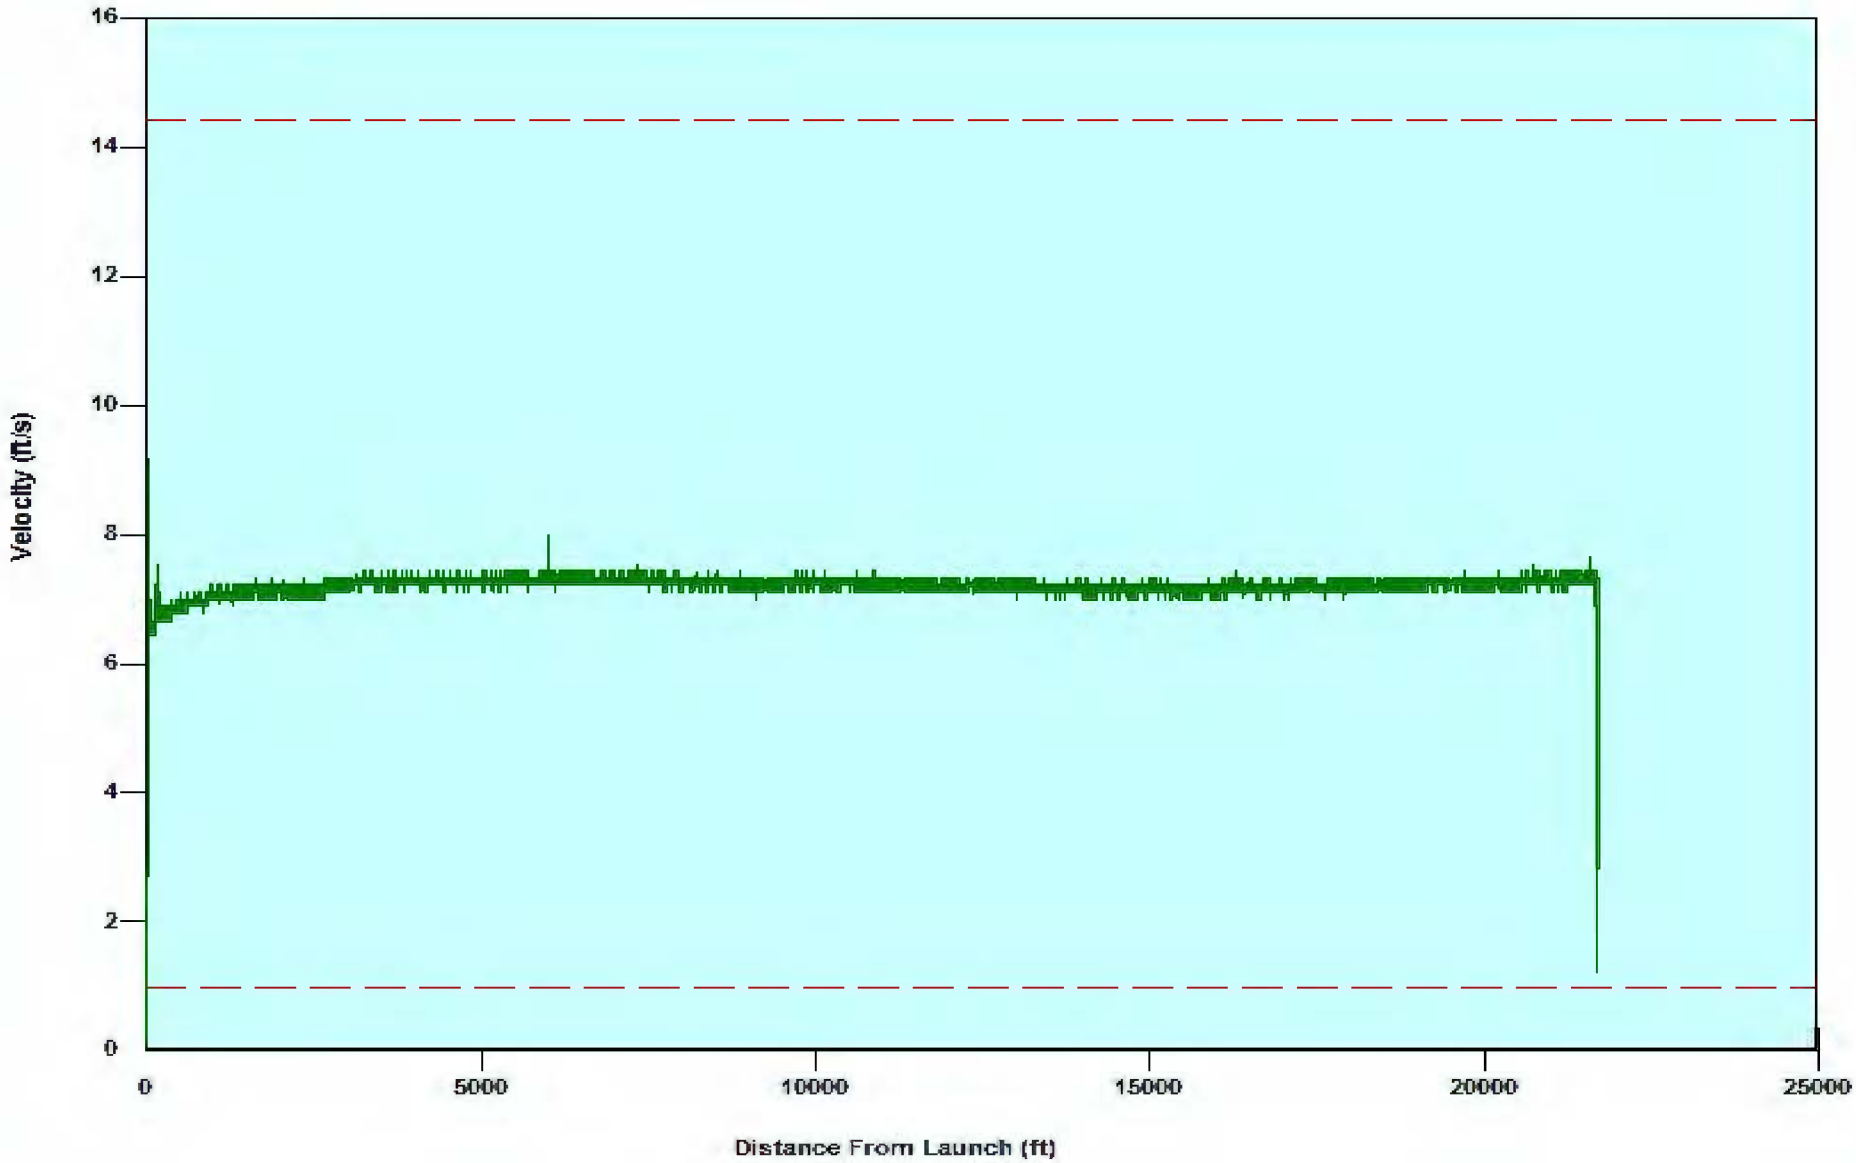
VELOCITY PLOT

The inspection vehicle did not exceed the specified maximum velocity during the inspection survey.

The inspection vehicle's average velocity during the inspection run was 7.2 ft/s.

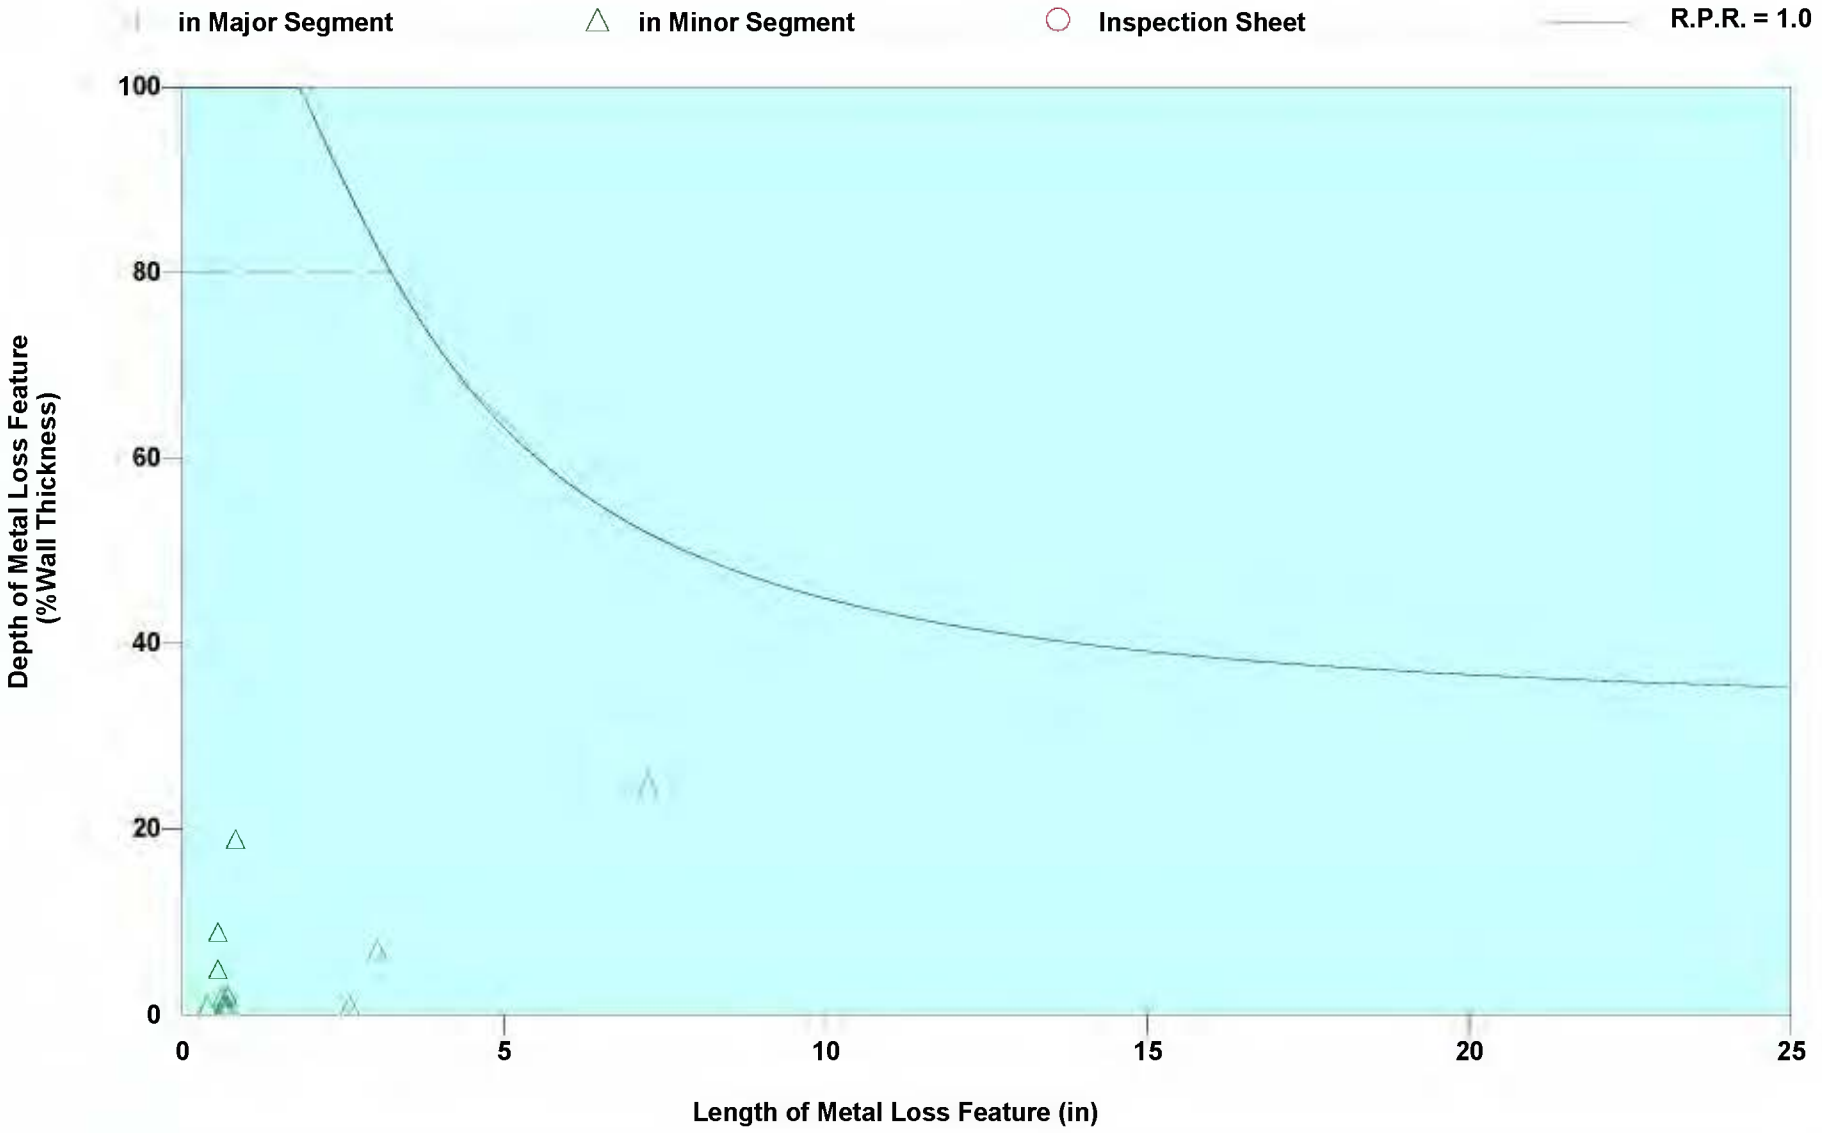
SENTENCED PLOT
Metal Loss

External Diameter 20 in
Wall Thickness 0.812 in
SMYS 30000.0 PSI
Modified ASME B31.G 0.85dL

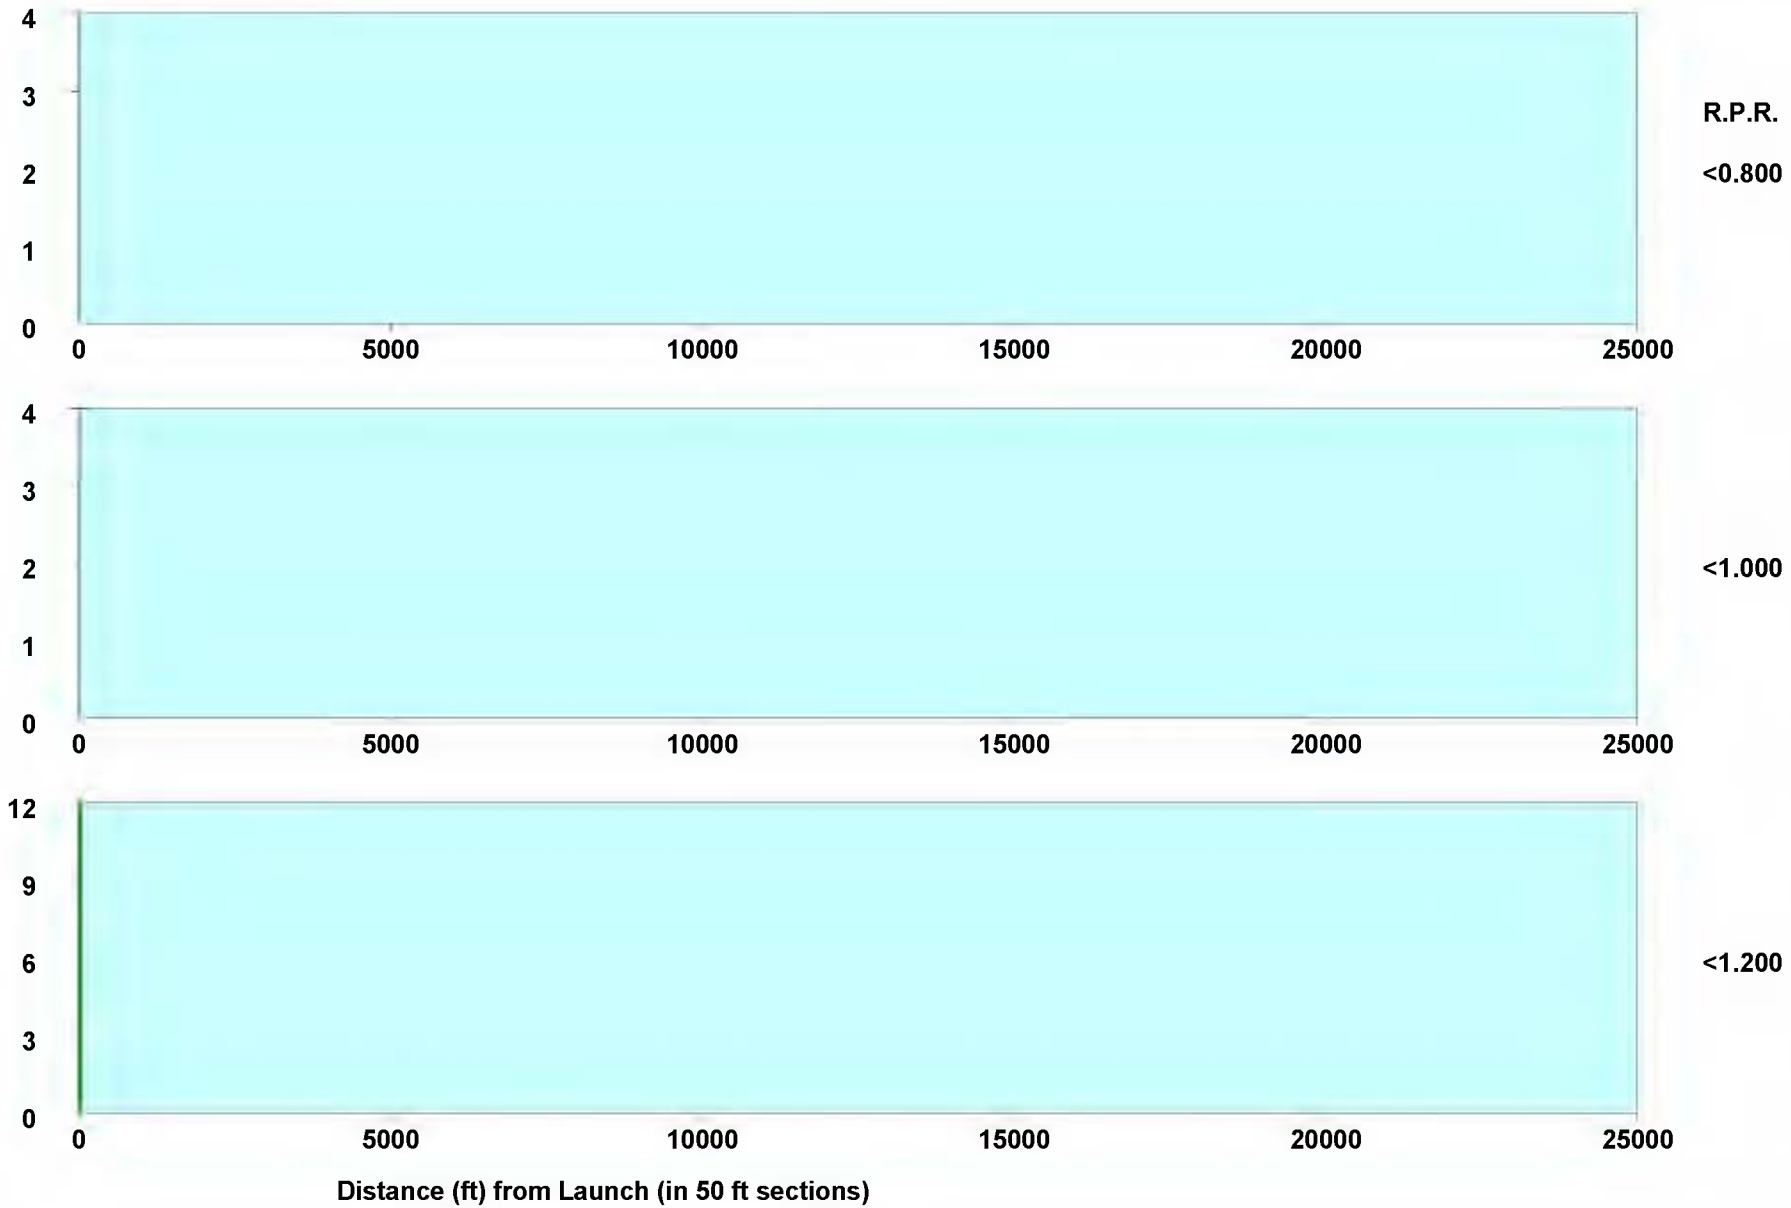
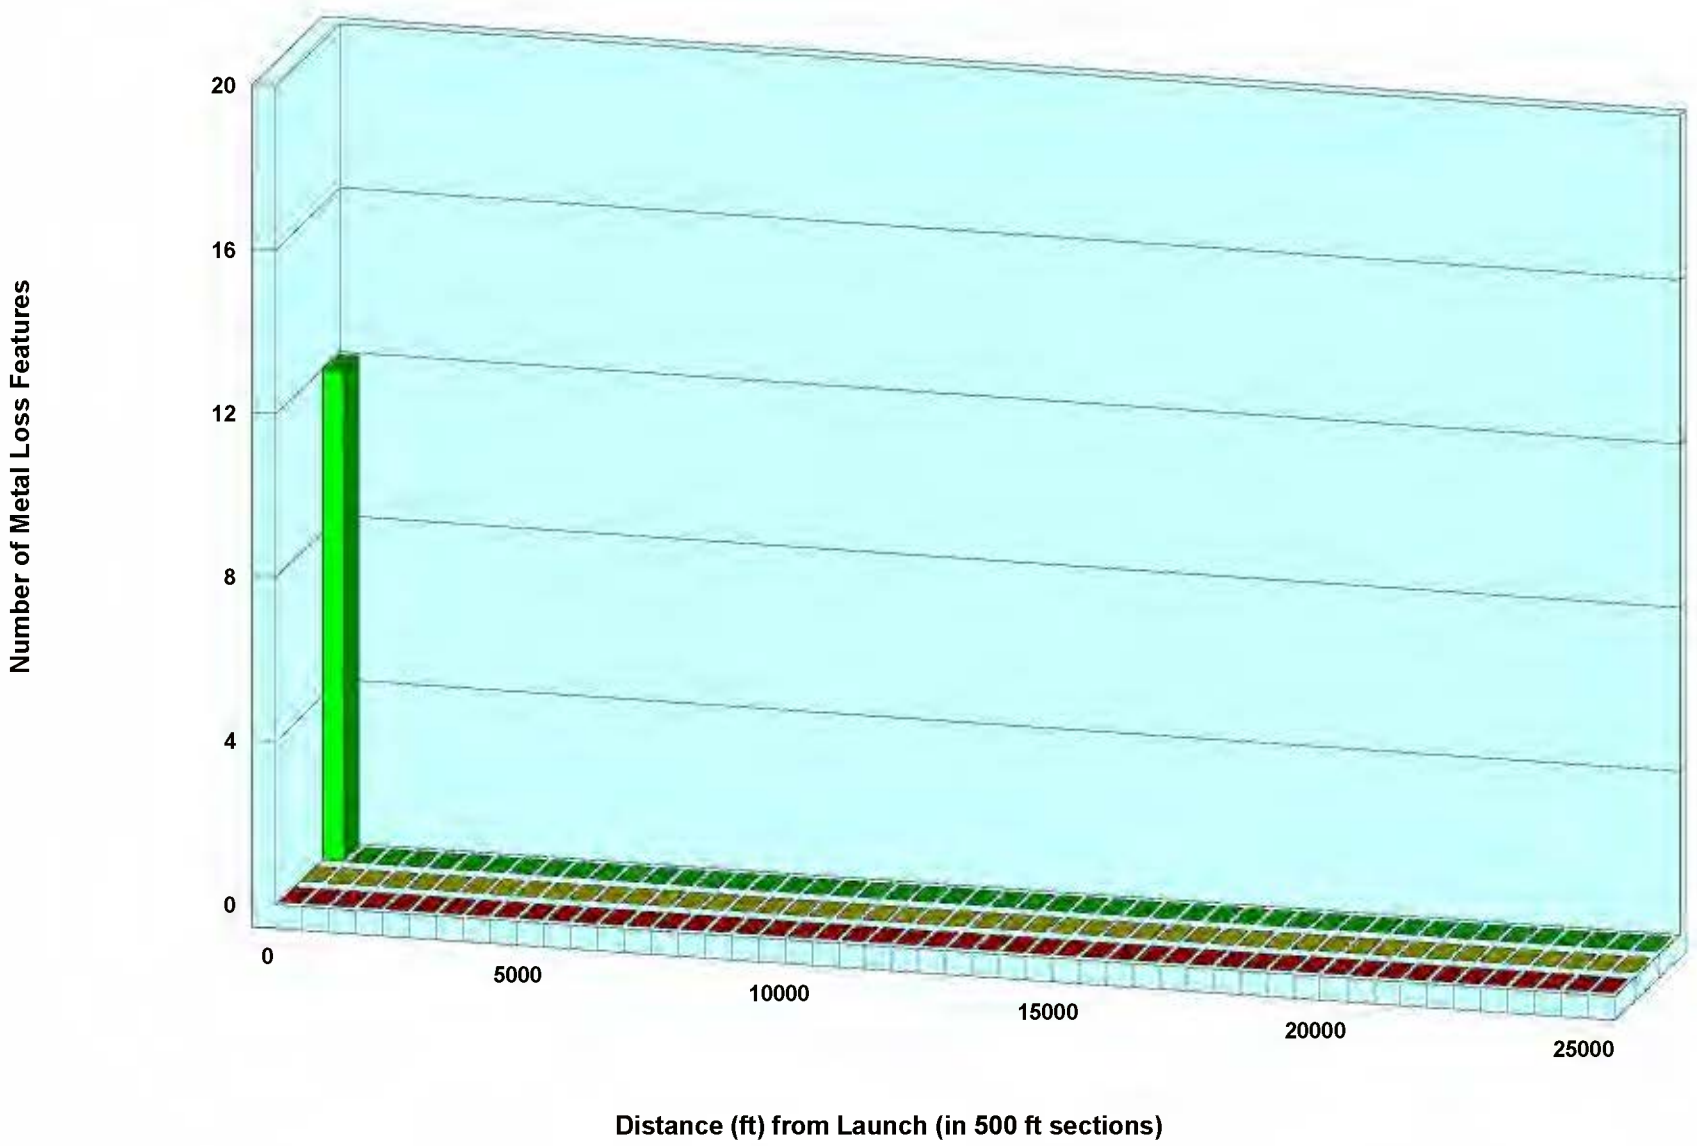
PRESSURE BASED HISTOGRAM

| **0** | metal loss features with RPR values <0.800 |
| **0** | metal loss features with RPR values <1.000 |
| **12** | metal loss features with RPR values <1.200 |
