PIPELINE INTEGRITY
CIRCUMFERENTIAL CRACK PROGRAM SUMMARY
LINE 5 ENO-EMA 2014 NDT UCC ILI

Last Update: March 1, 2016

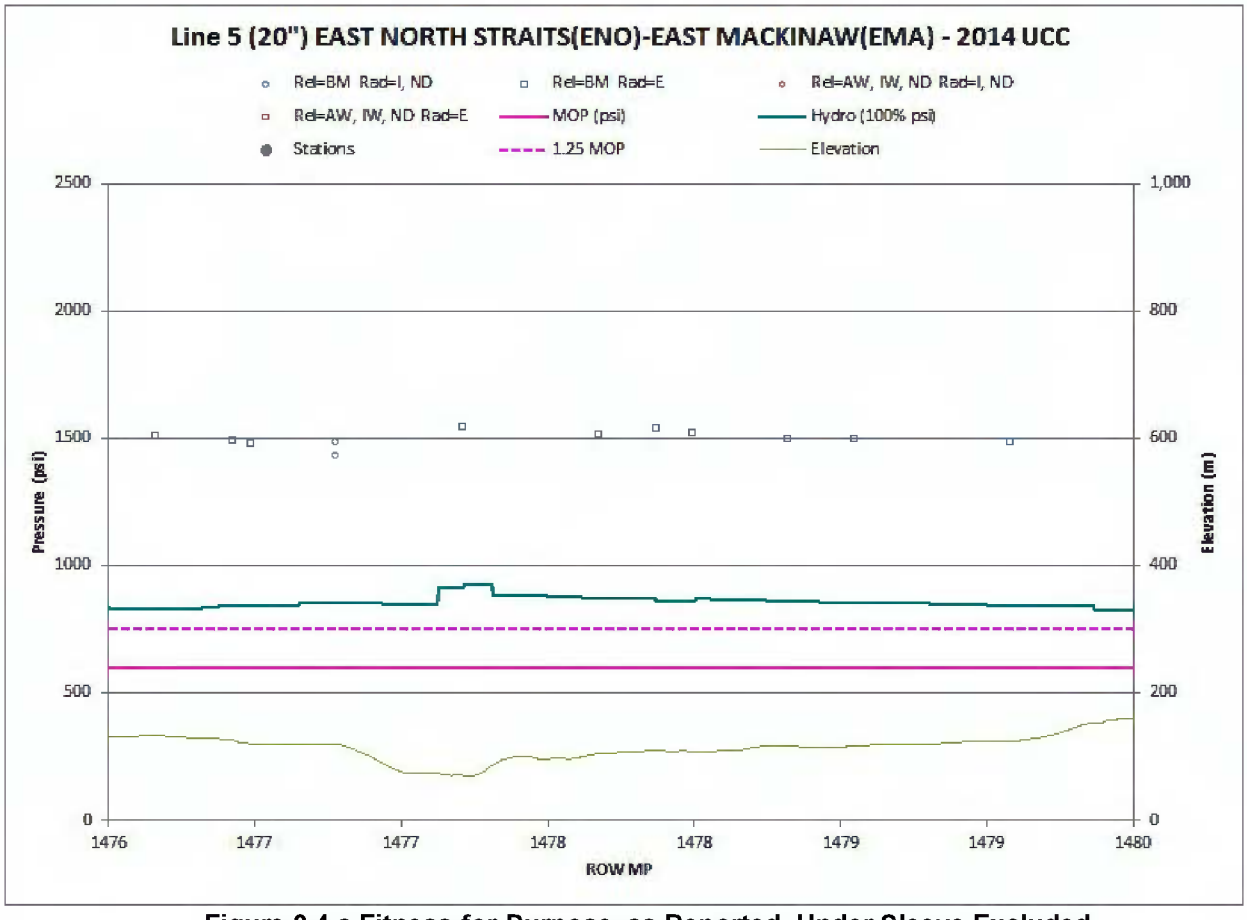
Figure 2.4.a Fitness-for-Purpose, as Reported, Under Sleeve Excluded

- 14 CL features were reported
- 2 features on one joint issued for excavation; one found to be a mill scab and the other a scab, both shallow in depth (trending plot not provided)
