Geometric ILI Summary Document

Line 5 ENO-EMA 2017 GeminiCal

Effective Date: <5/24/2017>

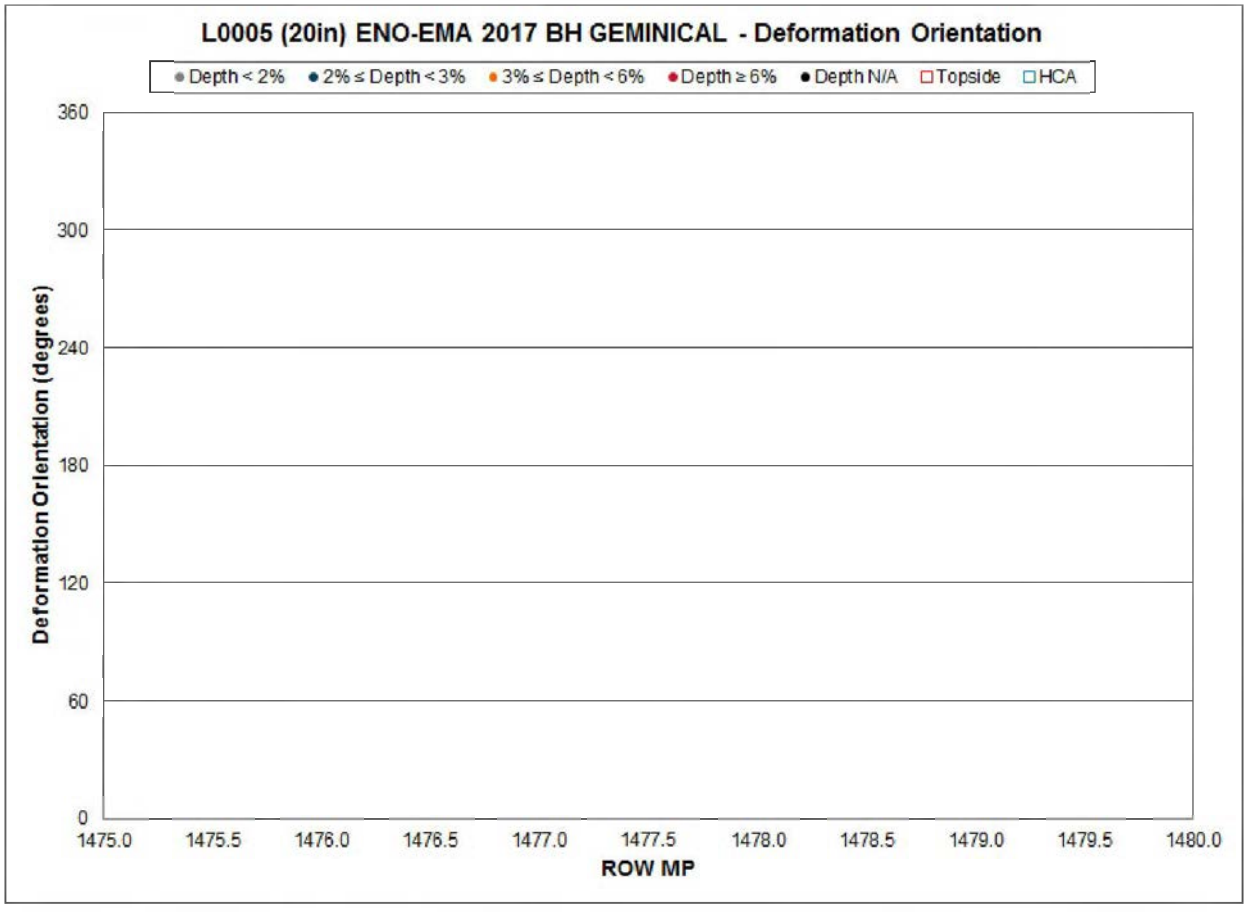
Figure 1 Orientation of all unmitigated features remaining in the pipeline system after completing the excavation program.

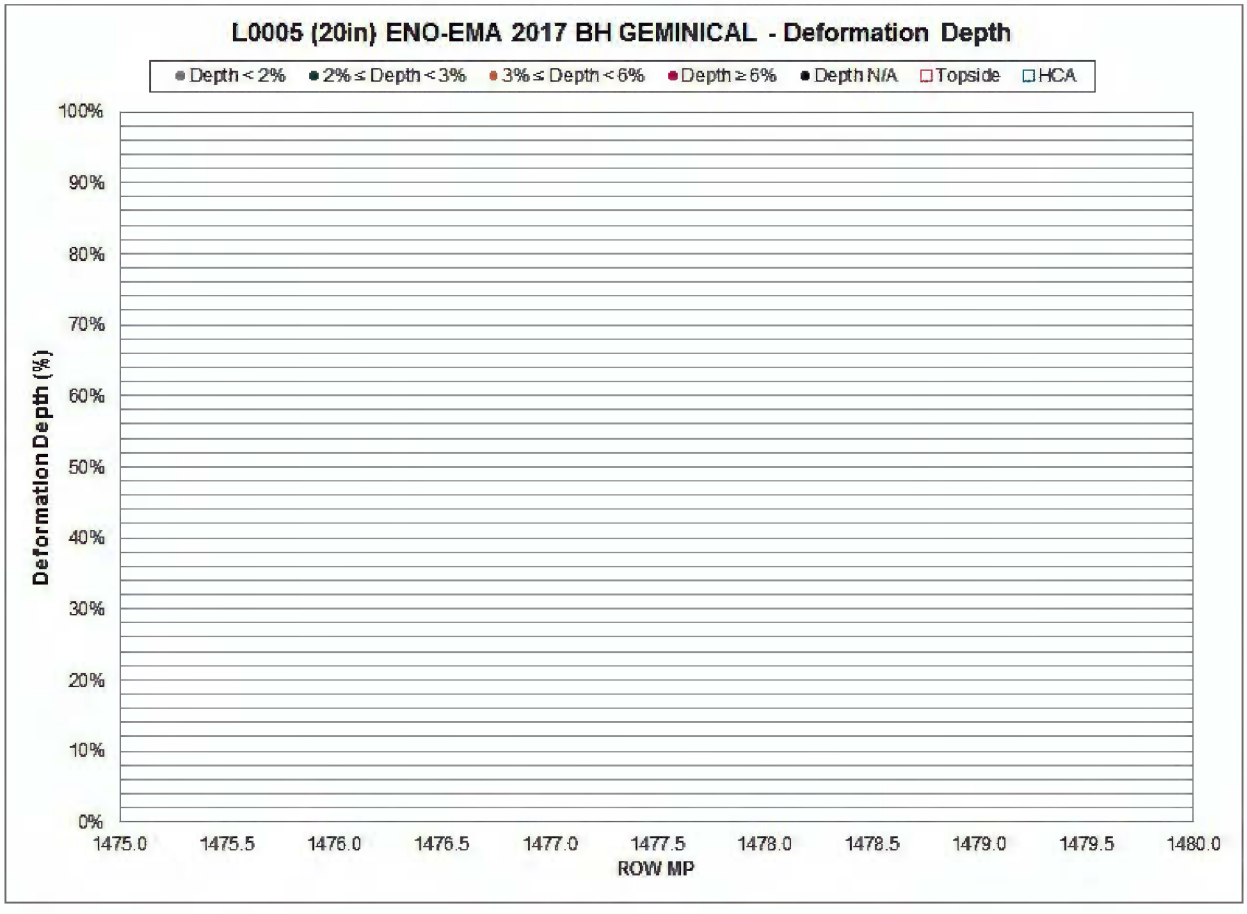
Figure 2 Depth of all unmitigated deformation features remaining in the pipeline system after completing the excavation program.

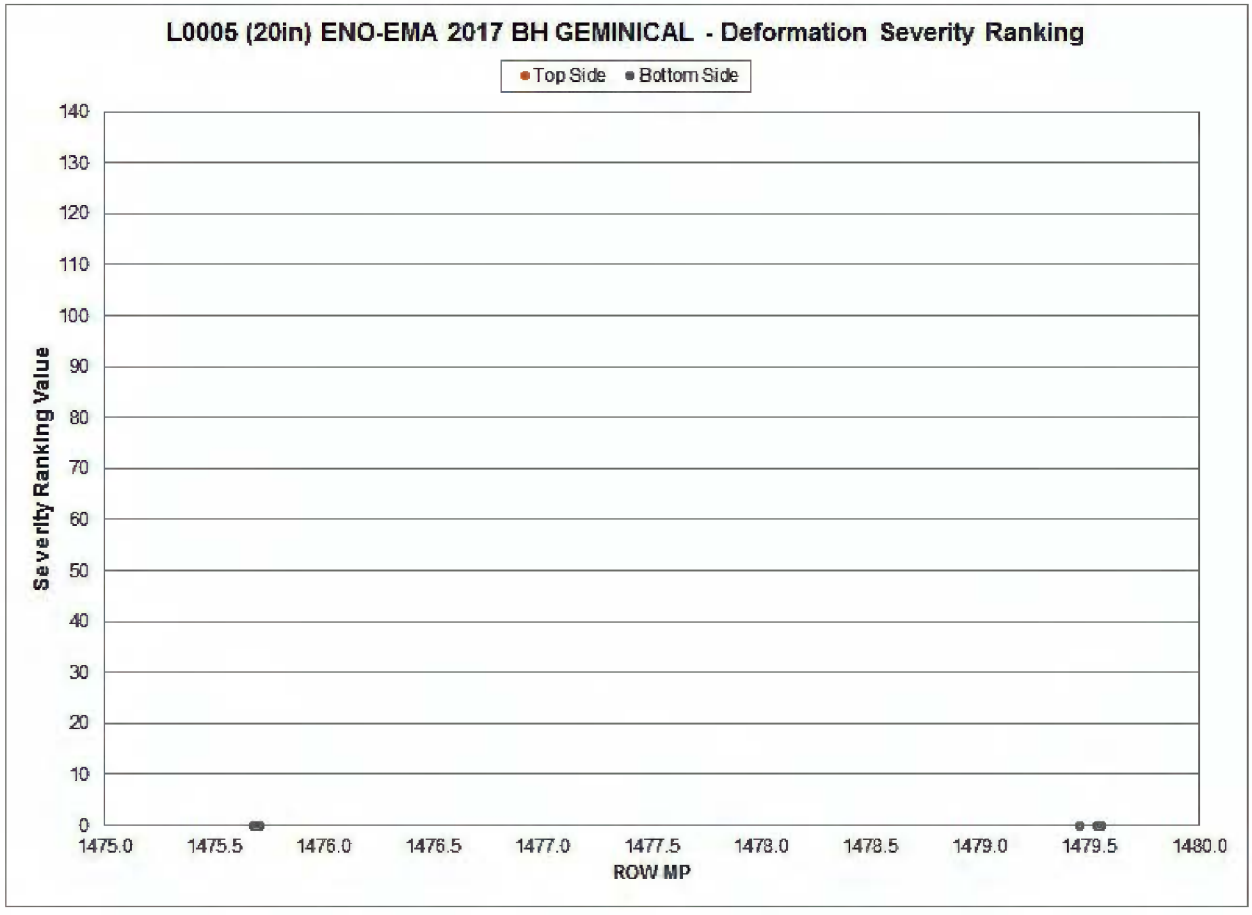
Figure 3 Severity ranking of all unmitigated deformation features remaining in the pipeline system after completing the excavation program (the

As no features were reported, and this aligns with our expectations for this Line and with previous inspections, no digs are required.
