Geometric ILI Summary Document

Line 5 ENO-EMA Apr 18, 2018 BH Geopig

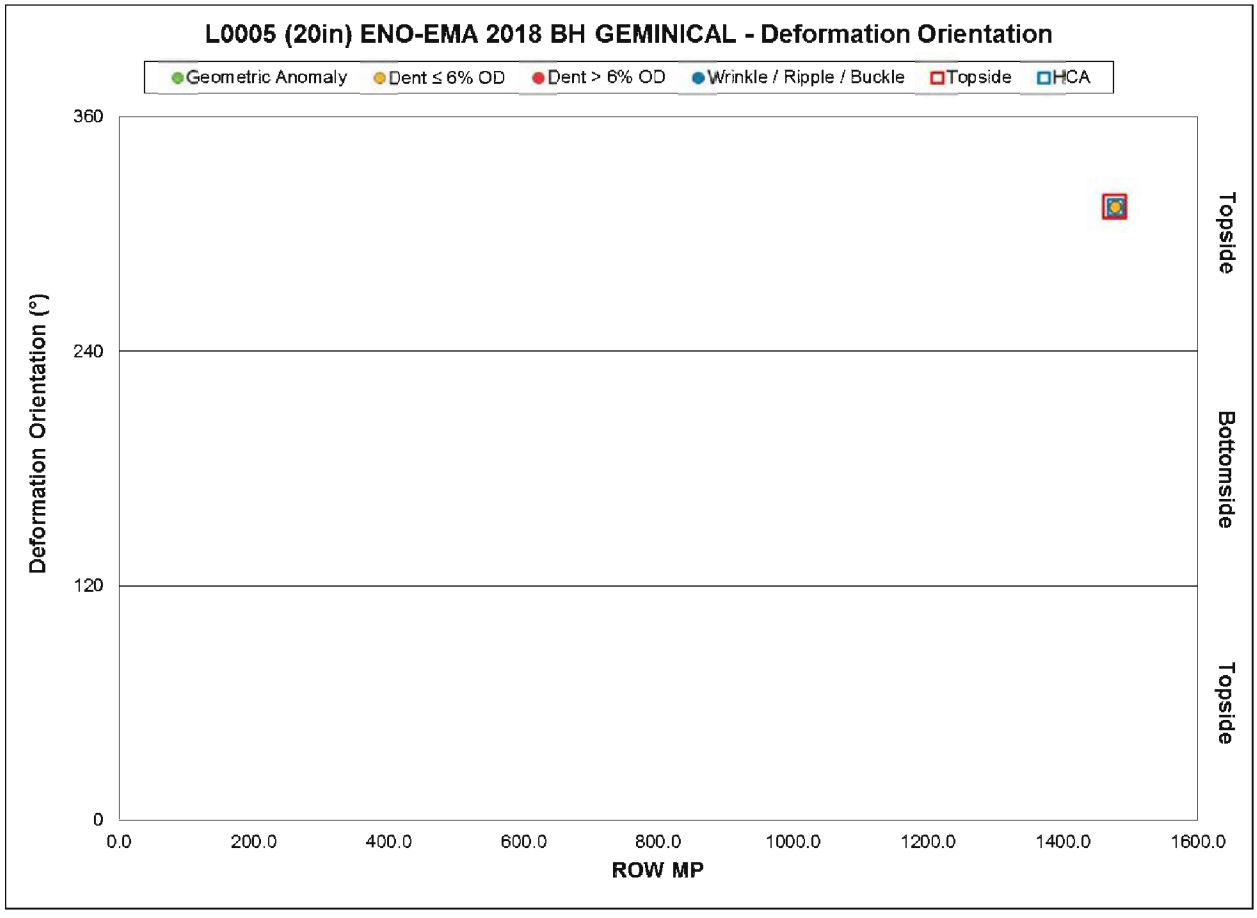
Figure 1 Orientation of all reported deformation features on the pipeline system based on the 2018 Geopig program.

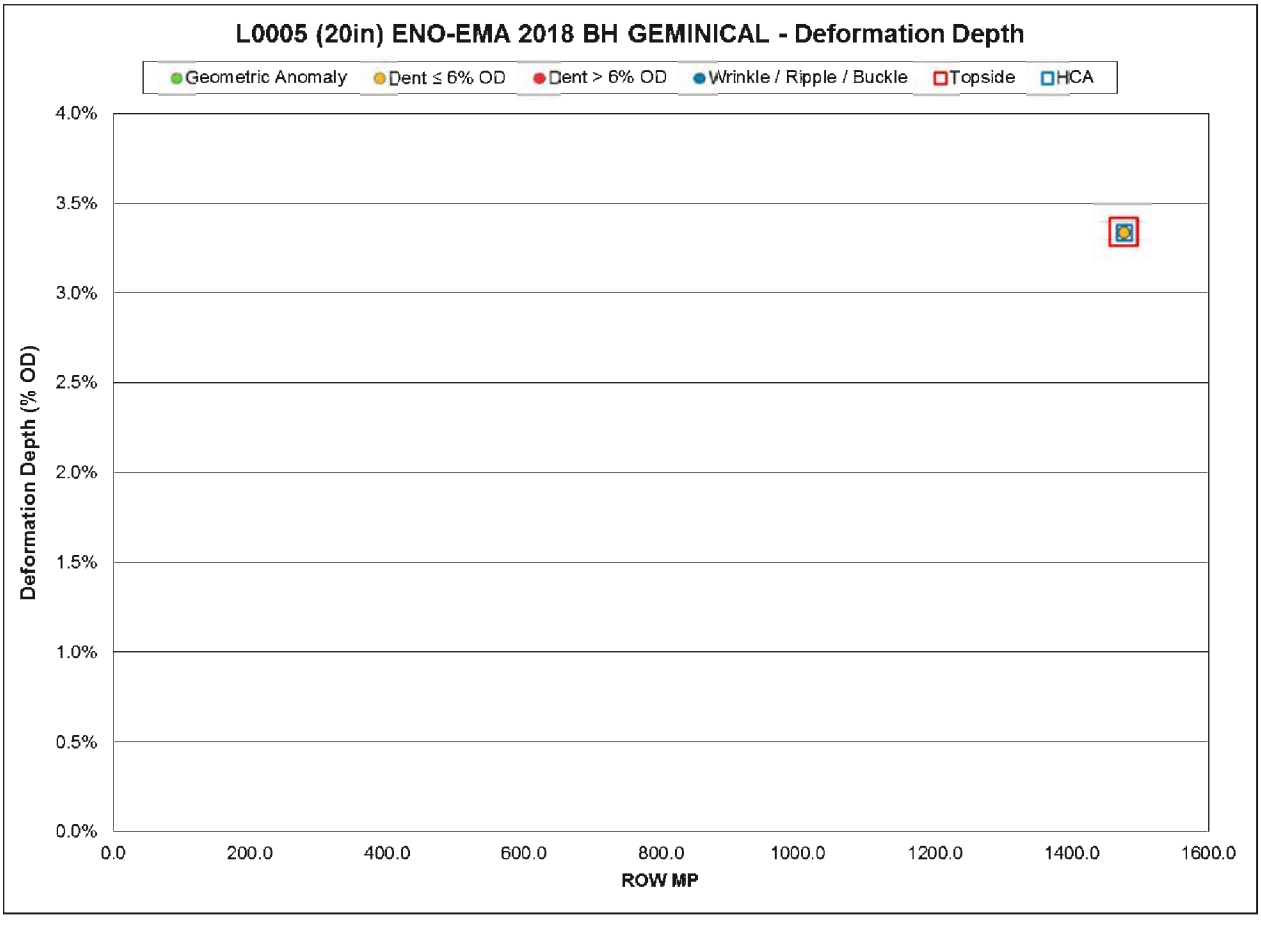
The 3.34% OD topside dent is a result of the April 2018 anchor strike and has already been inspected by ROV and divers; a dent was confirmed with two minor gouges in it (no cracking was identified). The gouges were hand filed and removed at < 10% NWT. Additionally, one mill surface irregularity and two linear features, not associated with the dent, were filed down and removed. There are no longer any surface indications present. This plain dent was issued for excavation as part of the April 7, 2018 Geopig program and will be repaired with a composite wrap repair and recoated.

Figure 2 Depth of all reported deformation features on the pipeline system based on the 2018 Geopig program.

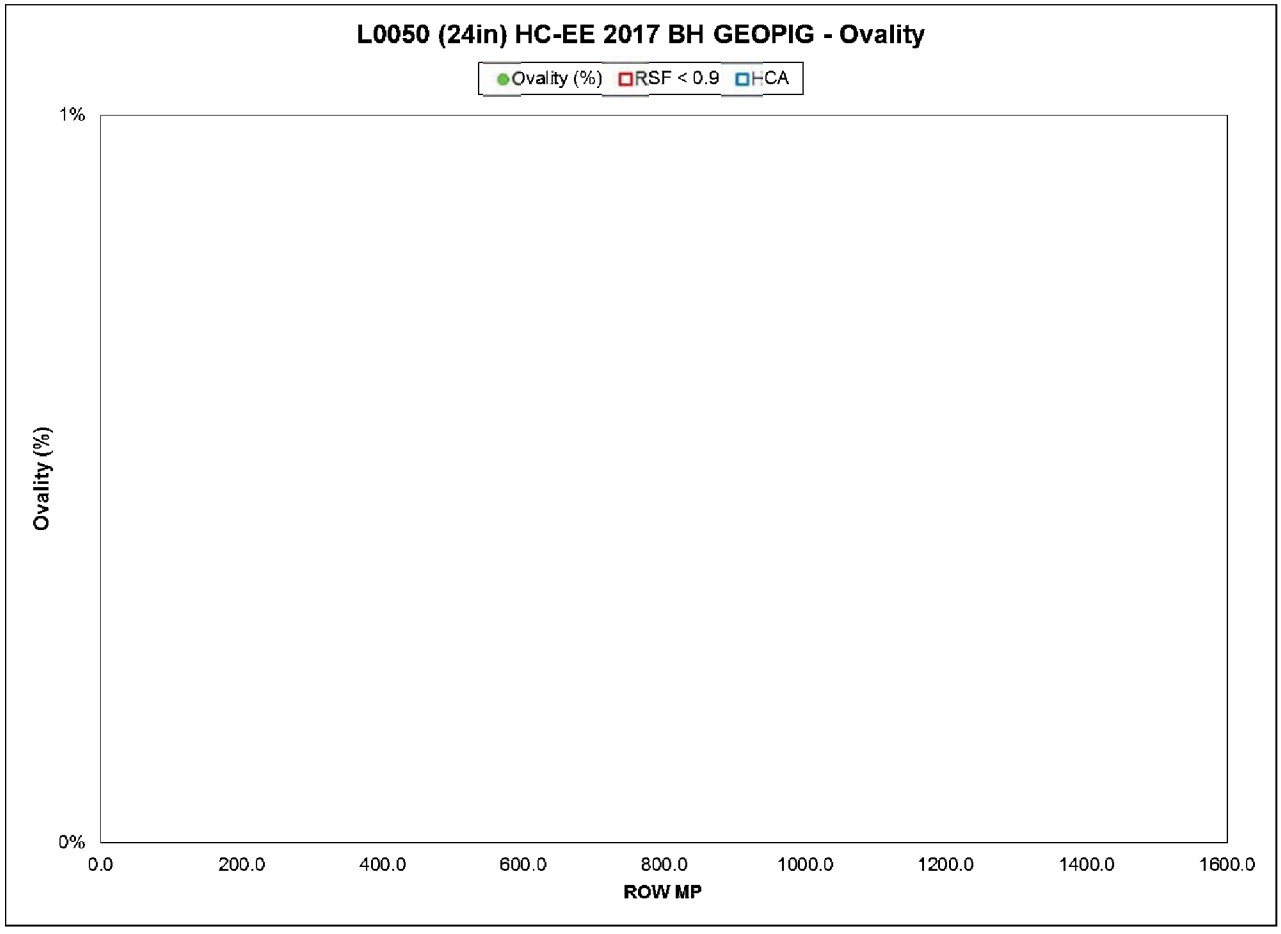
Figure 3 Severity ranking of all reported ovality features on the pipeline system based on the 2018 Geopig program.
