Geometric ILI Summary Document

Line 5 WNO-WMA April 2018 BH Geopig

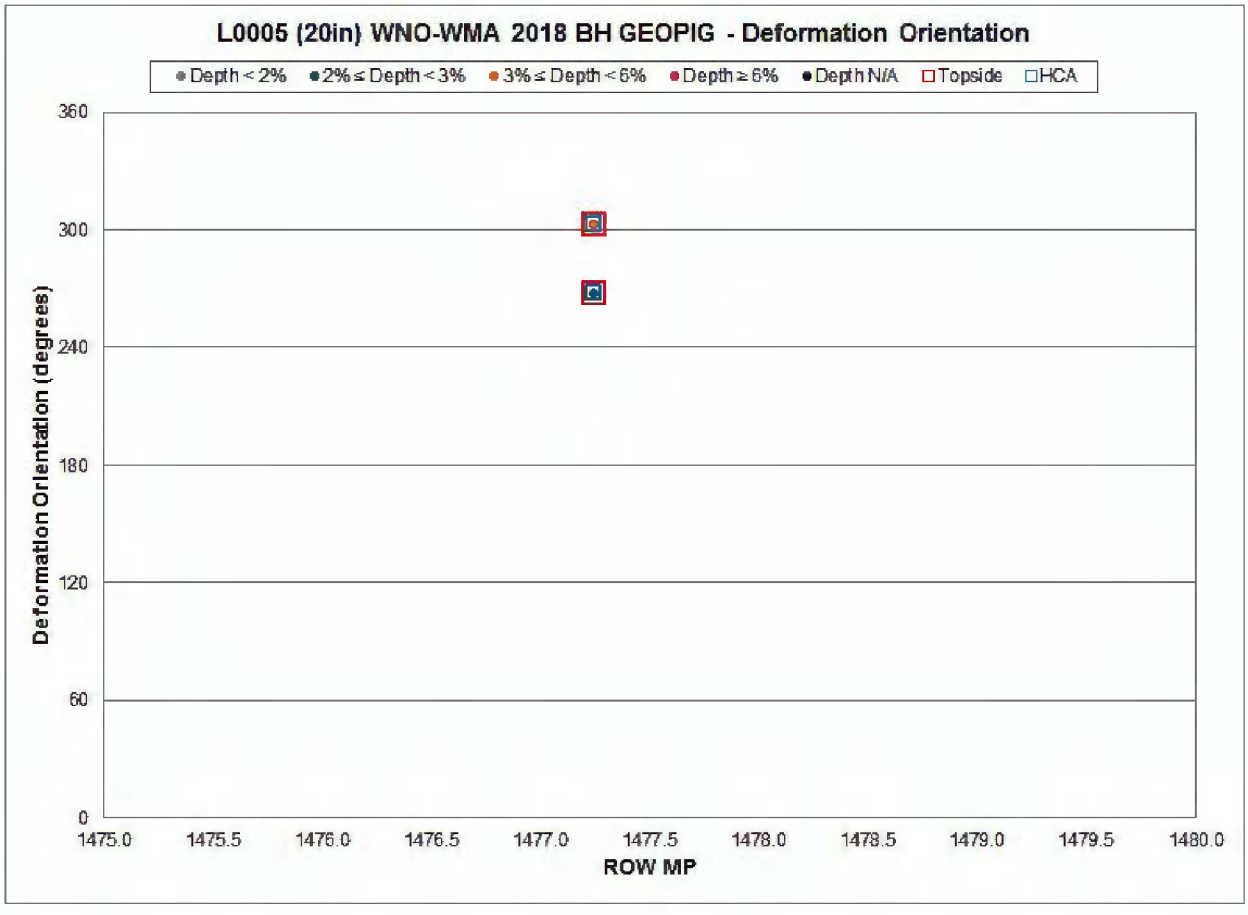
Figure 1 Orientation of all reported features on the pipeline system based on the 2018 Geopig program.

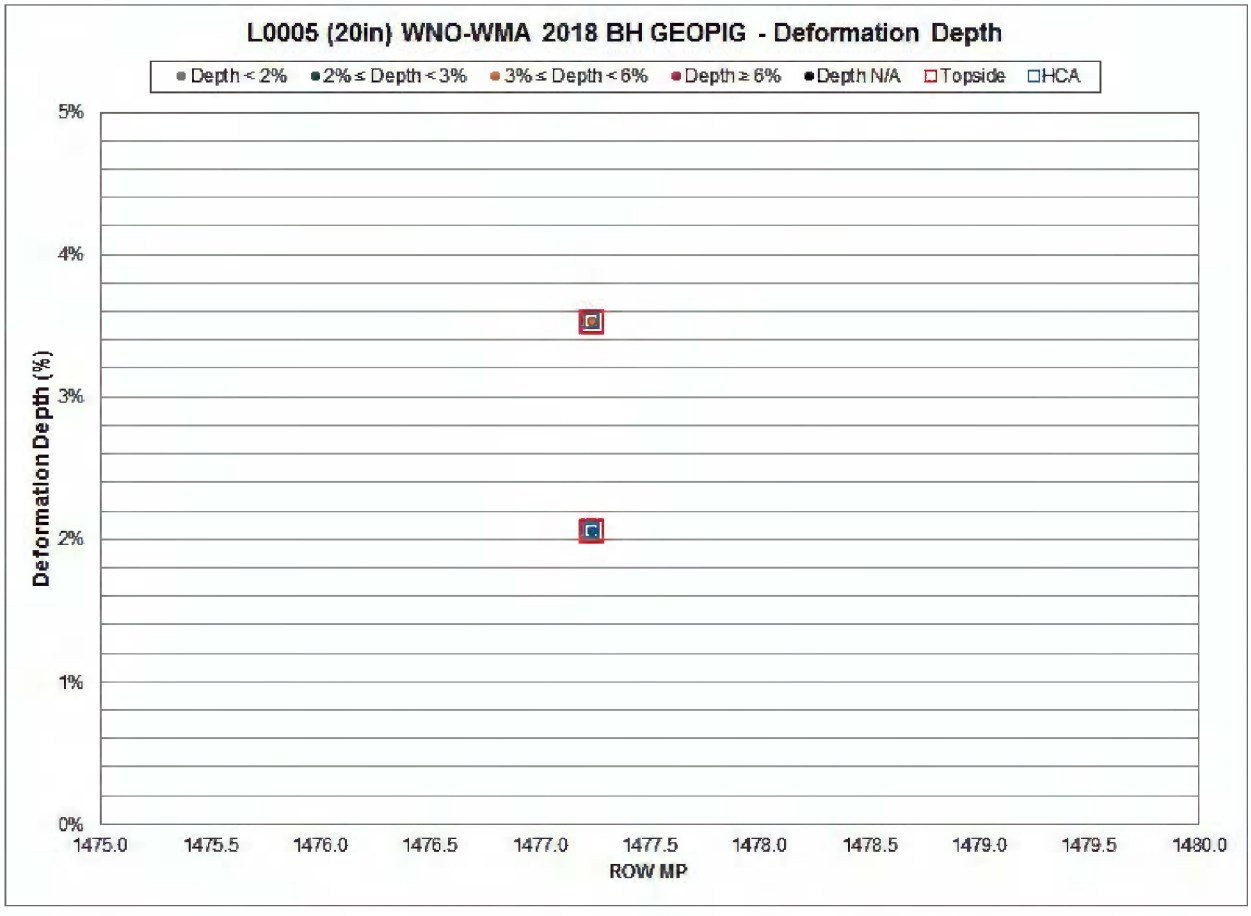
Figure 2 Depth of all reported features on the pipeline system based on the 2018 Geopig program.

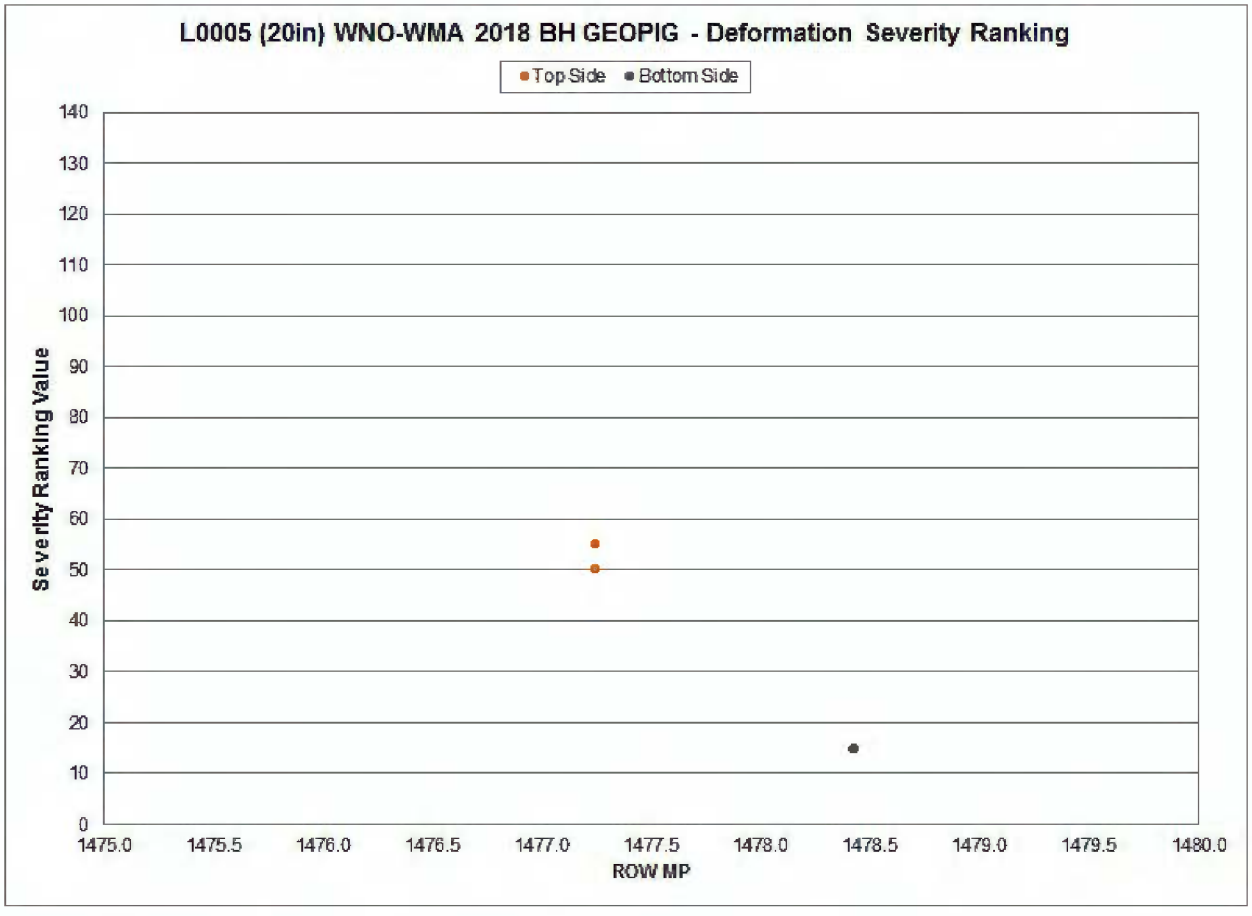
Figure 3 Severity ranking of all reported features on the pipeline system based on the 2018 Geopig program.
