Geometric ILI Summary Document

Line 5 WNO-WMA March 2018 BH Geopig

Effective Date: <6/13/2018>

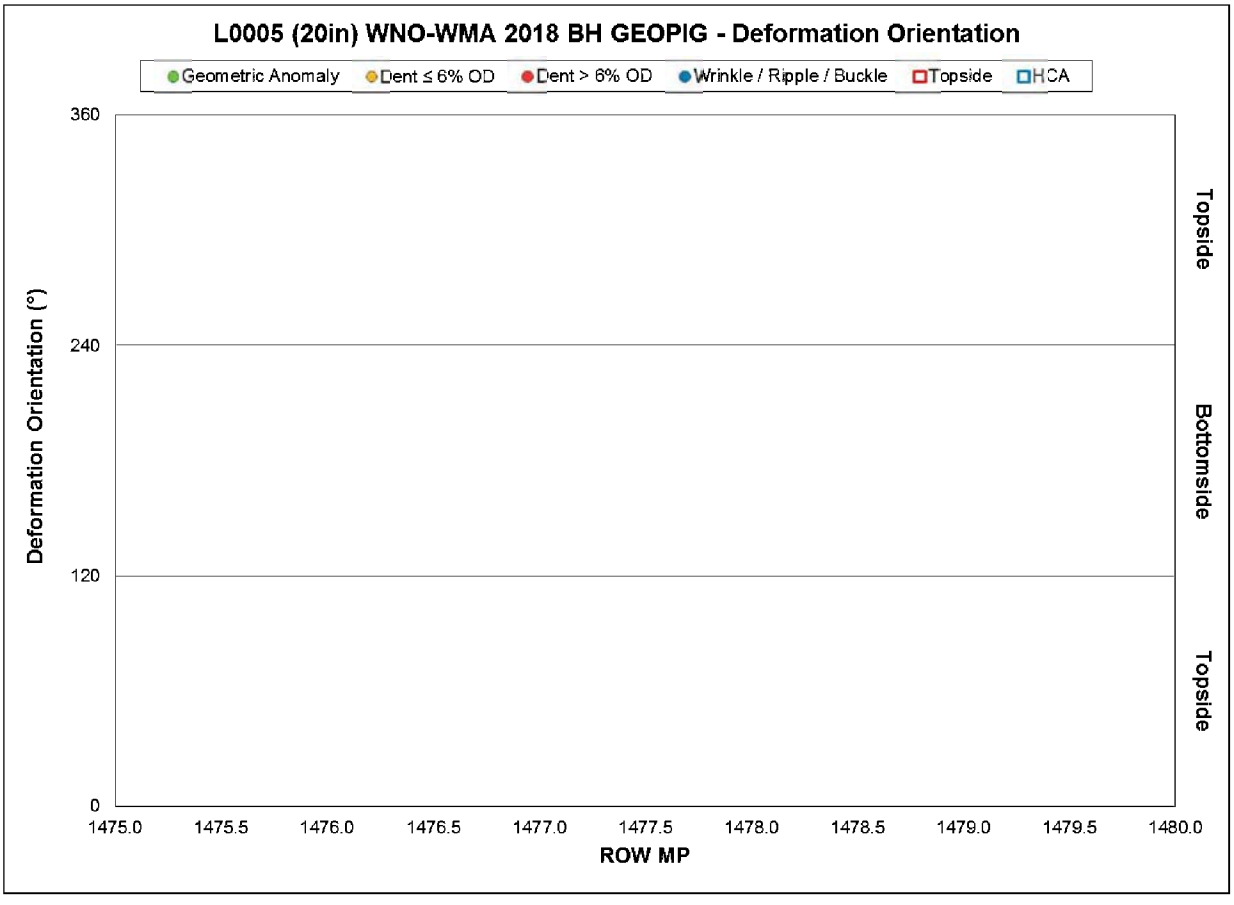
Figure 1 Orientation of all reported deformation features on the pipeline system based on the 2018 Geopig program.

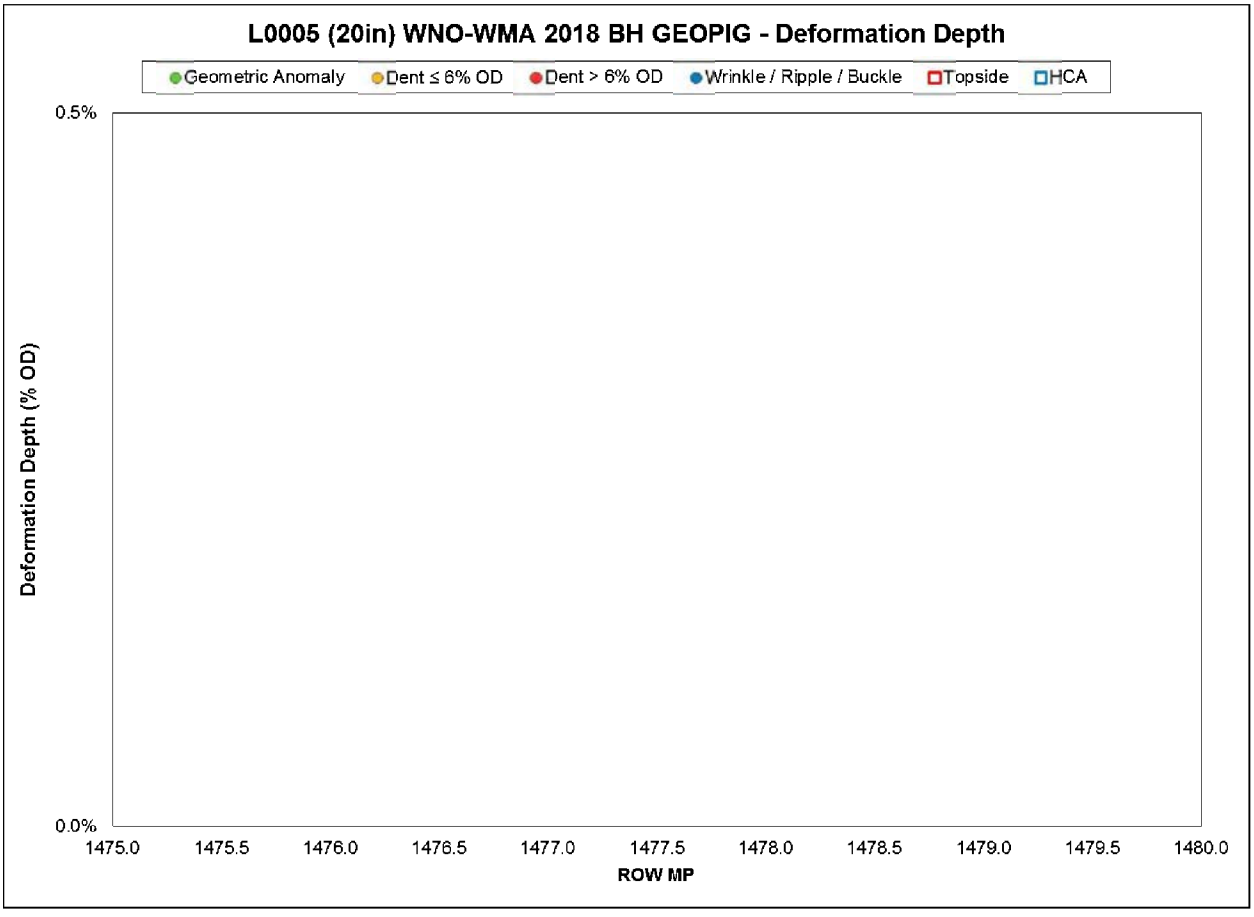
Figure 2 Depth of all reported deformation features on the pipeline system based on the 2018 Geopig program.

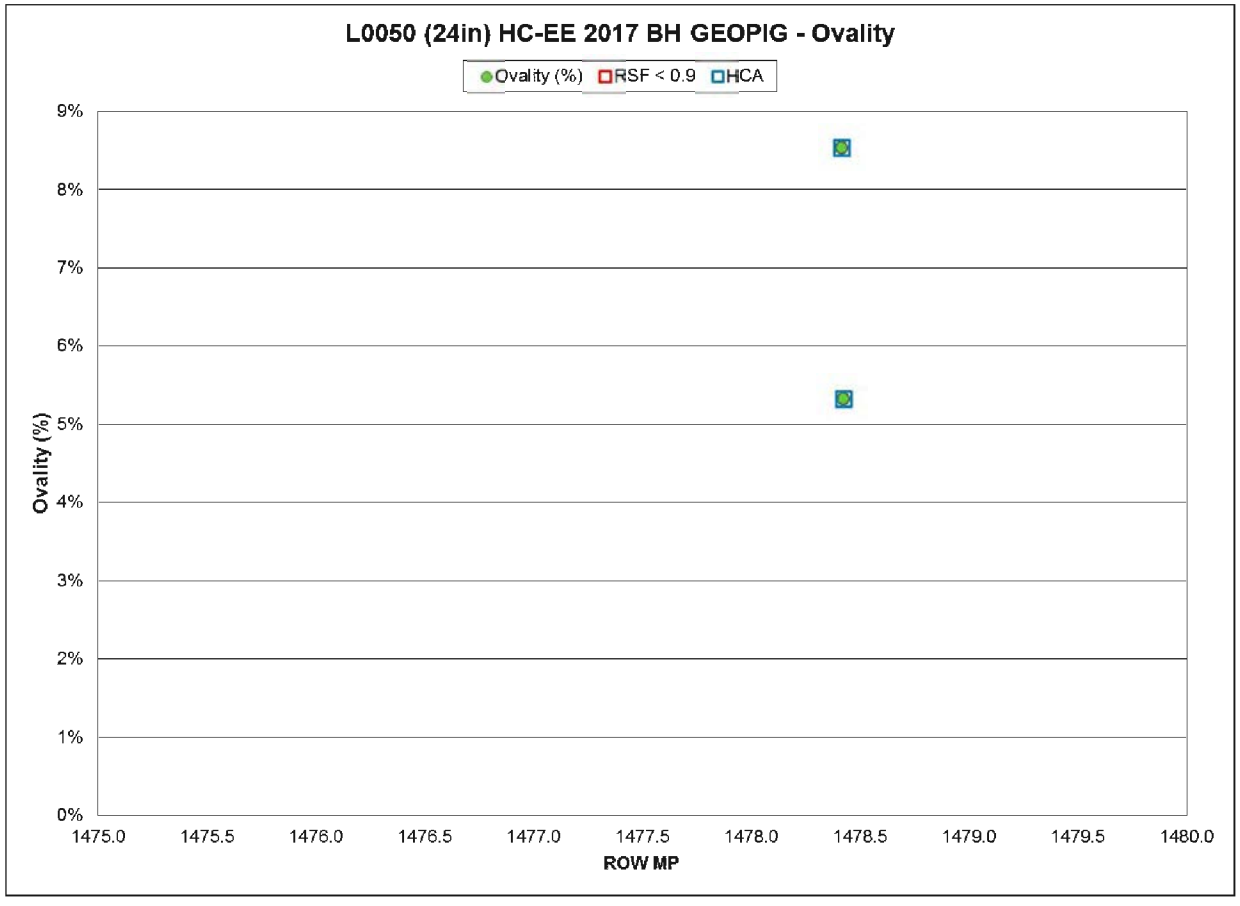
The two features listed in Table 3 refer to OVL 1 and OVL 2 which have Minimum IDs of 17.20" and 17.67", respectively. These are below the minimum allowable ID (17.9") as per OMM Book 3 05-03-03. These IDRs do not pose an integrity threat; they are provided by the ILI vendor for operability reasons.

- ✓ Per API 579 out-of-roundness assessment methodology, the RSFs for OVL 1 and OVL 2 are 1.24 and 1.71, respectively. These values are > 0.9, and thus are not an issue from a FfP perspective.
- ✓ Both ovalities have been identified in the 2005, 2013, 2017, 2018 caliper inspections with no significant changes in depth; all fluctuations are within tool tolerance (± 1% OD). Using CSA Z662 Ovality sizing methodology, the depths are:

Caliper Inspection	OVL 1 Depth GW 6080	OVL 2 Depth GW 6100
2005 Geopig	8.3% OD	5.3% OD
2013 Geopig	8.75% OD	5.45% OD
2017 Geopig	7.9% OD	5.6% OD
Mar 2018 Geopig	8.5% OD	5.3% OD
Apr 7, 2018 Geopig	8.2% OD	5.3% OD
Apr 18, 2018 GEMINI CAL	7.8% OD	5.2% OD

- ✓ Both ovalities are reported to be associated with field bends (29.6° for OVL 1 and 27.3° for OVL 2).
- ✓ No interacting features were identified through Threat Integration.
- ✓ No strain sites are reported at the ovality locations.
- ✓ In February 2018, a fatigue reliability assessment was performed on both ovalities using numerical and analytical modelling methods. These assessments estimate fatigue lives > 200 years for both ovalities.

Figure 3 Depth of all reported ovality features on the pipeline system based on the 2018 Geopig program.

These features will be monitored in future inspections.
