Geometric ILI Summary Document

Line 5 ENO-EMA 2019 BH GEOPIG

Effective Date: <5/17/2019>

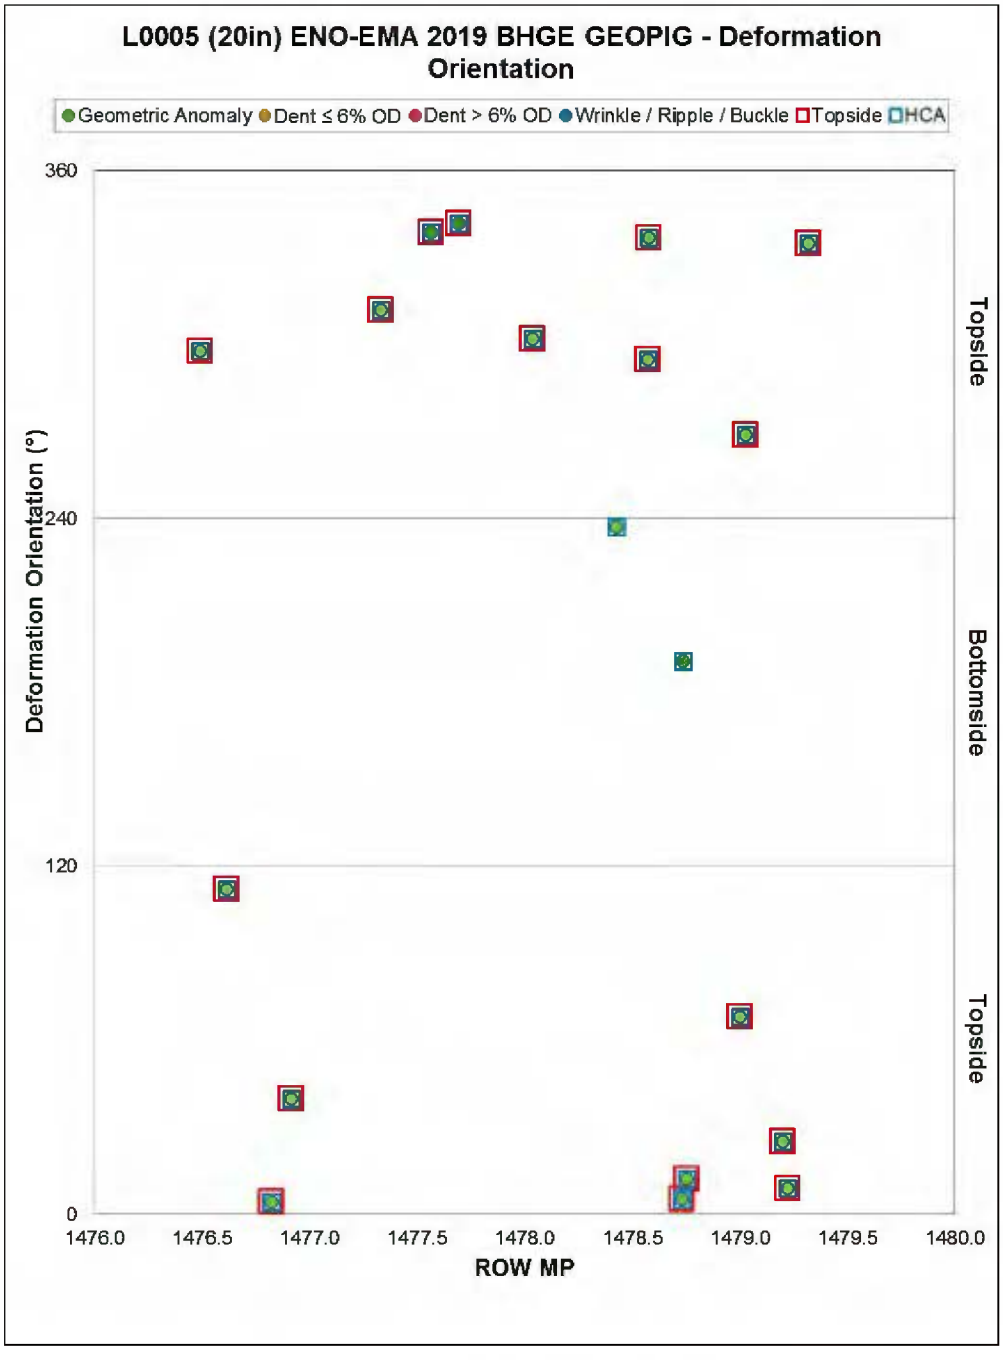
Figure 1 Orientation of all reported deformation features on the pipeline system based on the 2019 Geopig program.

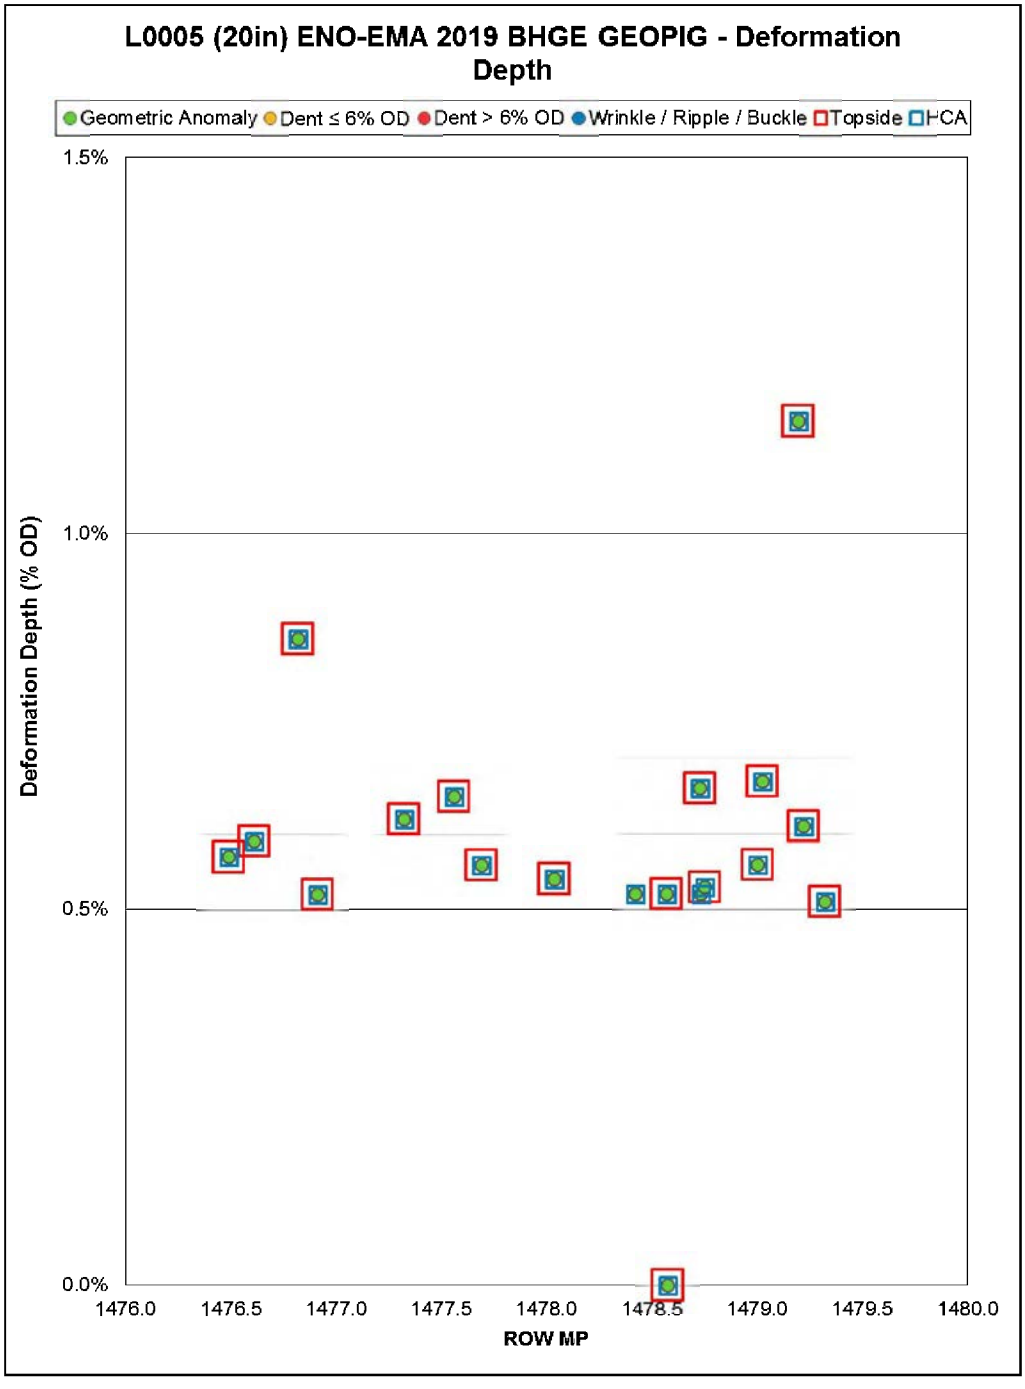
Figure 2 Depth of all reported deformation features on the pipeline system based on the 2019 Geopig program.

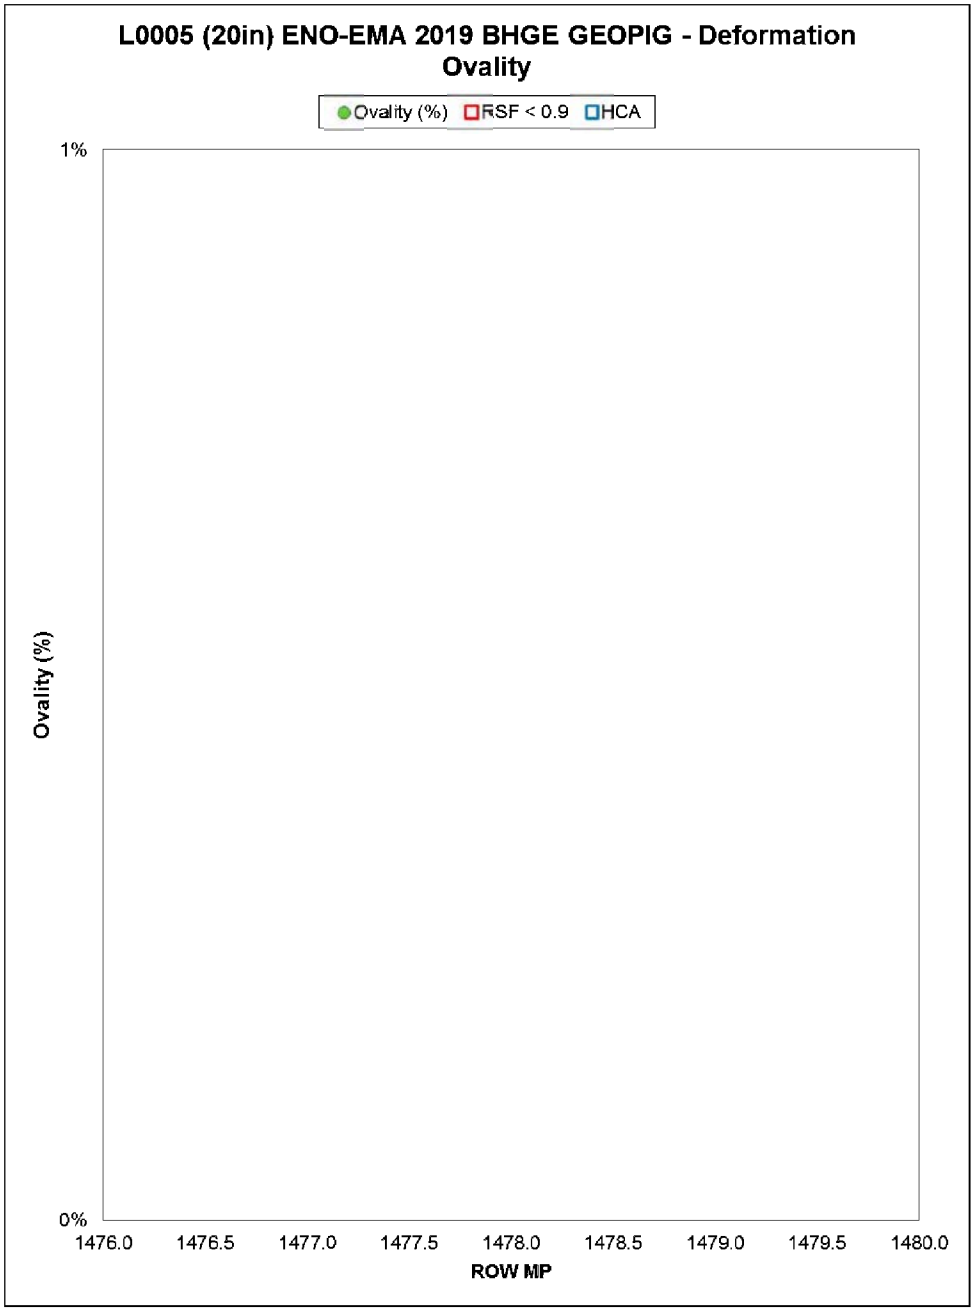
Figure 3 Severity ranking of all reported ovality features on the pipeline system based on the 2019 Geopig program.
