Enbridge Line 5

Straits of Mackinac, MI

Biota Investigation Work Plan

Final Report

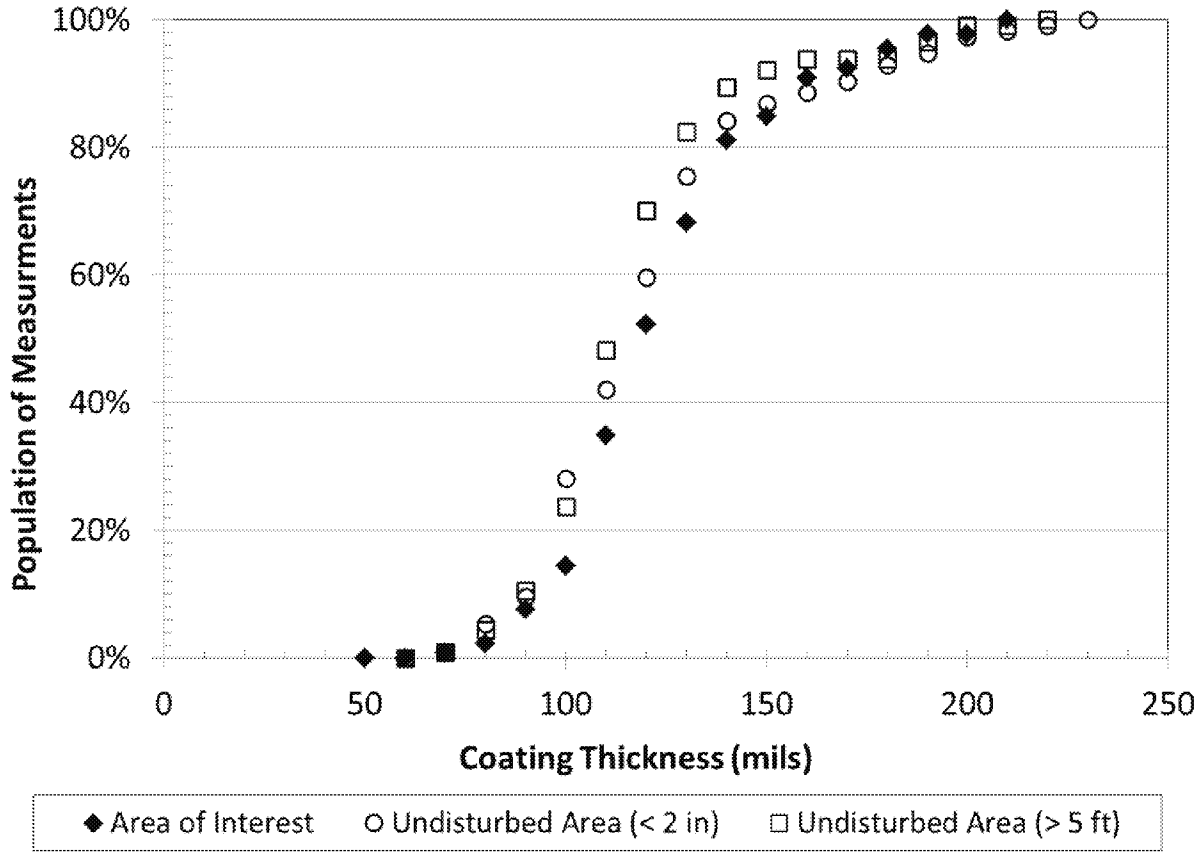
Figure 2: Distribution plot of the percentage of measurements at various coating thicknesses.

Figure 2 shows the distribution of the thickness measurements and provides a visual comparison between the three measurement locations. The measurements collected from the BIWP suggest that the majority of the AOI locations have intact coating and are not Dislodged Coating or Holidays. As mentioned in Section 3.1, three (3) dive sites presented exposed metal in the as-found condition (EAS 1, EAS-3 and EAS-4). EAS-3 and EAS-4 were created by abrasion that occurred when an abandoned communications cable was hooked by a dive barge anchor on August 26, 2017, during execution of the BIWP. EAS-1 presented a small coating defect with bare metal observed, as well as areas covered by a calcareous deposit.

Average measurements for the Area of Interest, Undisturbed Area (< 2 in), and Undisturbed (> 5 ft) were 125 ± 6 mils, 122 ± 8 mils, and 118 ± 6 mils, respectively.

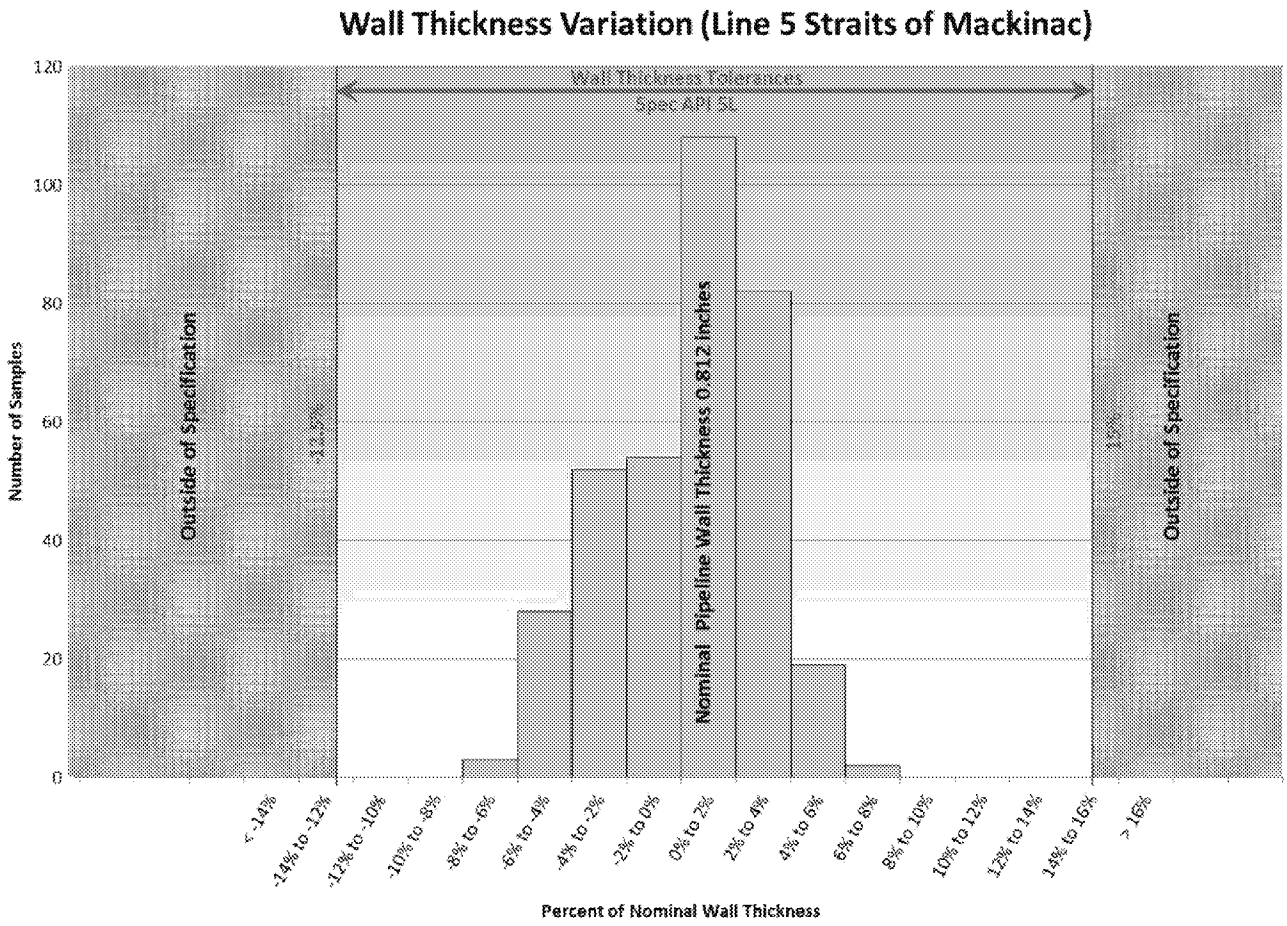
Figure 3: Pipe wall thickness distribution at 2017 coating repair locations.

Separate and independent of the BIWP, pipe wall thickness measurements were taken at various locations on the Dual Pipelines. In 2017, a total of 348 measurements were taken at coating repair locations after cleaning the area of any adherent material.

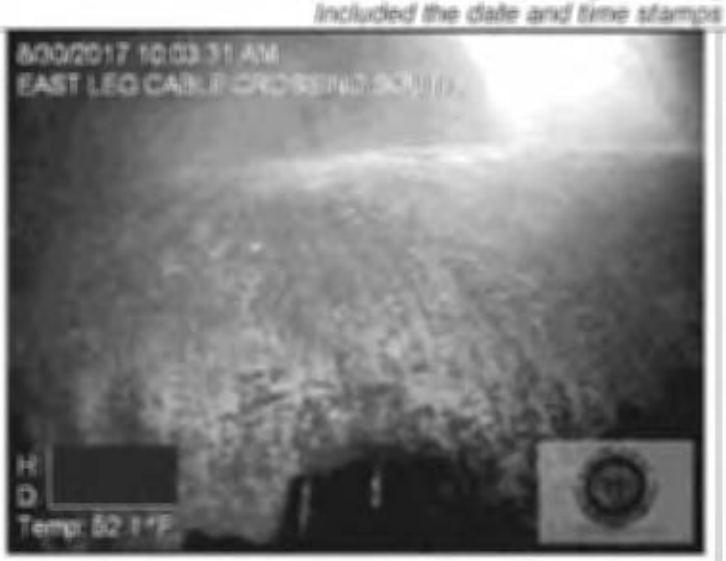
Cathodic Protection and Coating Measurements (if Holiday is found) - Holiday 2							
CP Reading #1 (mV)	-981 -1012	CP Reading #2 (mV)	-907 -933	CP Reading #3 (mV)	-944 -974		
Temperature (°F)	44	DFT at Holiday (mil)	≤ 25	DFT Adjacent to Holiday (mil)	105, 140, 76, 95, 84

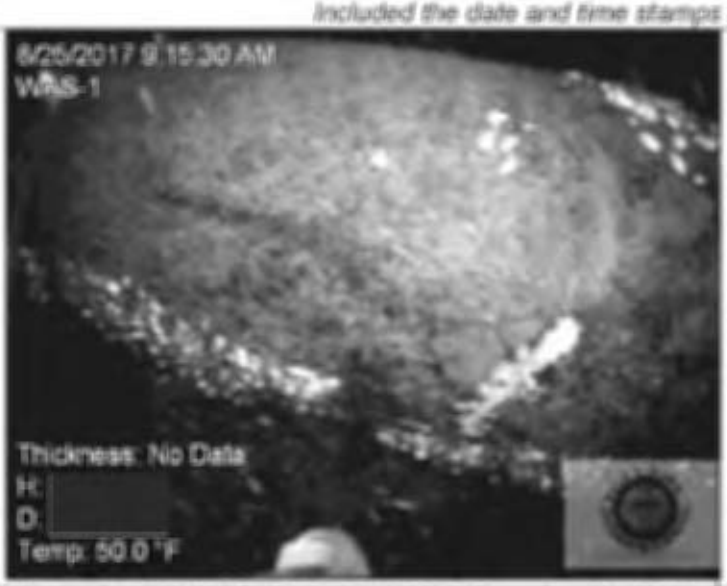
Cathodic Protection and Coating Measurements (if Holiday is found) - Holiday 1

CP Reading #1 (mV)	-1300 -1362	CP Reading #2 (mV)	-1277 -1336	CP Reading #3 (mV)	-1277 -1322
Temperature (°F)	43	DFT at Holiday (mil)	≤ 25	DFT Adjacent to Holiday (mil)	90, 93, 110

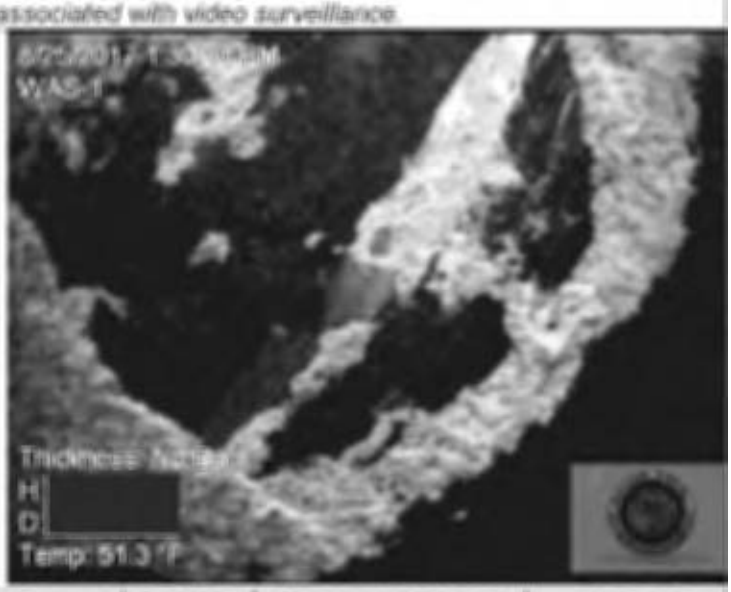
Cathodic Protection and Coating Measurements (if Holiday is found) - Holiday 2

CP Reading #1 (mV)	-1274 -1328	CP Reading #2 (mV)	-1283 -1237	CP Reading #3 (mV)	-1375 -1372
Temperature (°F)	43	DFT at Holiday (mil)	≤ 25	DFT Adjacent to Holiday (mil)	79, 94, 100

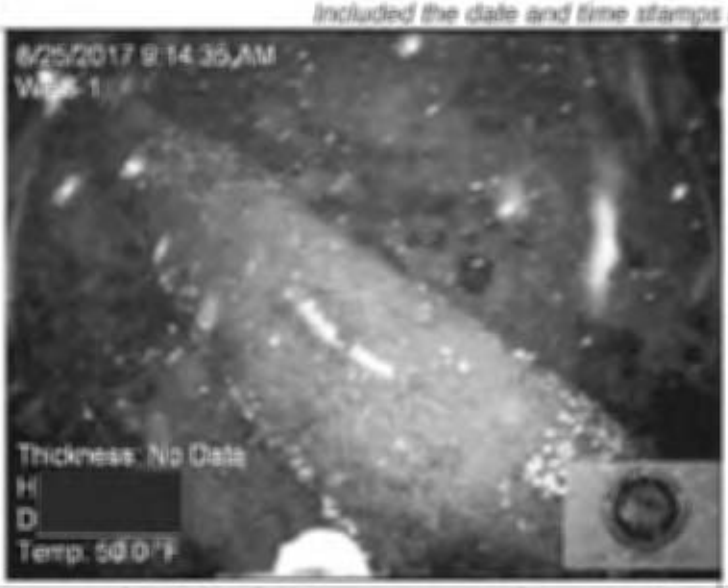
Cathodic Protection and Coating Measurements (if Holiday is found) - Holiday 3							
CP Reading #1 (mV)	-1340 -1388	CP Reading #2 (mV)	-1342 -1389	CP Reading #3 (mV)	-1343 -1385		
Temperature (°F)	43	DFT at Holiday (mil)	≤ 25	DFT Adjacent to Holiday (mil)	95, 83, 89

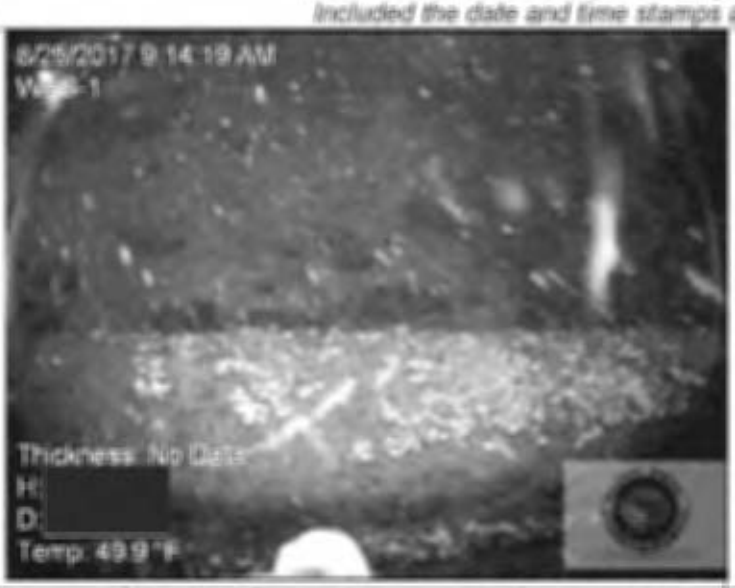
Cathodic Protection and Coating Measurements (if Holiday is found) - Holiday 4							
CP Reading #1 (mV)	-1384 -1433	CP Reading #2 (mV)	-1390 -1430	CP Reading #1 (mV)	-1380 -1430		
Temperature (°F)	43	DFT at Holiday (mil)	≤ 25	DFT Adjacent to Holiday (mil)	80, 80, 90

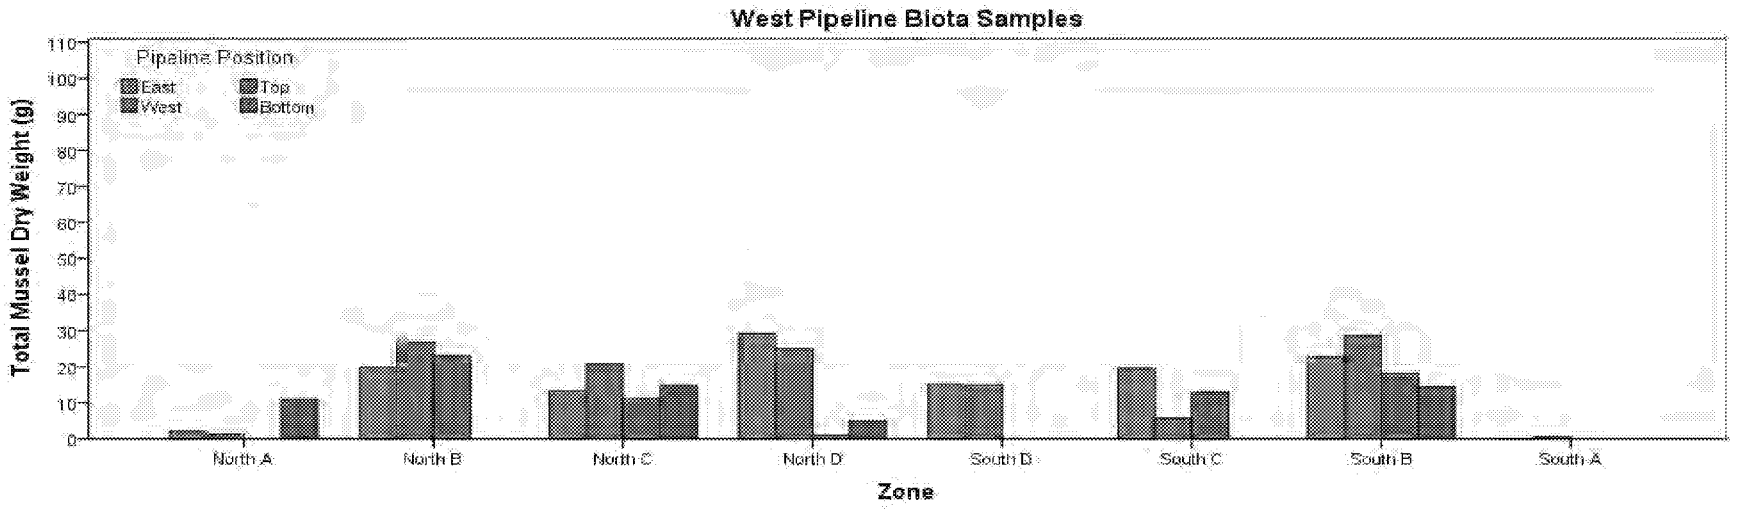
Figure 11: 2017 West Pipeline Total Mussel Biomass (dry weight)

The weight of mussels in the west pipeline Biota samples also varied according to the pipeline position (i.e., top, bottom, east side, west side) from which they were sampled (Figure 11; Table 17). In general, the greatest mussel weights were observed in samples from the sides (east and west) of the pipeline, as opposed to the top and the bottom, but the bottom of the pipeline was not able to be safely sampled at all west pipeline locations.

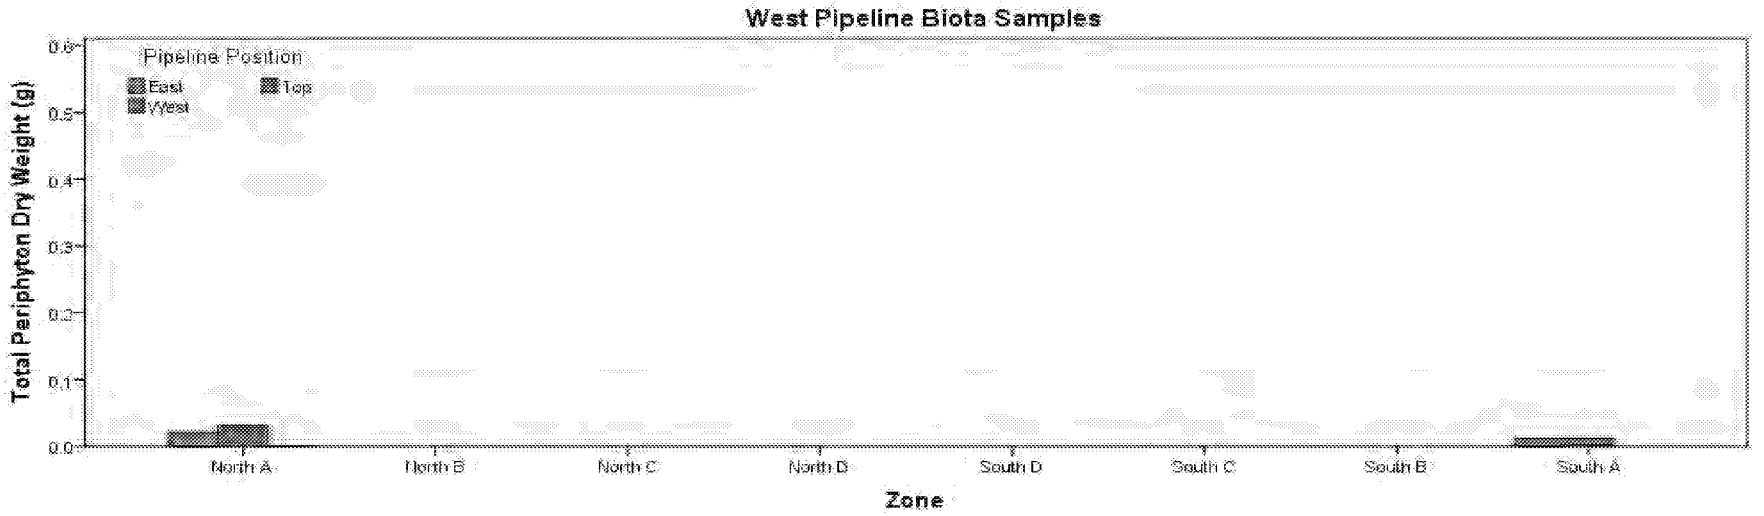
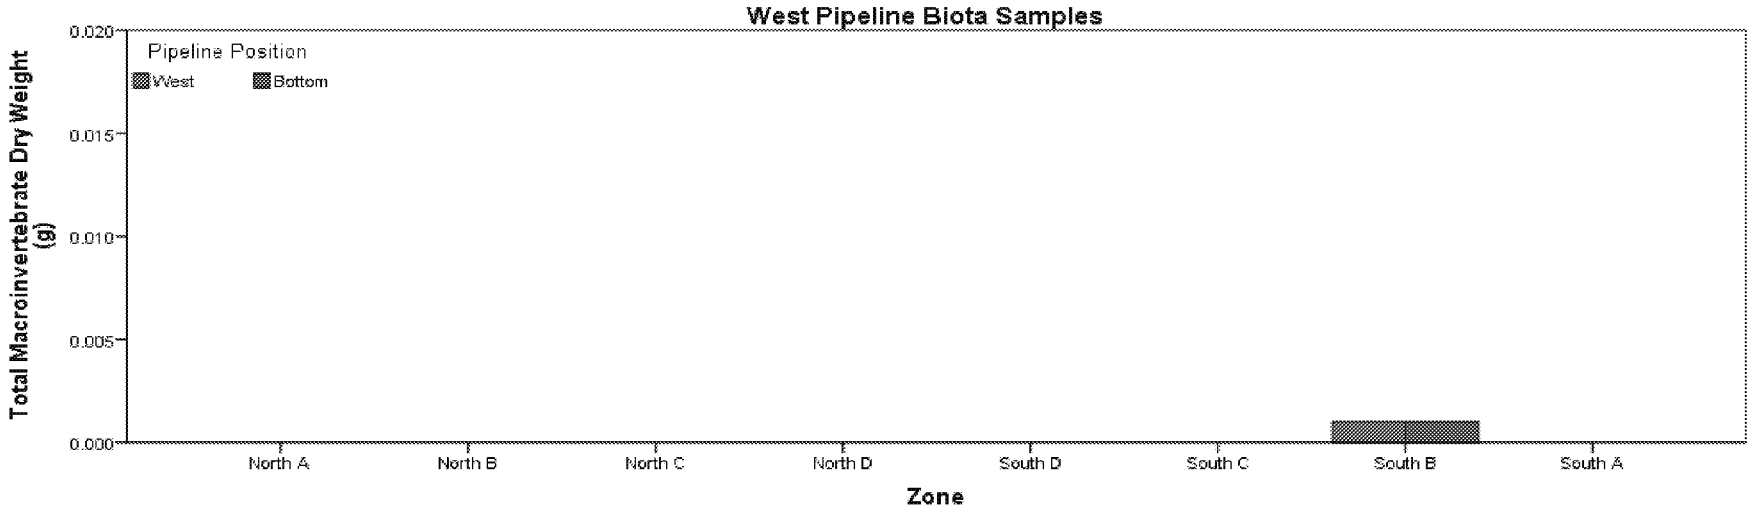
The total biomass of non-mussel strata such as algae and benthic macroinvertebrates was negligible in comparison to the biomass of mussels (Figures 12 and 13; Table 13), and was less than one gram (dry weight) at the few sites where these strata were found. However, as stated in the east pipeline results, the diversity and abundance of these types of Biota may have been underestimated due to design characteristics of the Biota sampling device. Since these smaller Biota would represent an insignificant amount of weight (less than one gram, dry weight) on the pipeline, there is no impact on the validity of the assessment.

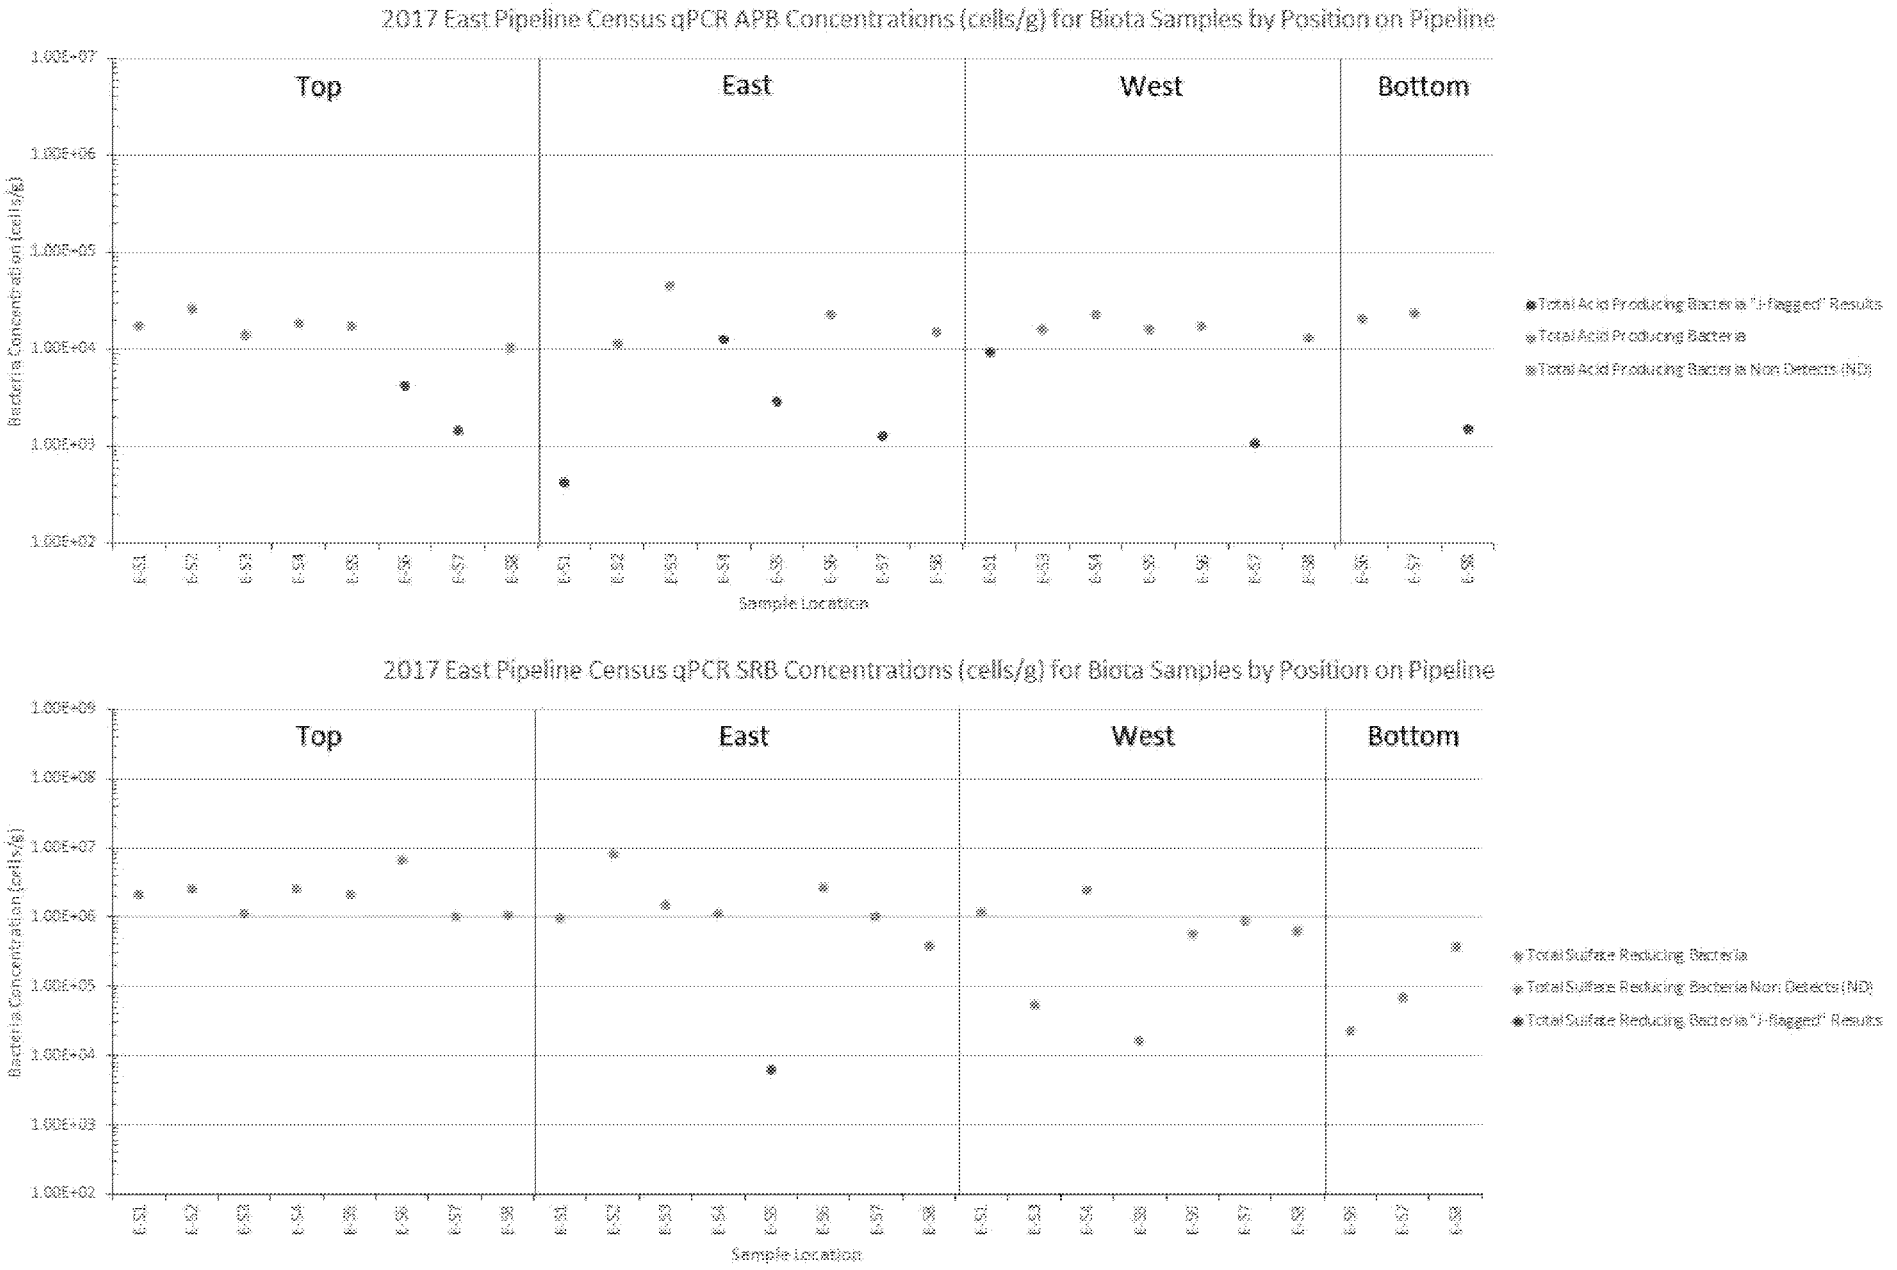
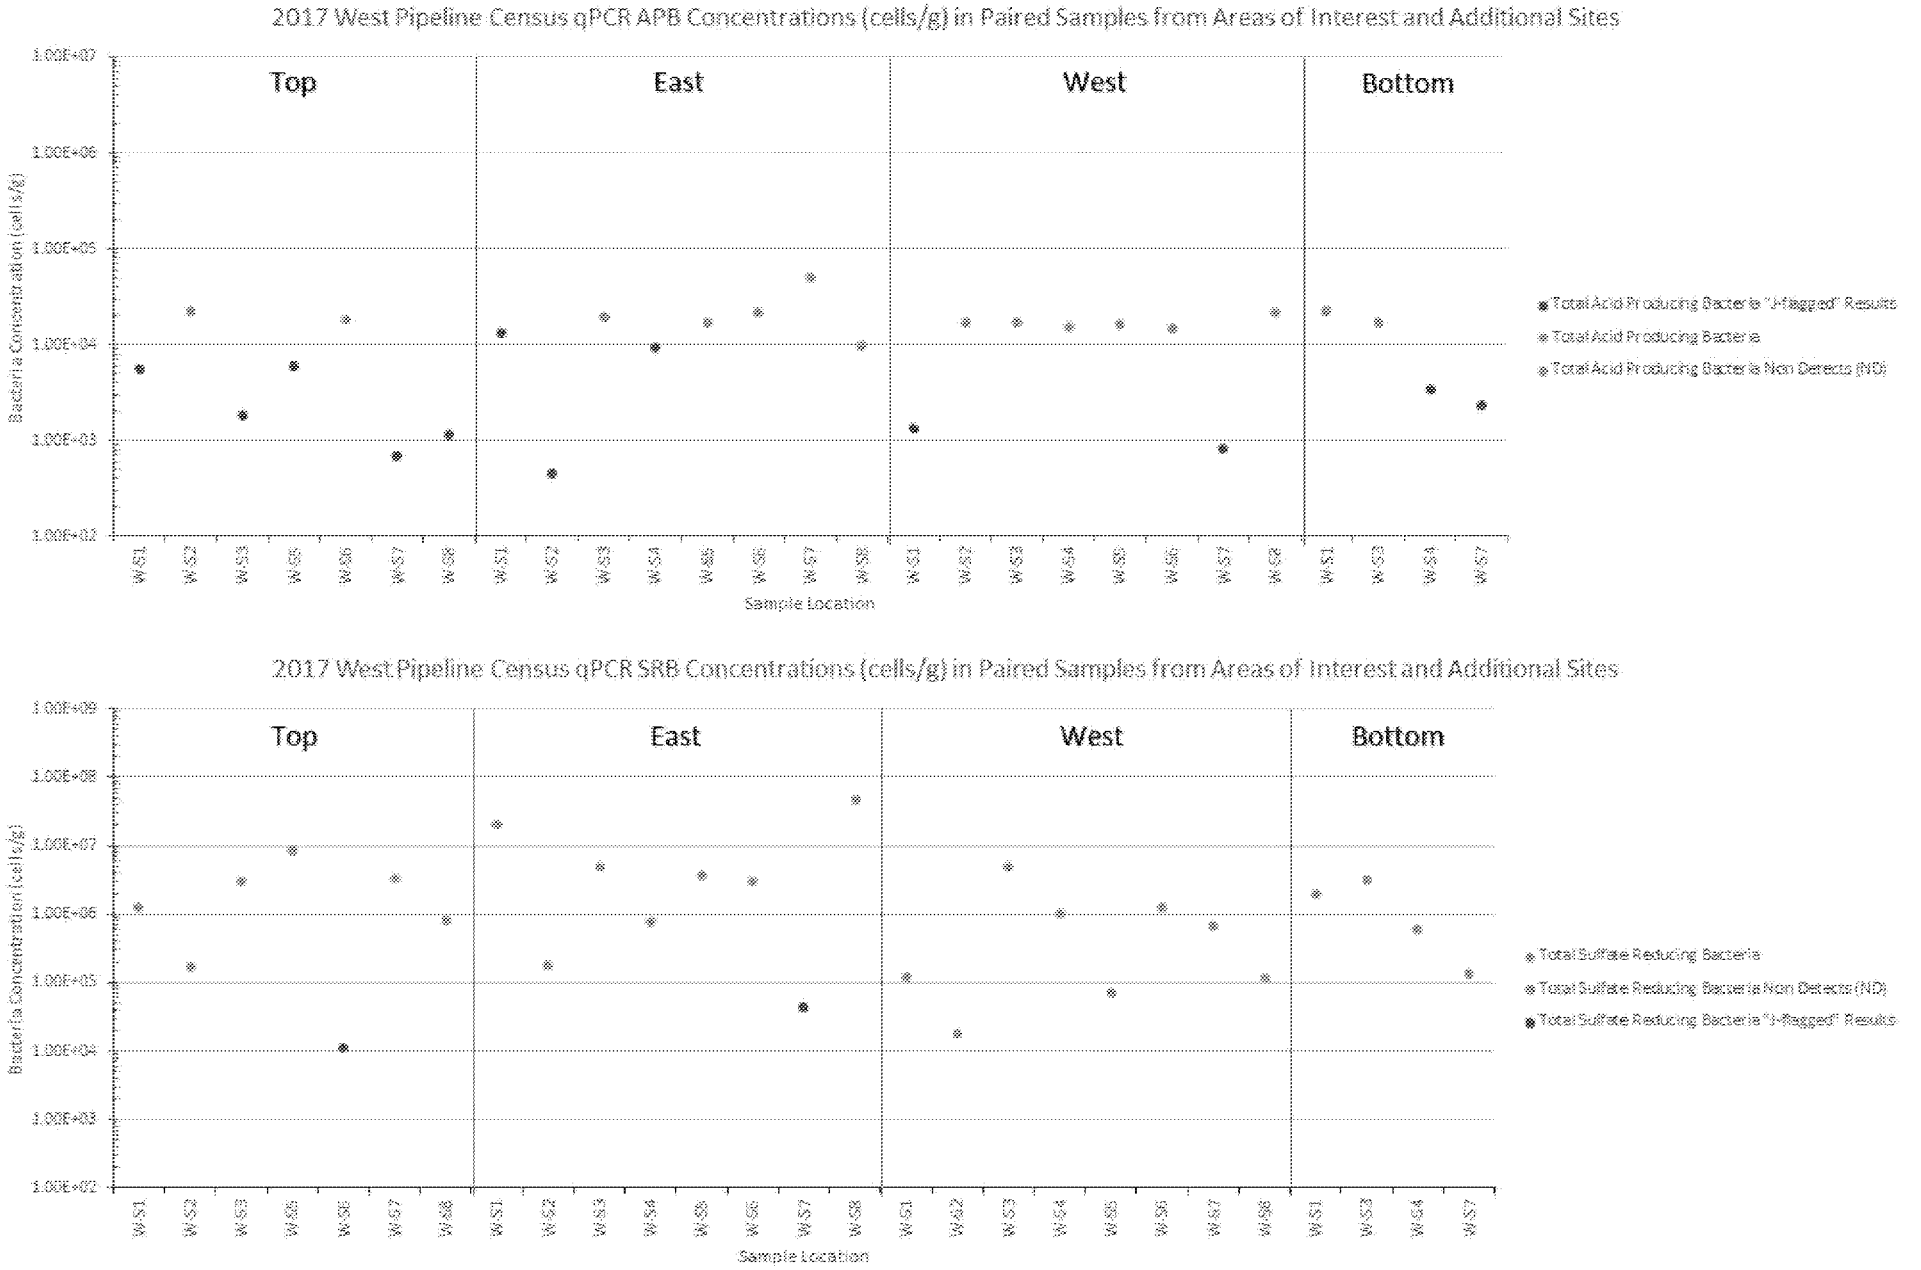
There was no discernable pattern in APB concentrations in Biota samples based on pipeline position as most samples were J-qualified or not detected over the laboratory reporting limit. SRBs were detected above the laboratory reporting limit in samples from all pipeline positions and concentrations were relatively consistent (Figure 15).

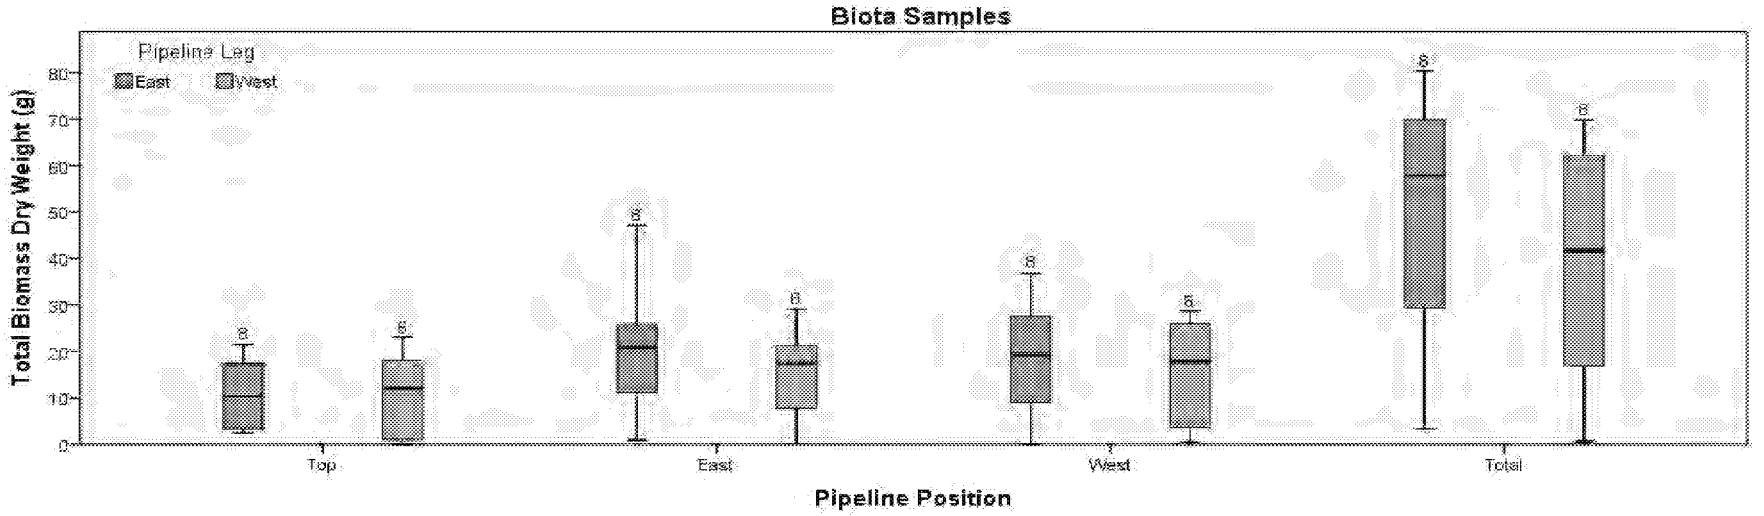
Figure 19: 2017 Comparison of Total Biota Biomass (dry weight) for East and West Pipeline by Position on Pipeline

The sampling scheme at the sixteen (16) Biota sites was developed to generate consistent data across both pipelines and across Zones within each pipeline (i.e., a Biota sampling site was located in every Zone of both pipelines). The data indicate that total biomass of Biota varies by pipeline, Zone, and pipeline position, likely due to the uneven distribution of mussels, the random selection of sampling sites (i.e., sites were not selected based on mussel density), and the number of sampling sites in relation to the length of the pipelines. In some cases, patterns were observed in the data. For example, the central tendency (mean) of total biomass is generally consistent across both pipelines (Figure 19). The central tendency (mean) of total biomass is also generally consistent across both pipelines when pipeline position is accounted for. Biomass from Biota collected from the top of the east pipeline is not statistically different than that of Biota from the top of the west pipeline (Appendix L). No apparent patterns were observed in biomass results across Zones of both pipelines.

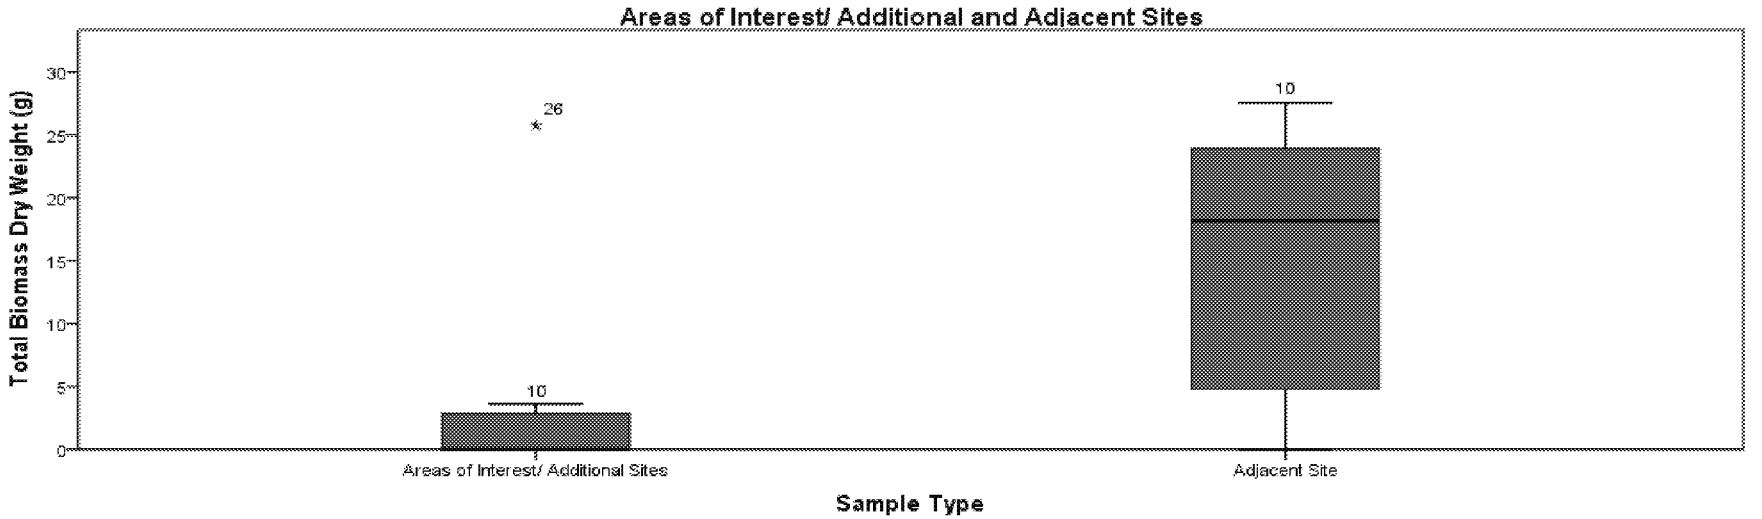
Figure 20: 2017 Comparison of Total Biota Biomass (dry weight) for Paired Samples form Areas of Interest and Additional Sites

The biomass of Biota was generally far less at Areas of Interest and Additional Sites than at samples collected from an undisturbed area directly adjacent to those sites (Figure 20; Tables 18 and 19). This difference is statistically significant ($p < 0.05$). These data directly support video footage observed during the Biota sampling dives, which clearly showed far less Biota at Areas of Interest and Additional Sites when compared to immediately adjacent undisturbed areas. This also directly correlates to the visual criteria outlined in Section 3.2 of the BIWP that was used to select the Areas of Interest and Additional Sites. It is unclear why fewer mussels and other Biota were observed at those areas during the BIWP work reported herein.

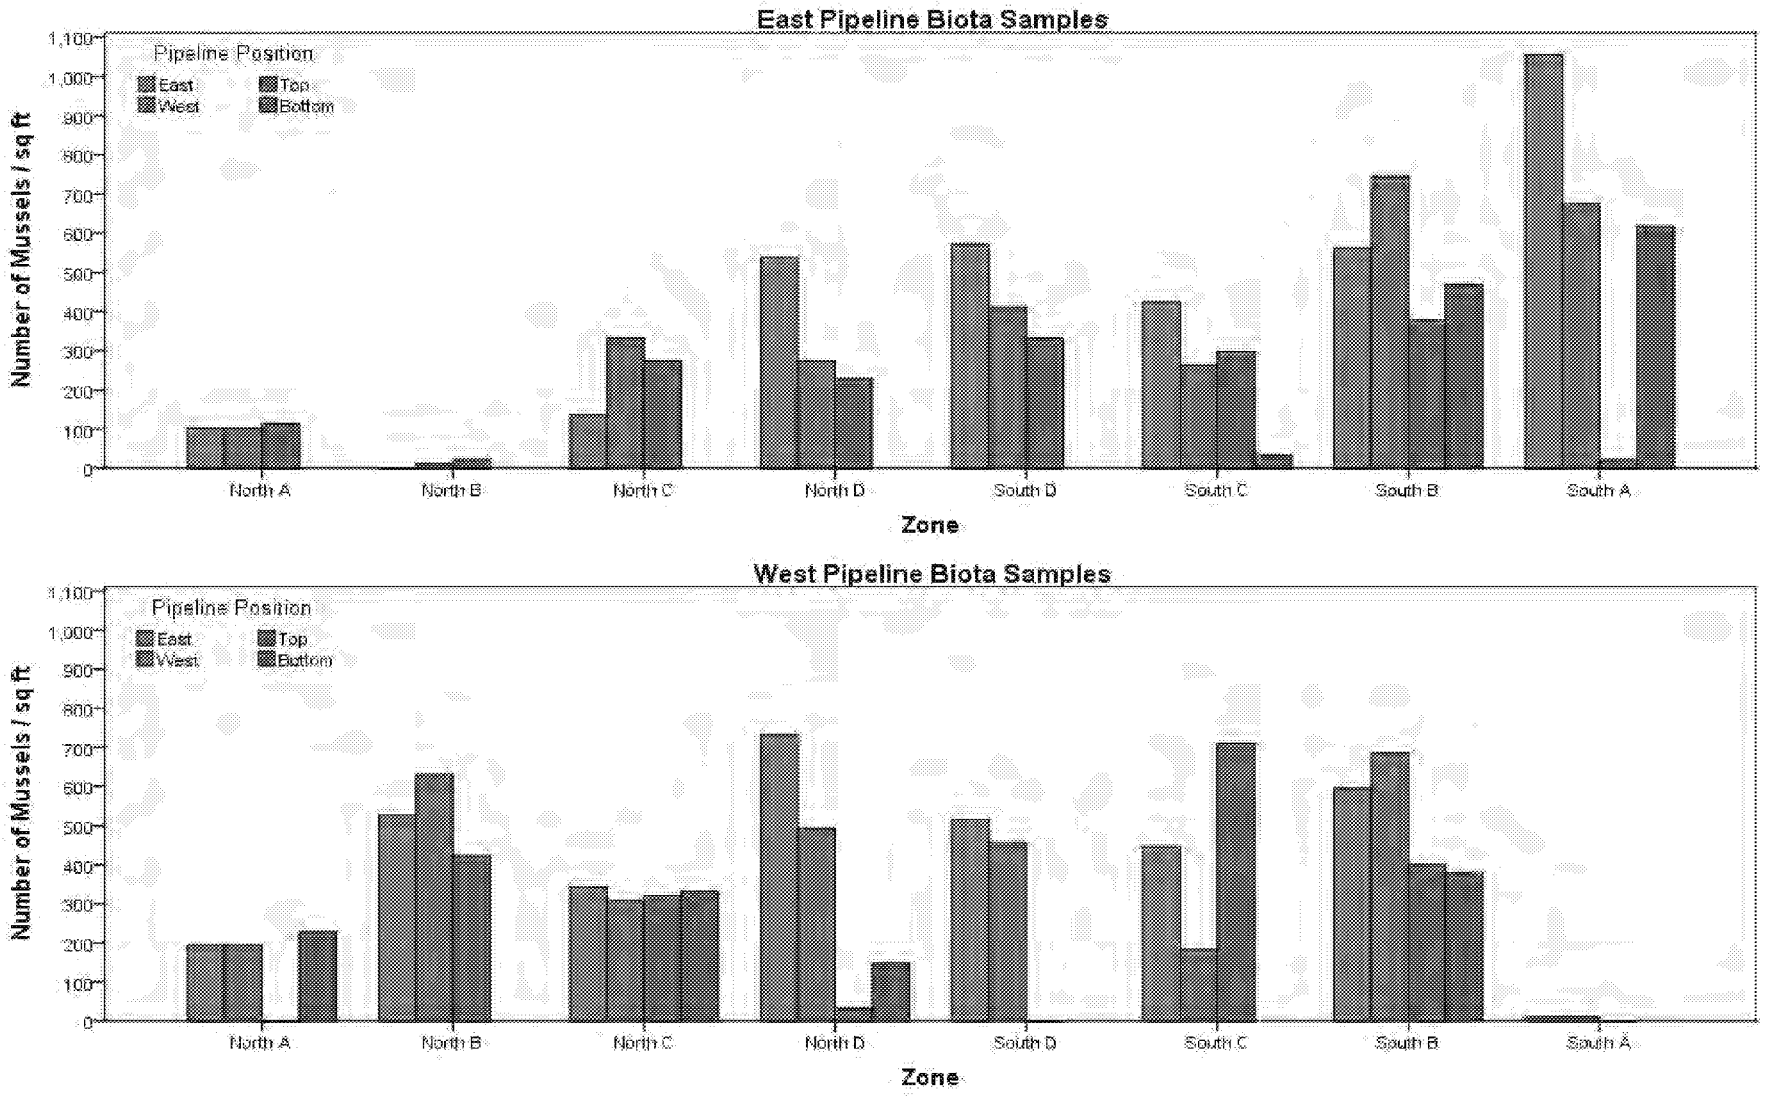
Figure 21: 2017 Biota Sample Mussel Density by Study Zone and Pipeline Positionsion

Mussel density and weight was variable across pipelines, Zones, and pipeline positions (top, bottom, east, west), with density spanning multiple orders of magnitude, from 0 to over 1,000 mussels per square foot (Figure 21 and Appendix F). Again, this variability is likely driven by the uneven distribution of mussels and the random selection of sampling sites. The uneven distribution can be observed in photographs from previous surveys of the pipelines (Figure 5 – location E-40, Enbridge 2017b). For reasons unknown, fewer mussels were present on the top of the pipeline as opposed to the sides. Mussel recruitment was evident based on the appearance of multiple age classes of mussels in Biota samples (Photograph 36) from nearly all Zones of both pipelines (Mills et al. 1996; Wilson et al., 2006). Dead quagga mussels were regularly observed in Biota samples and often appeared to still be attached to the pipelines.

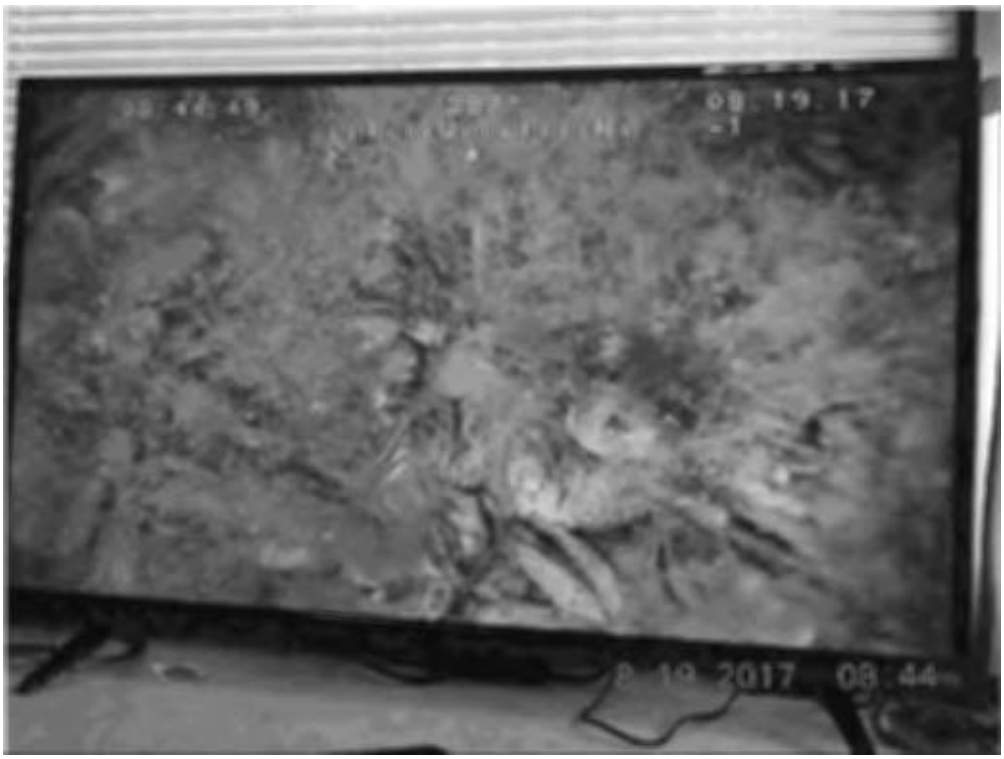
Photo 7. Heavy mussel colonization on the west pipe position

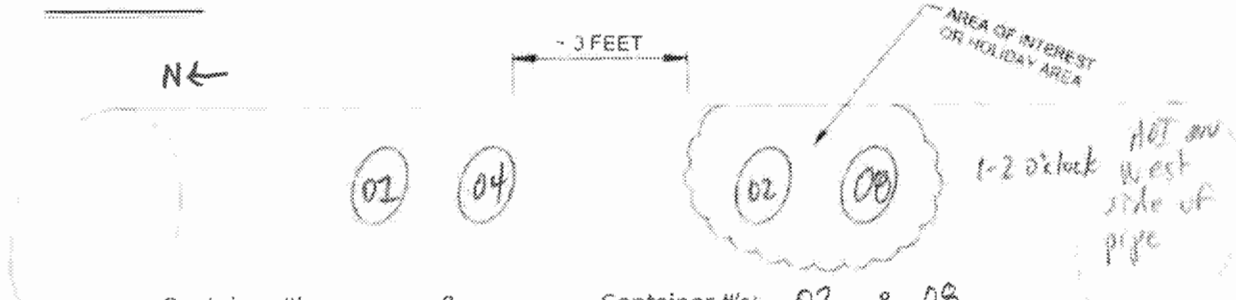
Mussel colonization: Sparse, @ AOI
Biota layers: Multiple
Sample depth (ft): 93
Water sample(s):
Container order: 08, 02, 04, 02

Critical issue!
Difficult to confirm holiday (or lack thereof) w/o cleaning pipe off.

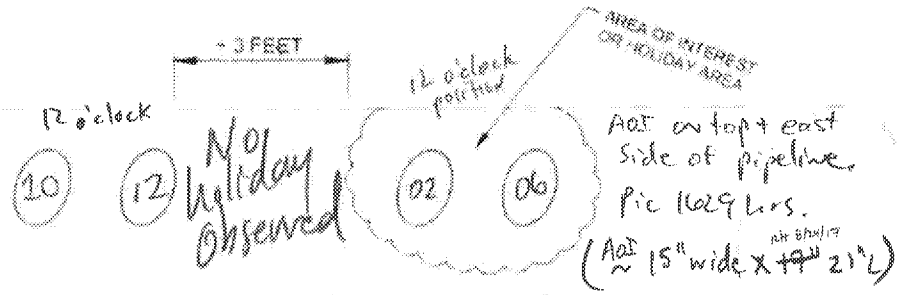
Notes (also indicate if additional notes are on reverse side of form): Apparent "cracks" or "ridges/bubbles" in coating. 2 samples w/in that area, 2 samples ~ 3' to north of that area. Loose pieces of apparent dislodged coating were collected from ~12 o'clock position

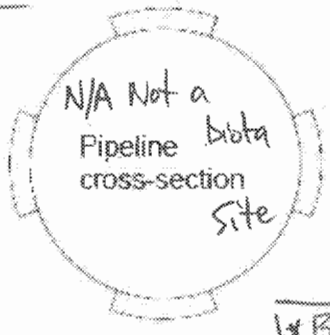
- Dive/sample collection video feed: 1032-1038
- 13' (A) measured length of pipe encompassing all calcium areas. Video 1043-1045. 18" tall from "tallest" calcium area. 3" allow w/ade bottom most to top most calcium area.

*Reveal apparent "calcium" pieces observed in sample

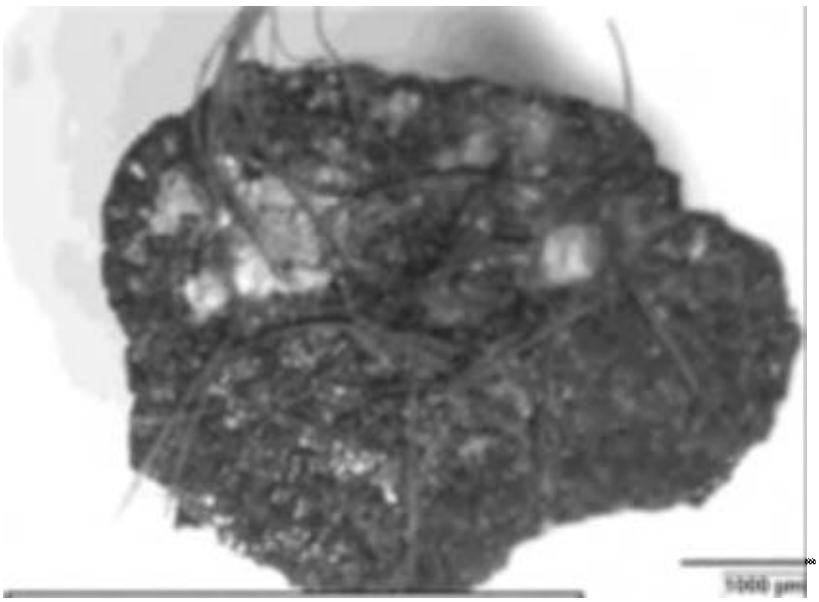
Byssal Threads on Calcium Carbonate (Tan) Deposit

Byssal threads are abundant on the calcium carbonate deposits in Sample #13. The striated thread surfaces, foot morphologies, and elemental composition reflecting protein are consistent and characteristic.

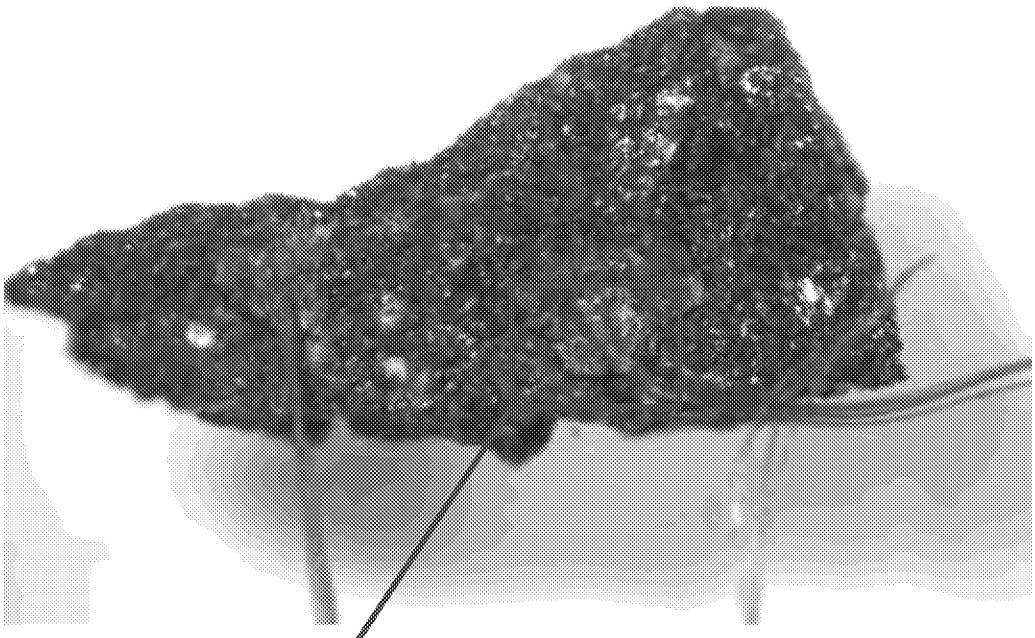
Byssal Threads on Pipe Coating (Black) Material

Byssal threads are also present on the pipe coating material in Sample #13, though they appear less abundant than on the calcium carbonate deposits. The striated thread surfaces, foot morphologies, and elemental composition reflecting protein are the same between the two types of substrate surfaces.

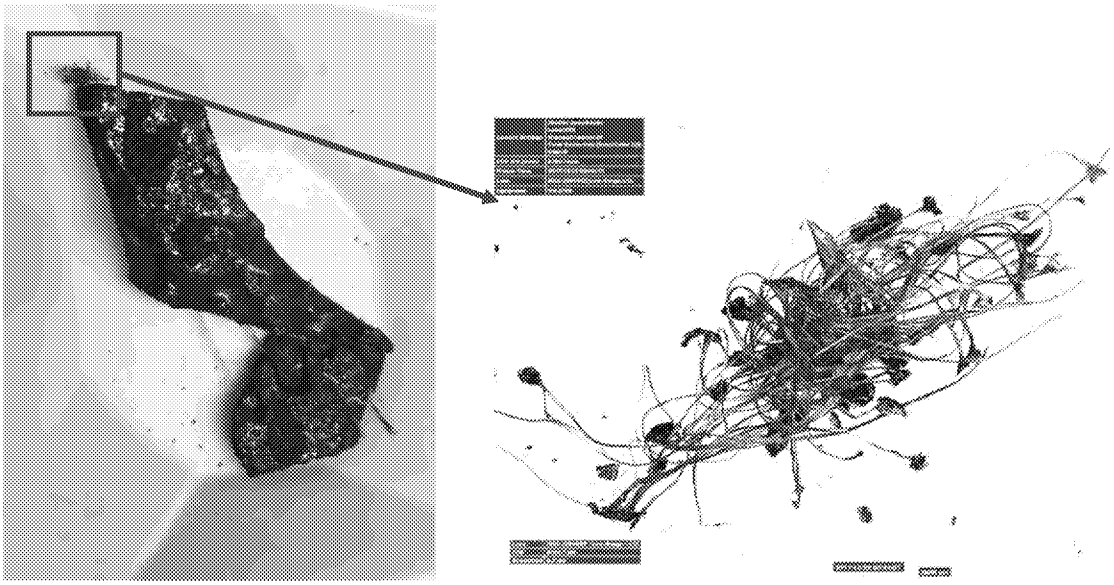
Pipe Exterior Parent Coating

A cluster of detached byssal threads was recovered from one end of this sample and was selected for analysis.

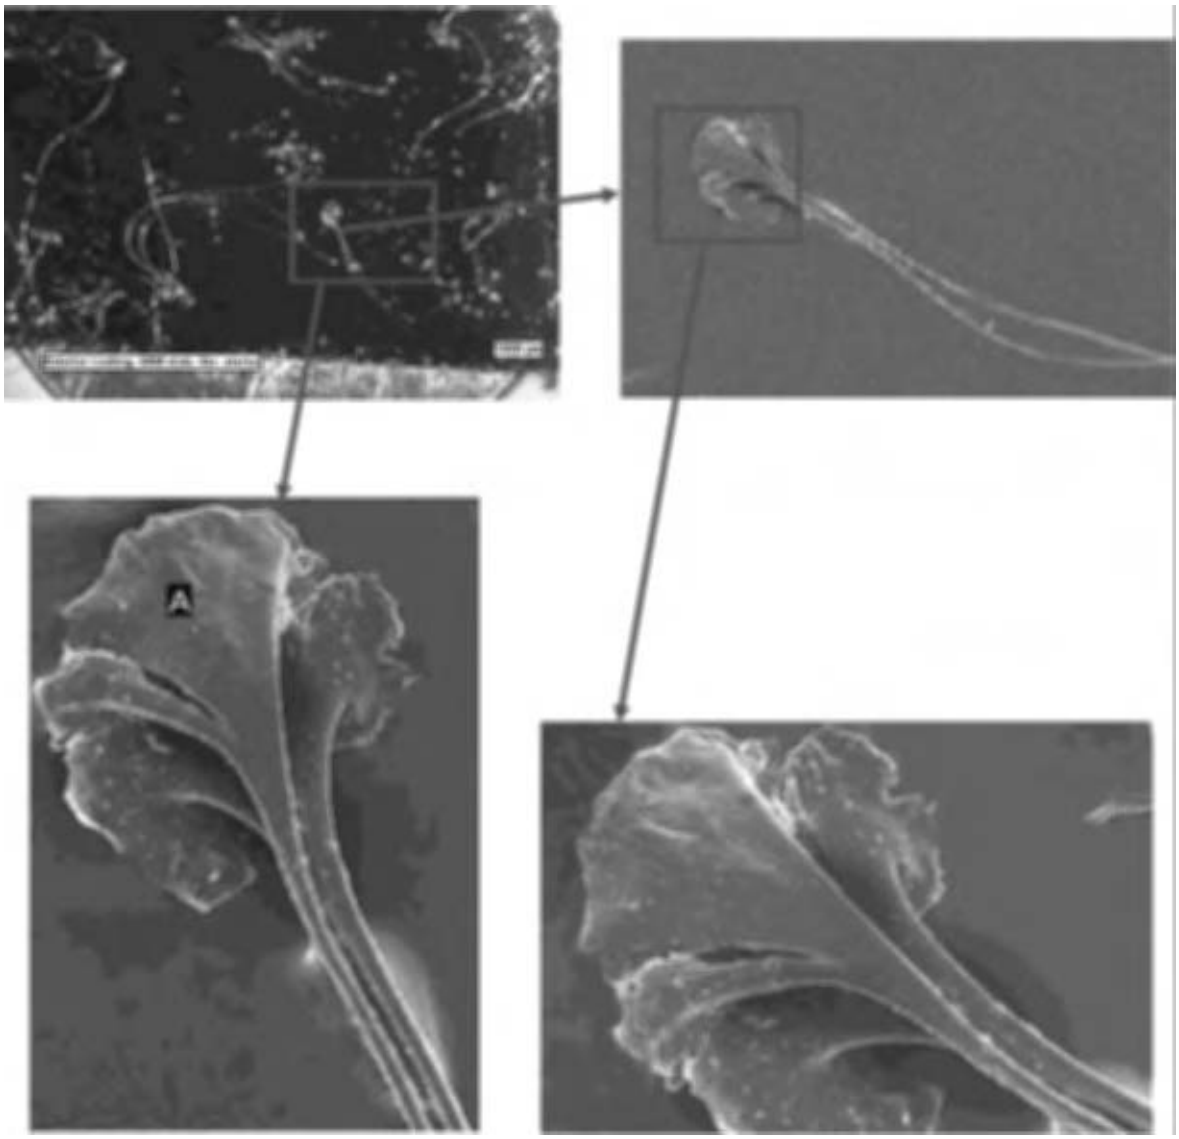
Disaggregated Byssal Threads **Transferred to Carbon Black Tape**

The SEM images reveal byssal threads of relatively uniform lengths and diameters, but with a variety of morphologies in the byssal thread foot. EDS spectra and elemental mapping indicate the byssal threads and feet are uniformly composed of carbon, nitrogen and oxygen, with lesser amounts of sulfur and calcium, a composition consistent with their protein makeup.
