Enbridge Line 5

Straits of Mackinac, MI

Biota Investigation Work Plan

Final Report

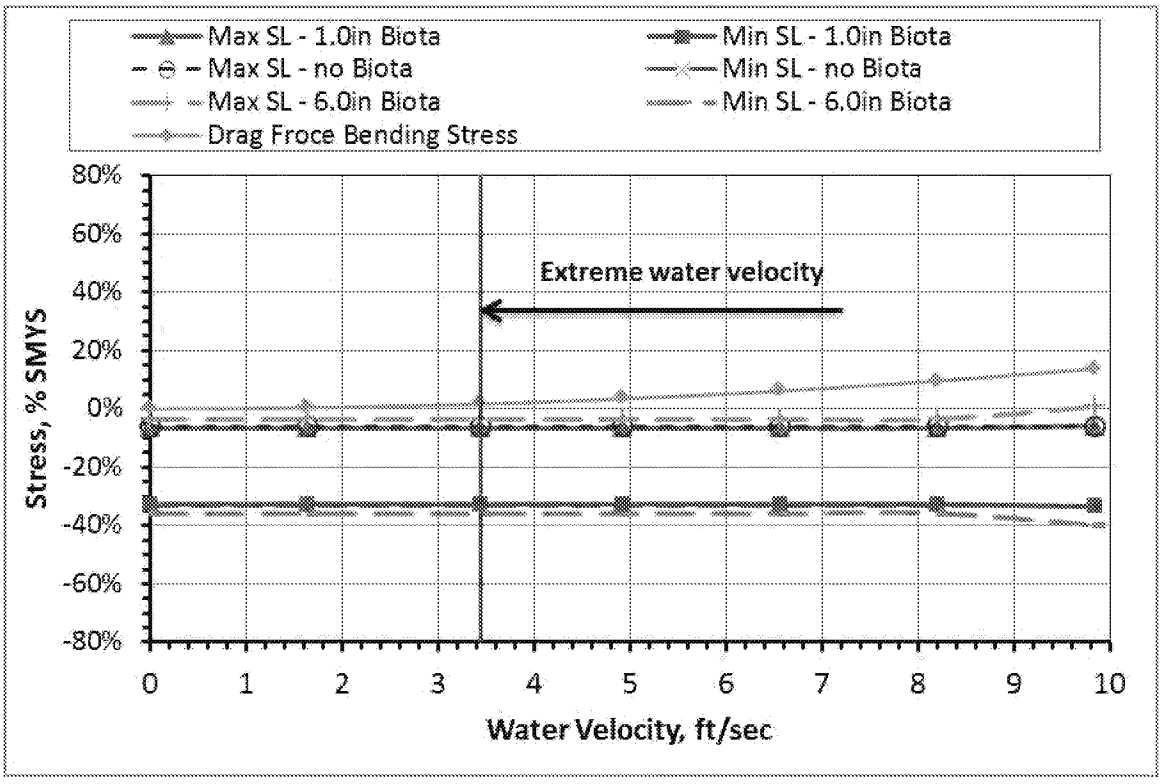
Figure 13. Longitudinal Stress vs Water Velocity for 75-foot Span

Figure 13 shows the results for a 75-foot long span. The horizontal axis is water velocity in ft/sec and the vertical axis is pipe longitudinal stress as a percent of SMYS. The plots show the maximum additive longitudinal stress (Max SL) and minimum additive longitudinal stress (Min SL) for a pipeline with no biota as well as two different biota thicknesses of 1.0 and 6 inches (25.4 and 75 mm) under a differential temperature of 30 F. The pipelines normally operates at temperatures between 40 (winter) and 60 F (summer), while the water temperature vary from about 35 F in winter to about 45 F in summer. This creates differential temperatures of 0 to about 25 F between the pipelines and the water (pipeline operates at temperatures warmer than the water). Since the pipe body temperature would have to be about the same as the water temperature during the installation, a differential temperature of 30 F is deemed to be conservative. A differential temperature of 30 F creates an axial compressive stress of about 19.4% in the pipeline. The limits of the vertical axis represent the allowable stress limit of 0.8 SMYS. The extreme water velocity of 3.44 ft/sec is marked with a red vertical line. The net axial stress is compressive due to the positive differential temperature. The green line in the figure is the bending stress due to the water drag force only (excluding gravitational forces and differential temperatures). It can be seen that for this span length bending stress from the drag force is not significant, even at the extreme water velocity of 3.44 ft/sec. The figure shows that for water velocities below the extreme velocity the highest additive longitudinal stress is less than 33% SMYS.

Thickness of biota affects the results in two ways: first it increases the drag force; and second it increases pipe weight. The solid lines in the figure represent the maximum and minimum longitudinal stresses for a pipe with no biota, while the dashed lines represent the longitudinal stresses for 1.0-inch and 6-inch biota thickness. A comparison between the solid and dashed lines shows that the differences are insignificant relative to the material SMYS. At water velocities equal to or less than 3.44 ft/sec (the extreme water velocity) a biota thickness of 1 inch increases the stresses by less than 1% SMYS compared to a pipe with no biota. A biota thickness of 6 inches increases the stresses by less than 4% SMYS compared to a pipe with no biota. The insensitivity of the longitudinal stress to biota thickness is because the longitudinal stress is dominated by the compression from the differential temperature and bending stress from the pipe and product weight. Since biota thickness was found not to be an influential factor, in the reminder of this section the actual (measured) biota thickness of 1.0 inch was used.

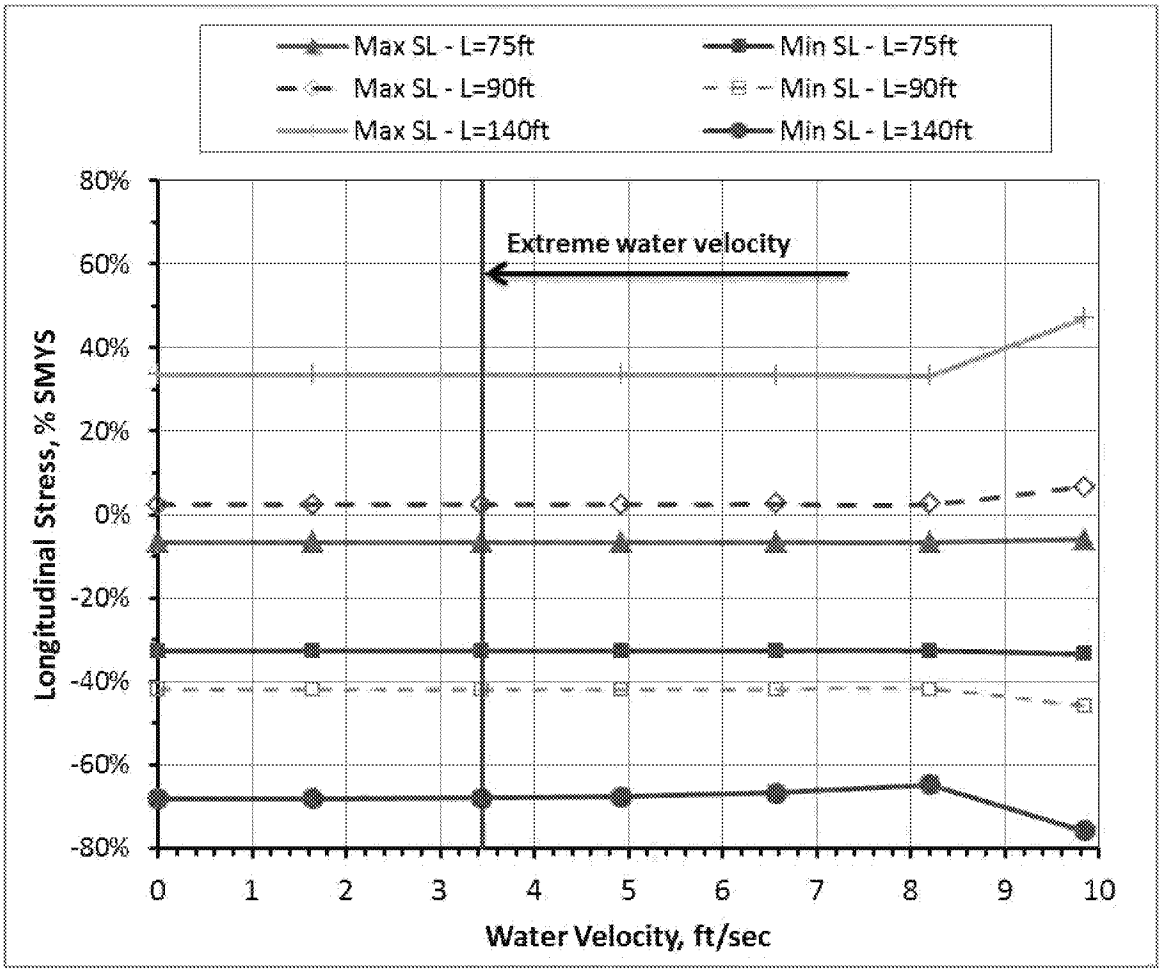
Figure 14. Longitudinal Stress vs Water Velocity for 75- to 140-ft Spans

Figure 14 shows a comparison between the longitudinal stresses for span lengths of 75, 90, and 140 feet. The data shows that (as expected) the span length plays a significant role in the longitudinal stresses. Although water velocity has a substantial effect on the drag force, it does not appear to influence the longitudinal stresses for water velocities below about 8 ft/sec. The insensitivity of the

longitudinal stress to water velocity is because of the dominance of the longitudinal compression from differential temperature and the weight of the pipe and product.

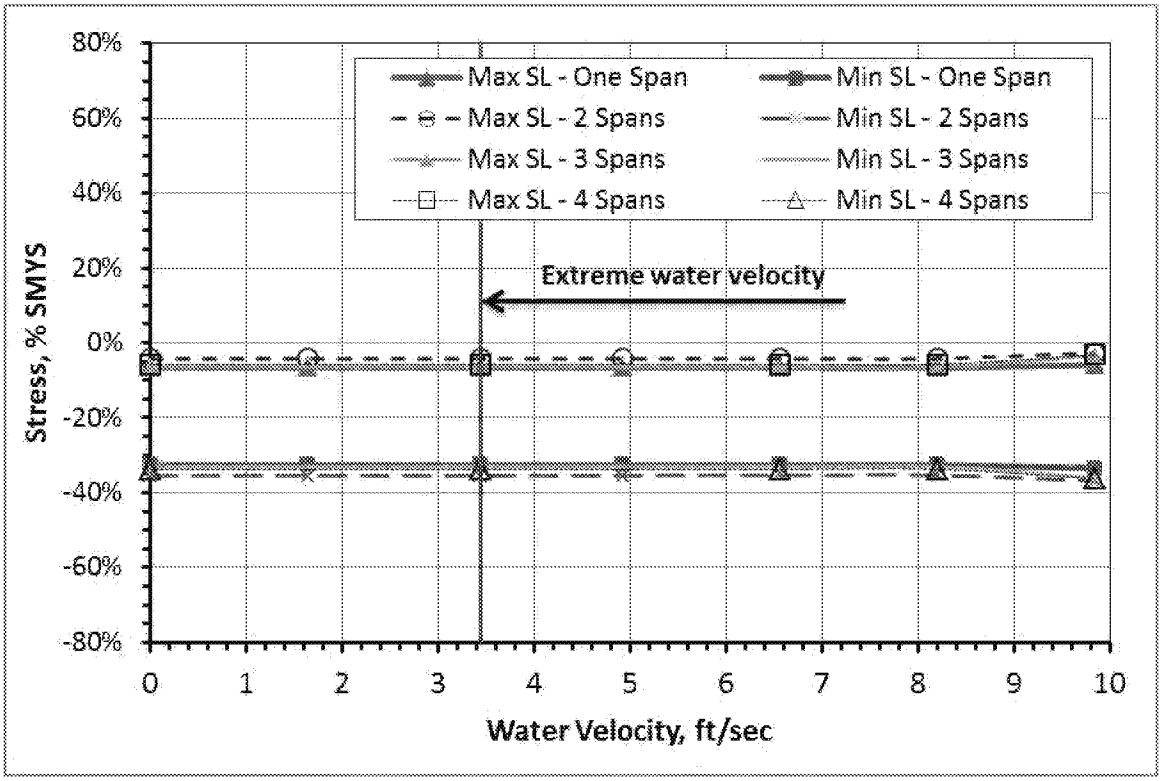
Figure 15. Effect of the Number of Continuous Spans on the Longitudinal Stress in 75-ft Long Spans

Figure 15 shows the effect of the number of continuous spans on the longitudinal stress values. Each curve in this figure is the maximum or minimum longitudinal stress versus water velocity. The data is presented for one through four continuous spans, each 75 feet long. Figure 17 shows similar graphs for one to four continuous 140-ft long spans. Figure 17 shows the effect of the number of spans for 75- and 140- foot spans. In Figure 17 and Figure 18 the longitudinal and equivalent stresses are plotted against the number of spans for the extreme water velocity of 3.44 ft/sec. Equivalent stresses in the figure are calculated as:

The limits for the longitudinal and equivalent stresses are also marked on the figure in green dashed and red dashed-dotted lines, respectively. Figure 15 through Figure 17 show that the number of continuous spans is not a very influential factor in the longitudinal and equivalent stress calculations. Furthermore, Figure 15 and Figure 16 show the effect of the number of continuous spans does not vary with water velocity.

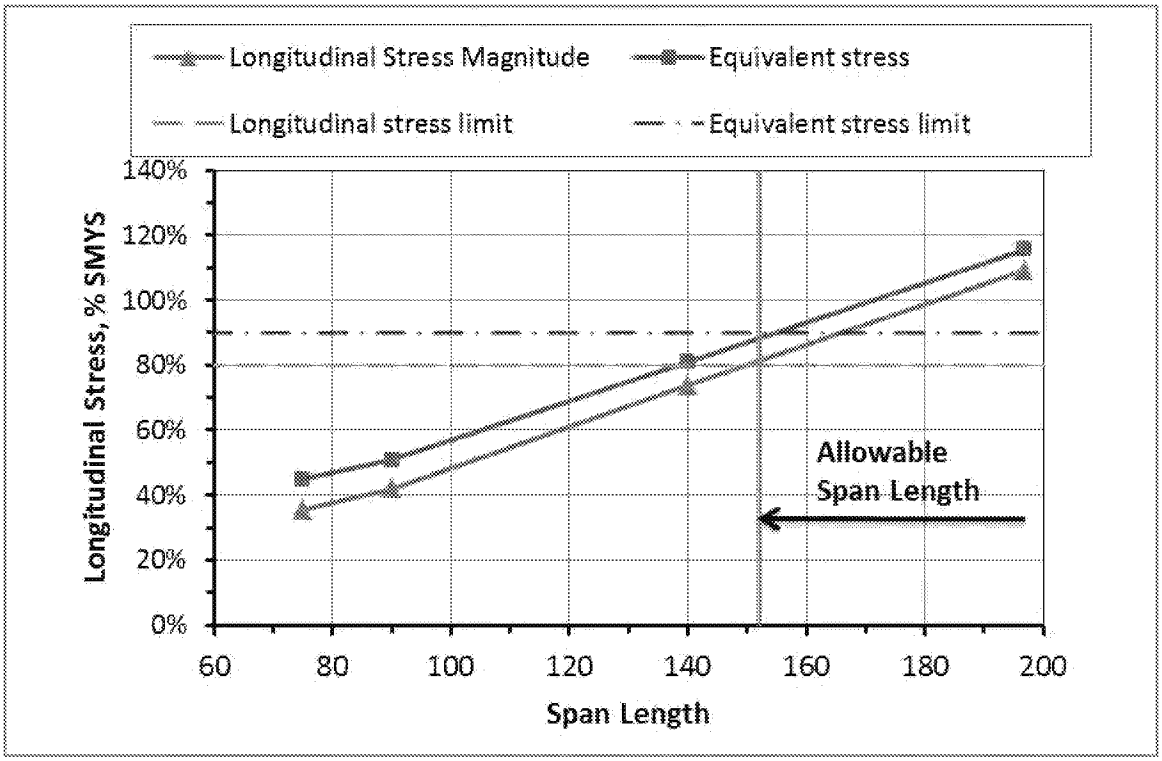
Figure 19. Longitudinal and Equivalent Stresses vs Span Length (two Continuous Spans)

Figure 19 shows the longitudinal stress magnitude and the equivalent stress versus span length for when there are two continuous spans. The stresses are presented for the extreme water velocity of 3.44 ft/sec. By limiting the allowable equivalent stress to the 0.9 SMYS limit, the allowable span length is determined as about 150 feet. As discussed above (and shown in Figure 17 and Figure 18) the number of continuous spans up to four spans does not affect the calculated length. Furthermore, more than 4 continuous spans does not increase the bending stress (e.g. see [7]). Based on the results presented in Figure 13 through Figure 18 combinations of a water velocity up to 8 ft/sec, a biota buildup of up to 6 inches, and number of continuous spans do not affect the calculated stresses by more than 5% SMYS. The calculations of the span length used a conservative value for differential temperature and extreme water velocity of 3.44 ft/sec.

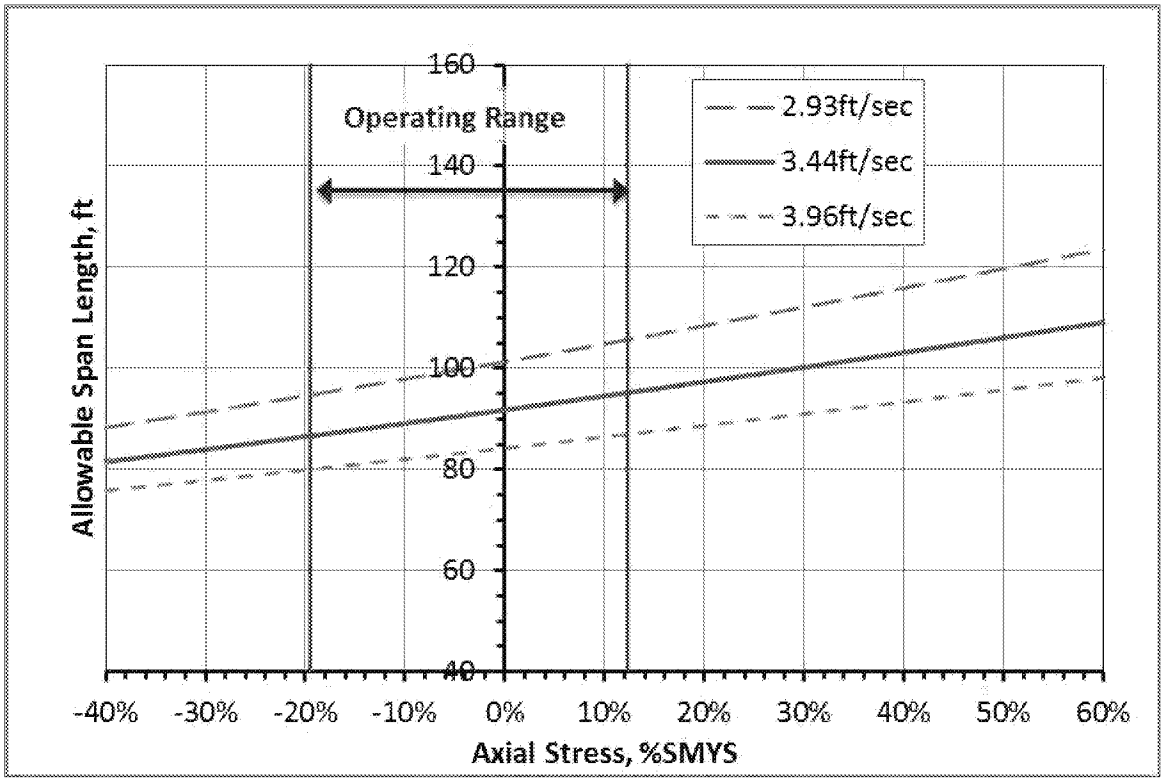
Figure 20. Allowable Span Length vs Axial Stress Based on VIV Avoidance Criteria for Three Water Velocities of $.9U_{extreme}$, $U_{extreme}$, and $1.1U_{extreme}$

Free span lengths were calculated under a variety of conditions based on the avoidance criteria for cross flow and inline VIV. Figure 20 shows allowable span length versus pipe axial stress calculated based on VIV avoidance criteria for three different water velocities when the pipelines carry liquid product with a 0.868 specific gravity. The model included 1.0-inch biota growth. The three water velocities depicted in the figure represent 0.9, 1.0, and 1.1 times the extreme water velocity of 3.44 ft/sec. These velocities are selected to demonstrate the sensitivity of the results to the water velocities. The vertical red lines show a conservative range of operating axial stresses in the pipelines. The minimum axial stress is calculated by assuming zero internal pressure and a differential temperature of 30 F, while the maximum axial stress is calculated by assuming no differential temperature and an internal pressure of 600 psig. These two scenarios are extreme cases and they do not necessarily exist in reality. The actual axial stress in the pipelines is expected to fall between the two red lines and normally within the compressive side because the pipeline operates at temperatures warmer than the water.

The results show that a higher compressive stress in the pipeline lowers the natural frequency of vibration, leading to a shorter span length. For this reason in the remainder of this report the axial stress is set to the lowest value of −19.4% SMYS based on FEA results under the differential temperature of 30 F. This value was calculated from the FEA models discussed in the 'Engineering Analysis of Spans' Section. The inline onset reduced velocity was lower than the cross flow reduced velocity and therefore was the critical criterion in determining the allowable span length. The inline onset reduced velocity for the pipelines was between 1 and 1.25 (with a safety factor of 1.1 included), while the cross flow onset reduced velocity was about 2.5 (with a safety factor of 1.2 included). Figure 20 also shows that water velocity is a major factor affecting the span length. A 10% increase in the water velocity reduces the acceptable span length from 87 to about 80 feet, while a 10% decrease in the water velocity, increases the span length to about 95 feet.

As seen in Figure 20 the axial stress has a moderate influence on the span lengths. The component of longitudinal stress due to internal pressure, with the pipeline in the least constrained condition, is at most half of the hoop stress. Pressure induced axial stress under the maximum operating pressure of 600 psig was assessed to have insignificant effect on the acceptable span length (<5%), and therefore the internal pressure component of the axial stress was ignored in the VIV assessment.

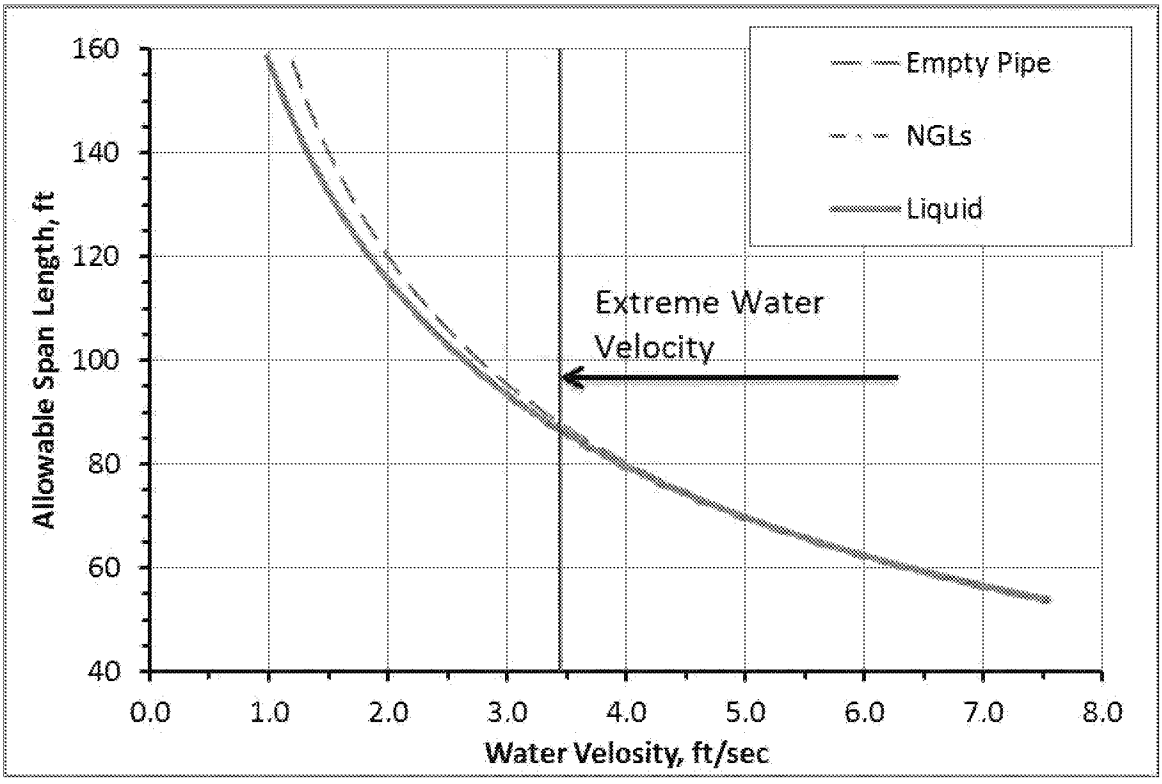
Figure 21. Allowable Span Length vs Water Velocity for Various Product Types

Figure 21 shows the calculated span lengths versus water velocity for empty pipe, NGLs, and liquid product. The plotted span lengths are calculated based on the VIV avoidance criteria (Equation 6 and Equation 7) to prevent VIV. The vertical red line is at the extreme water velocity of 3.44 ft/sec. The VIV avoidance span length from this figure is again 87 feet for a single span with NGLs or liquid products and it is not very sensitive to the product unit weight. The empty pipeline was analyzed under a differential temperature of 15 F (versus 30 F for operating pipeline) because an empty pipe achieves thermal equilibrium with the water very quickly.

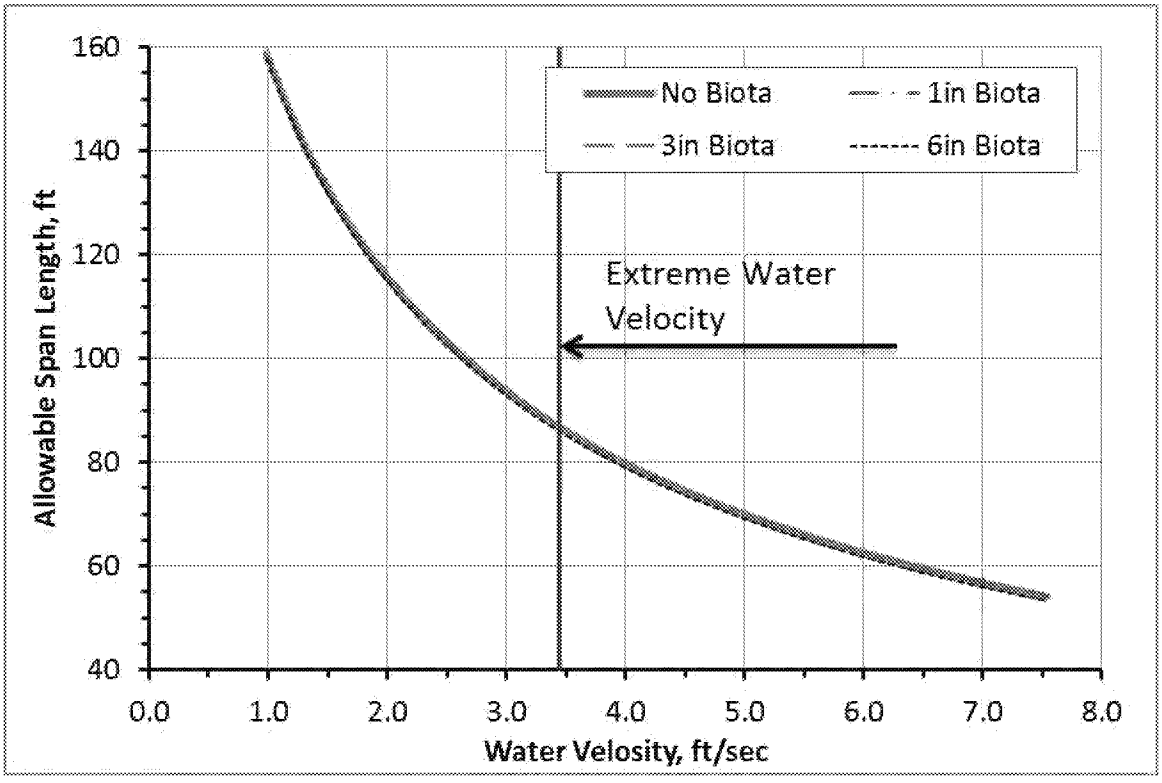
Figure 22. Allowable Span Length vs Water Velocity for Various Biota Buildups

Figure 22 show the effect of biota thickness on the VIV avoidance span length. The biota thickness is seen not to affect the span length significantly. Although, variations of biota thickness change the natural frequency of vibration, for the range of water velocities and biota thicknesses examined in this work the change is offset by a corresponding increase or decrease of the pipe hydrodynamic diameter and VIV onset reduced velocity. In essence the VIV analysis showed that spans with lengths equal to or shorter than 87 feet will not experience VIV when exposed to the extreme water velocity. The analysis used all the design safety factors recommended in DNVGL-RP-F105 (Table 5), and therefore is believed to be conservative.

The maximum measured thickness of biota was 1 inch. Information provided by Enbridge indicates that biota was introduced to the Great Lakes about 20 year ago. Therefore, it is not expected that the biota growth on the pipeline exceeds 6 inches of thickness.

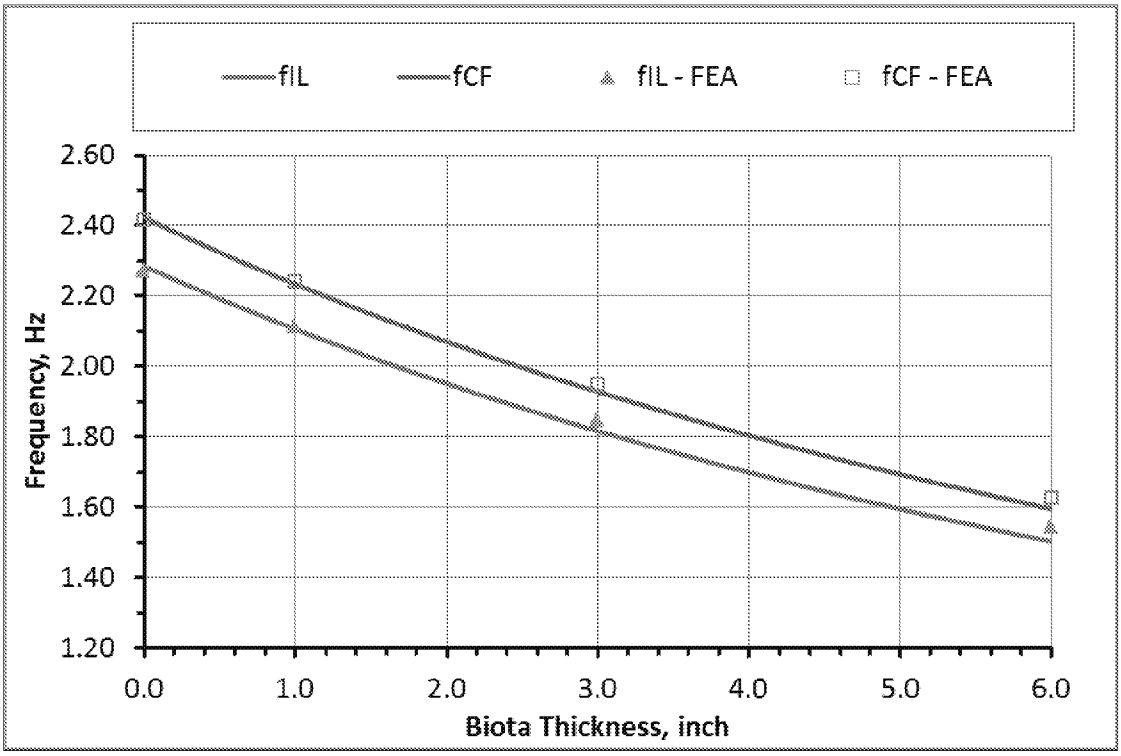
Figure 23. Effect of Biota Thickness on the Span Frequency; FEA vs Analytical Results

FEA simulations were first performed to confirm some of the sensitivity results presented in the previous section. Figure 23 shows a comparison between FEA and analytical results (DNV RPs equations) for the effect of biota thickness on the inline and cross flow fundamental frequencies. The two methods are in a good agreement for a biota range of zero to 6 inches. This shows that the results discussed in the 'VIV Analysis of Single Span' section are consistent with the FEA data.

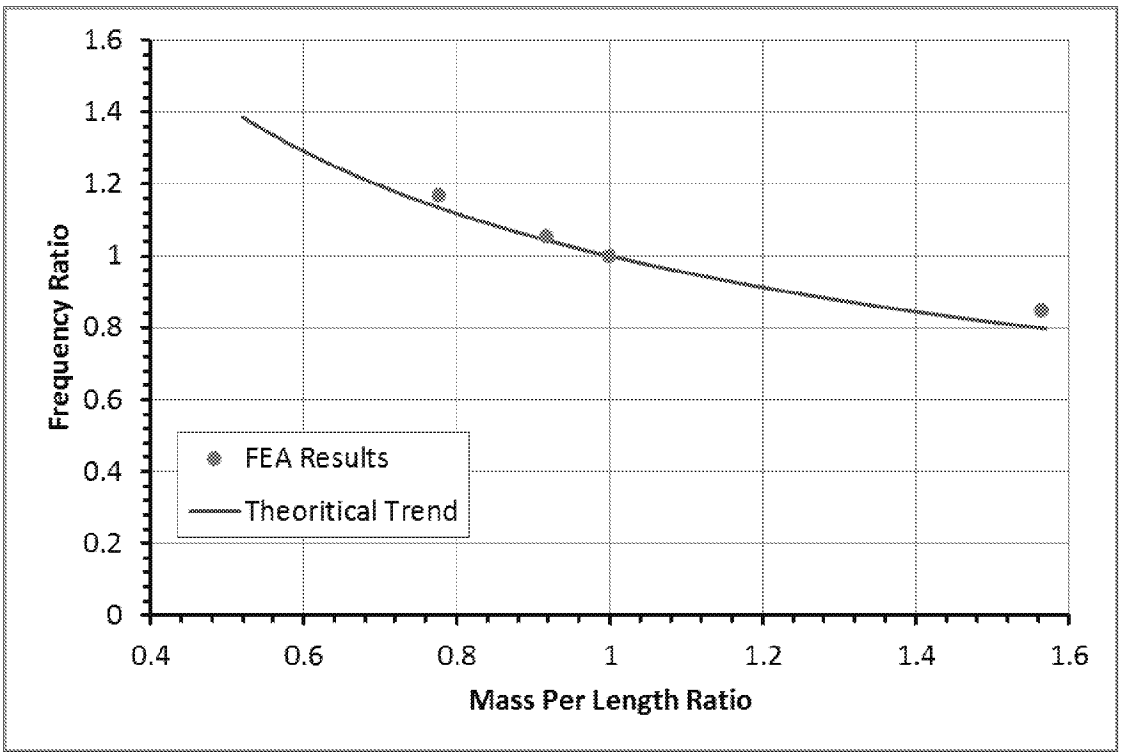
Figure 24. Effect of Pipe Mass on Mode 1 Inline Frequency of Vibration

Figure 24 shows the results of a sensitivity analysis on pipe mass per unit length. The FEA results are normalized by dividing pipe mass and Mode 1 inline frequencies to those of a benchmark case. The benchmark case was selected to be a pipe with liquid product and no biota built up. The mass ratio represents the actual mass of the pipeline with liquid product and coating (the added mass was excluded from the ratio because it is not a physical quantity). The continuous brown line in the graph represents the analytical trend from Equation 8, including the effect of soil support on the shoulders. It can be seen that the FEA results match the analytical trends closely.

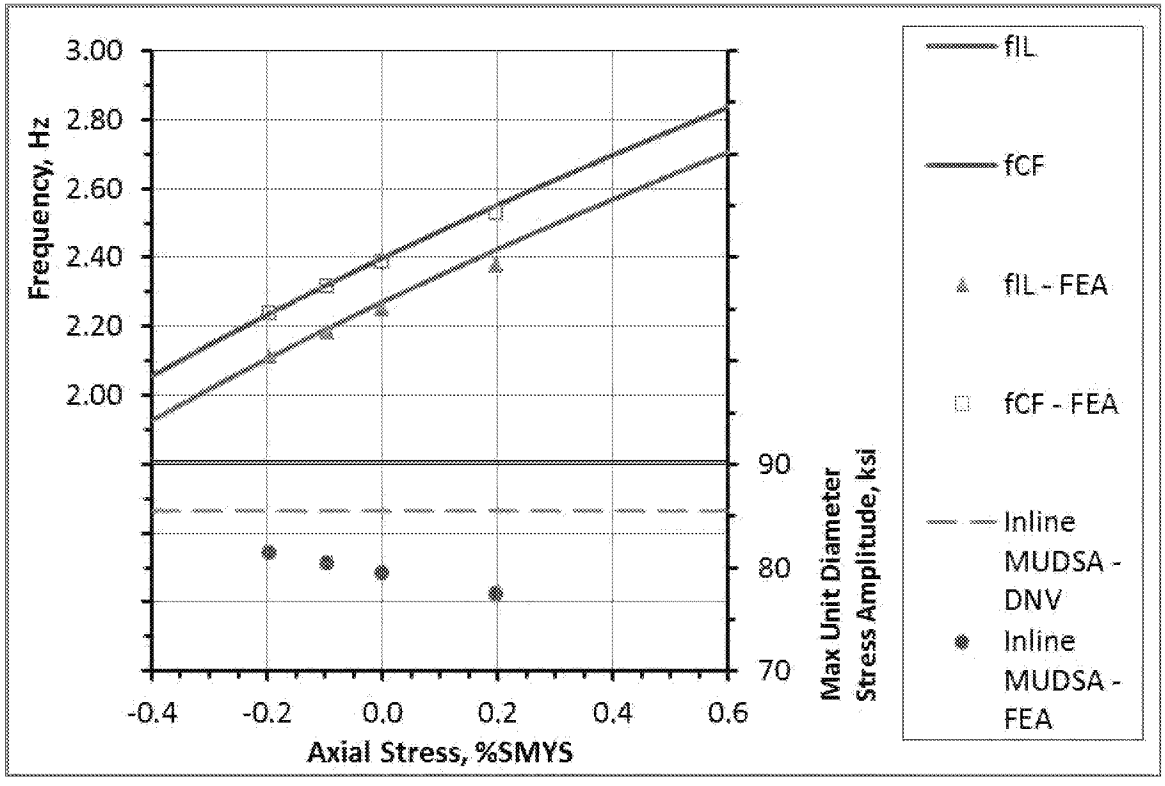
Figure 25. Modal FEA Sensitivity Results for Pipe Axial Stress

Figure 25 shows the axial stress sensitivity analysis results for a single 75-foot long span with 1.0 inch of biota. The horizontal axis is the pipe axial stress as a percent of SMYS. The left vertical axis is Mode 1 frequency, while the right vertical axis is the MUDSA in ksi. The continuous lines in the figure represent analytical results per DNV RPs and the individual symbols are the FEA results. The figure shows good agreement between the analytical and FEA results for a single span.

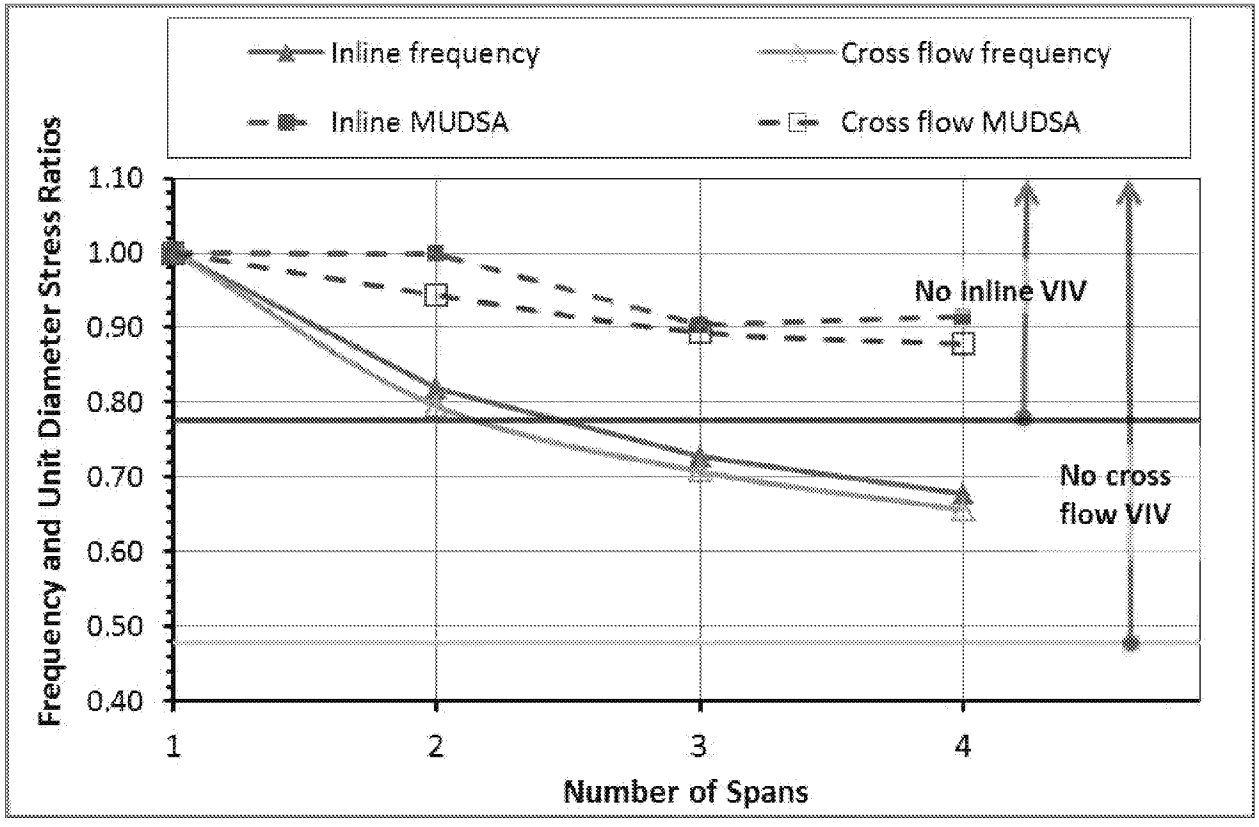
Figure 26. Modal Multi-Span FEA Results

Figure 26 shows the results of modal FEA for 1 through 4 continuous 75-foot spans. The horizontal axis of the graph is the number of continuous spans and the vertical axis is normalized frequency and MUDSA values. Each value is normalized by dividing the value to the corresponding single span value. For example Mode 1 inline frequencies are divided by Mode 1 inline frequency of a single 75-foot long span. Similarly Mode 1 cross flow frequencies are divided by the Mode 1 cross flow frequency of a single 75-foot long span. The graph represents how the number of continuous spans affects these parameters in a relative sense. Frequency decreases with the increasing number of spans, however the

graphs level off as the number of continuous spans increase. MUDSA shows some dependence with the number of continuous spans, but overall it does not decrease significantly with increasing number of continuous spans. The horizontal red and orange lines represent the avoidance criteria for the inline and cross flow VIV. As shown in the figure, with two or more continuous spans, the pipelines may potentially violate the inline avoidance criterion, while they meet the cross flow avoidance criterion.

Inline fatigue assessments were conducted to assess 100-year cumulative fatigue damage for 2 or more continuous spans. The fatigue calculations followed DNVGL-RP-F105 guidance. Cyclic stress magnitudes were calculated based on the MUDSA values and intensified using the pertinent DNV safety factors listed in the last row of Table 5. Stress concentration factor and fatigue resistance (S-N curve) parameters were based on DNVGL-RP-C203, Table 2-1, F3 [9]. The assessment showed that 100-year

cumulative fatigue damage in the pipelines was negligible for one through four continuous spans, each 75 feet long. The highest calculated fatigue index was 0.003 corresponding to four continuous spans[3].
