**2016 BELLE ISLE
COMPREHENSIVE
HYDROLOGIC
ASSESSMENT**

In response to tasks 2A and 2B of the Lake Okonoka Habitat Restoration project, this report aims to gain an understanding of the current hydrology on Belle Isle specific to the +/- 200 acre natural area referred to as the wet-mesic flatwoods forest (flatwoods).

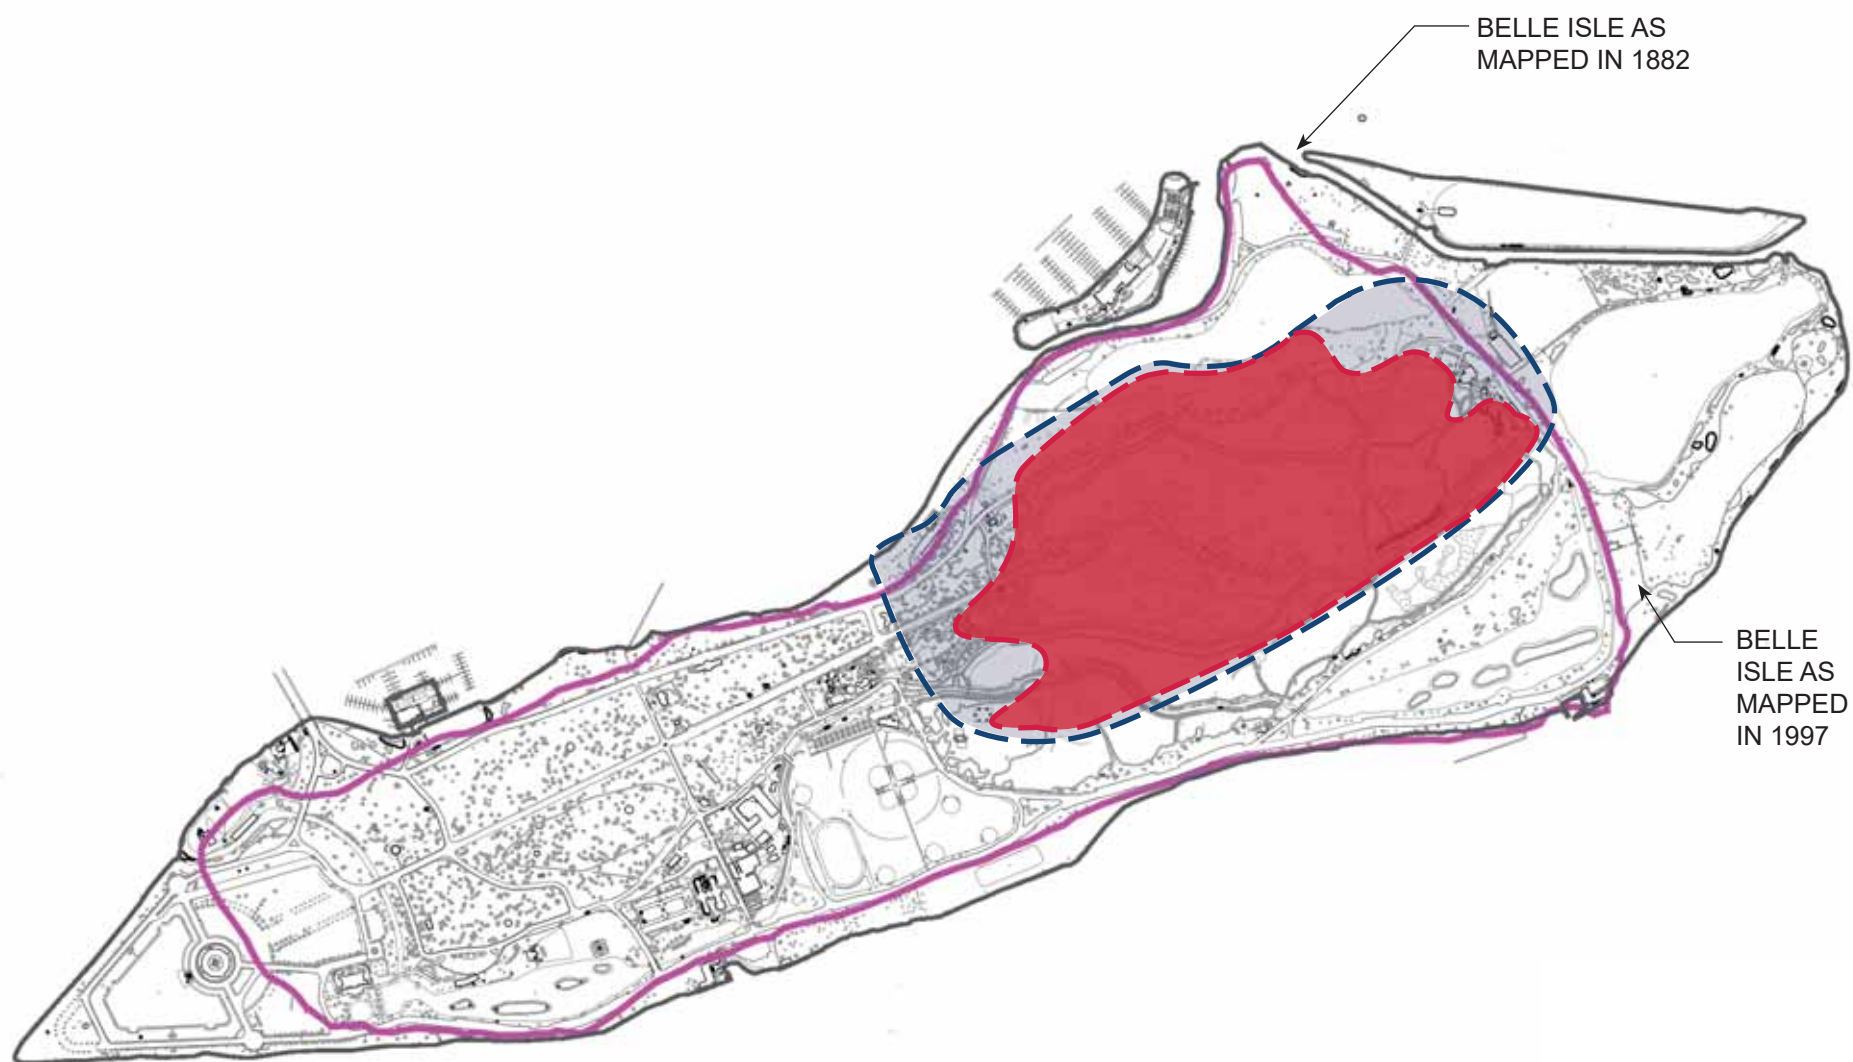
Figure 5. Historic Belle Isle & Flatwoods Overlay

Historically, Belle Isle was much smaller in size than today (Figure 5). While the enlargement of the island has benefited recreational uses and improved pedestrian and vehicular circulation, it has created adverse effects on hydrology specific to the flatwoods. The historical survey of the island and river bathymetry Figures 1 and 2) reveal that the drainage patterns of the flatwoods occurred in three directions (Figure 6). A natural ridge follows the approximate center of the flatwoods with the highest historical elevations occurring east of the Sylvan Canal including the now closed Safari Zoo. Drainage patterns to the north and south historically discharged into the wetland complex that represented a gradual transition from the flatwoods by approximately 2.5 feet. The eastern end of the flatwoods drained directly

The canal system has altered the hydrology of some areas of the flatwoods where their construction has intercepted historical surface flow to the north and south (Figure 5) and is most evident along Nashua Canal in the spring and following large storm events. This condition was further exasperated through the construction of ditches within the flatwoods that discharge into the canals at elevations lower than the top of the bank and will be discussed in the *Ditches and Culverts* section.

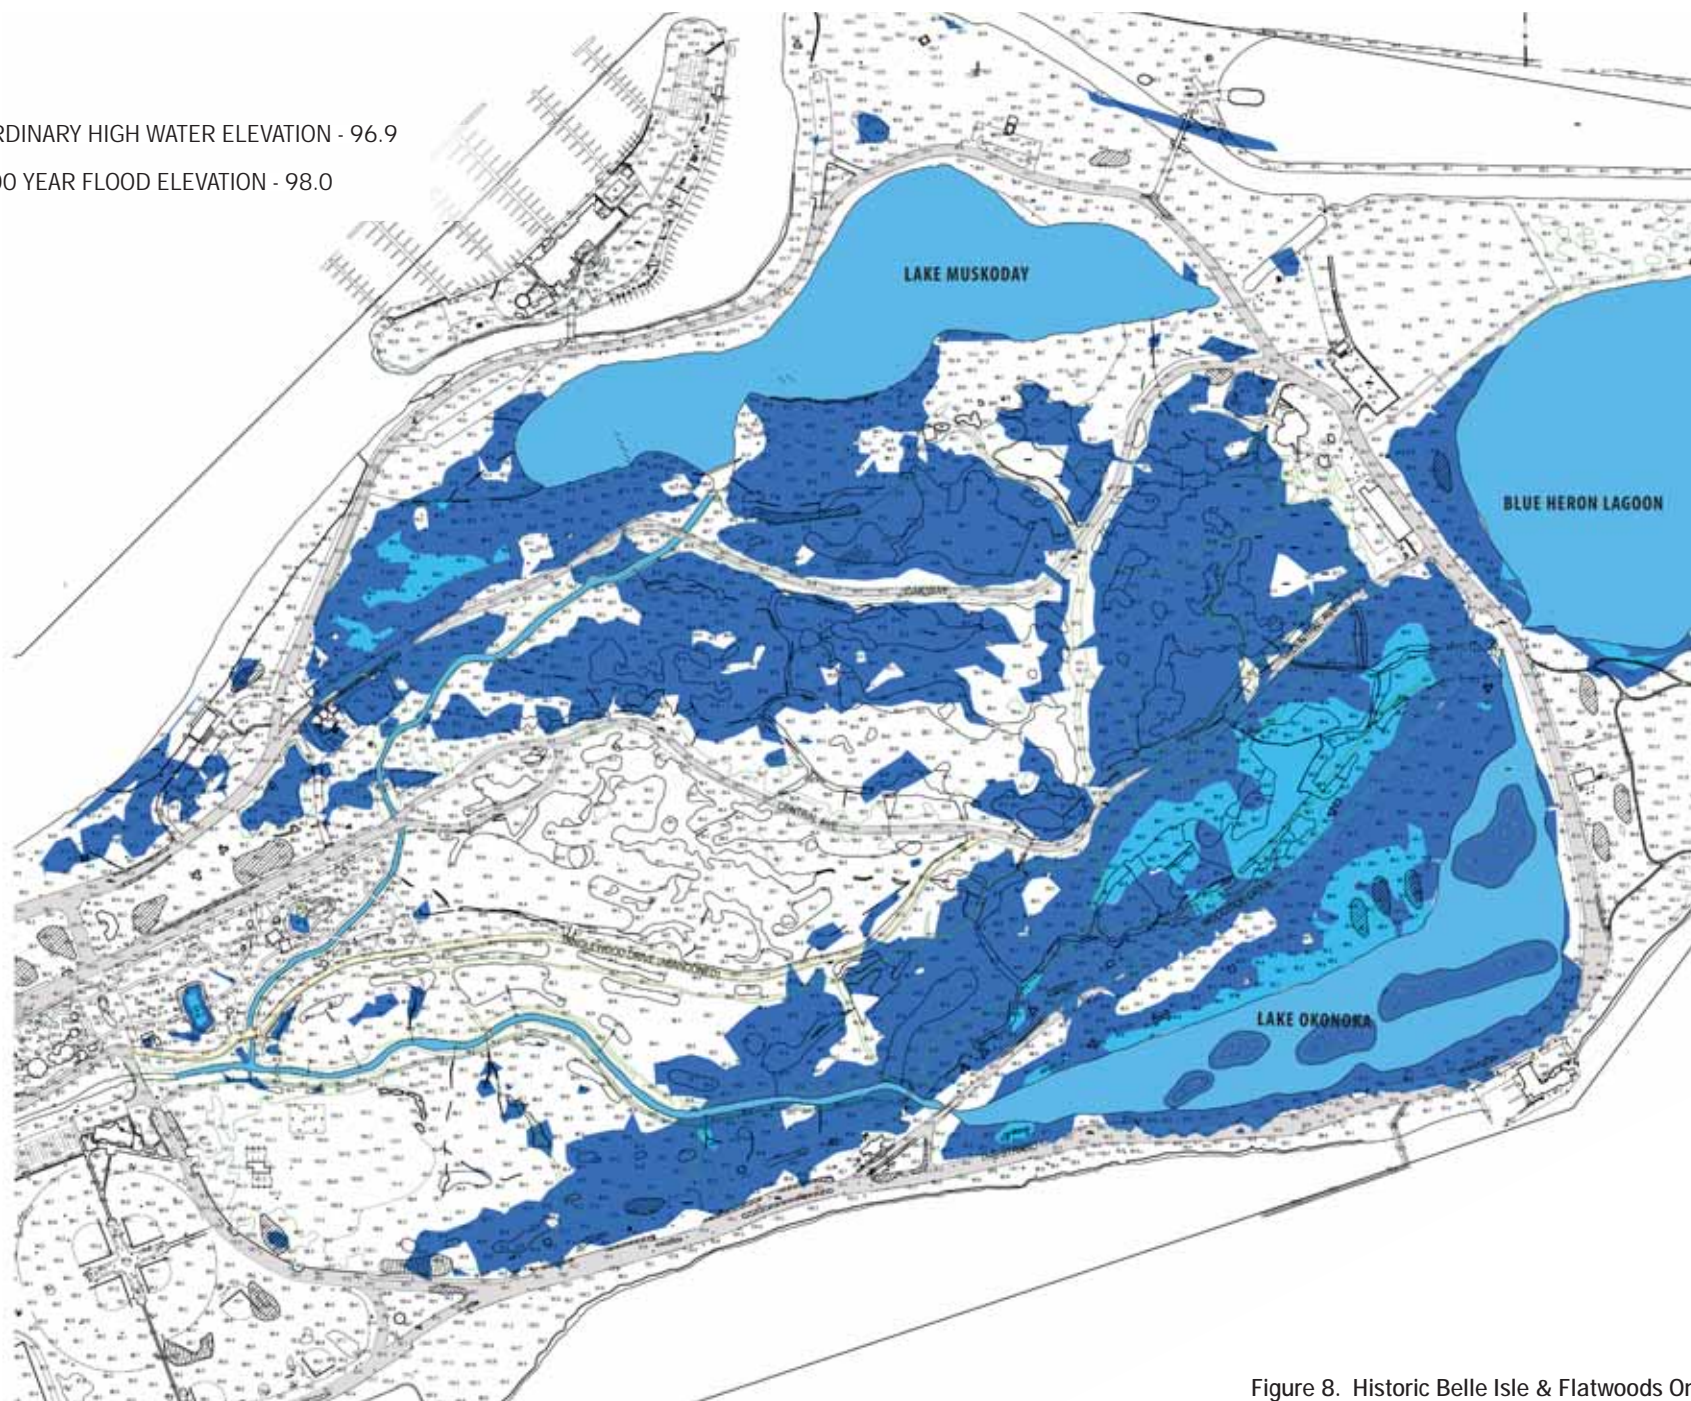
Figure 8. Historic Belle Isle & Flatwoods Only

Within the flatwoods, natural elevations range between 98.8 and 96.4 with almost half of the elevations below the 100-year flood elevation (Figure 8). While the 100-year flood datum is not as significant as the Mean or OHW, it is clear that in addition to precipitation and snow melt, the lower elevations of the flatwoods were periodically influenced by these fluctuations for extended periods of time. Conversely, low water cycles of the Detroit River had little to no impacts on flatwoods hydrology but most likely effected the wet meadow and shallow water

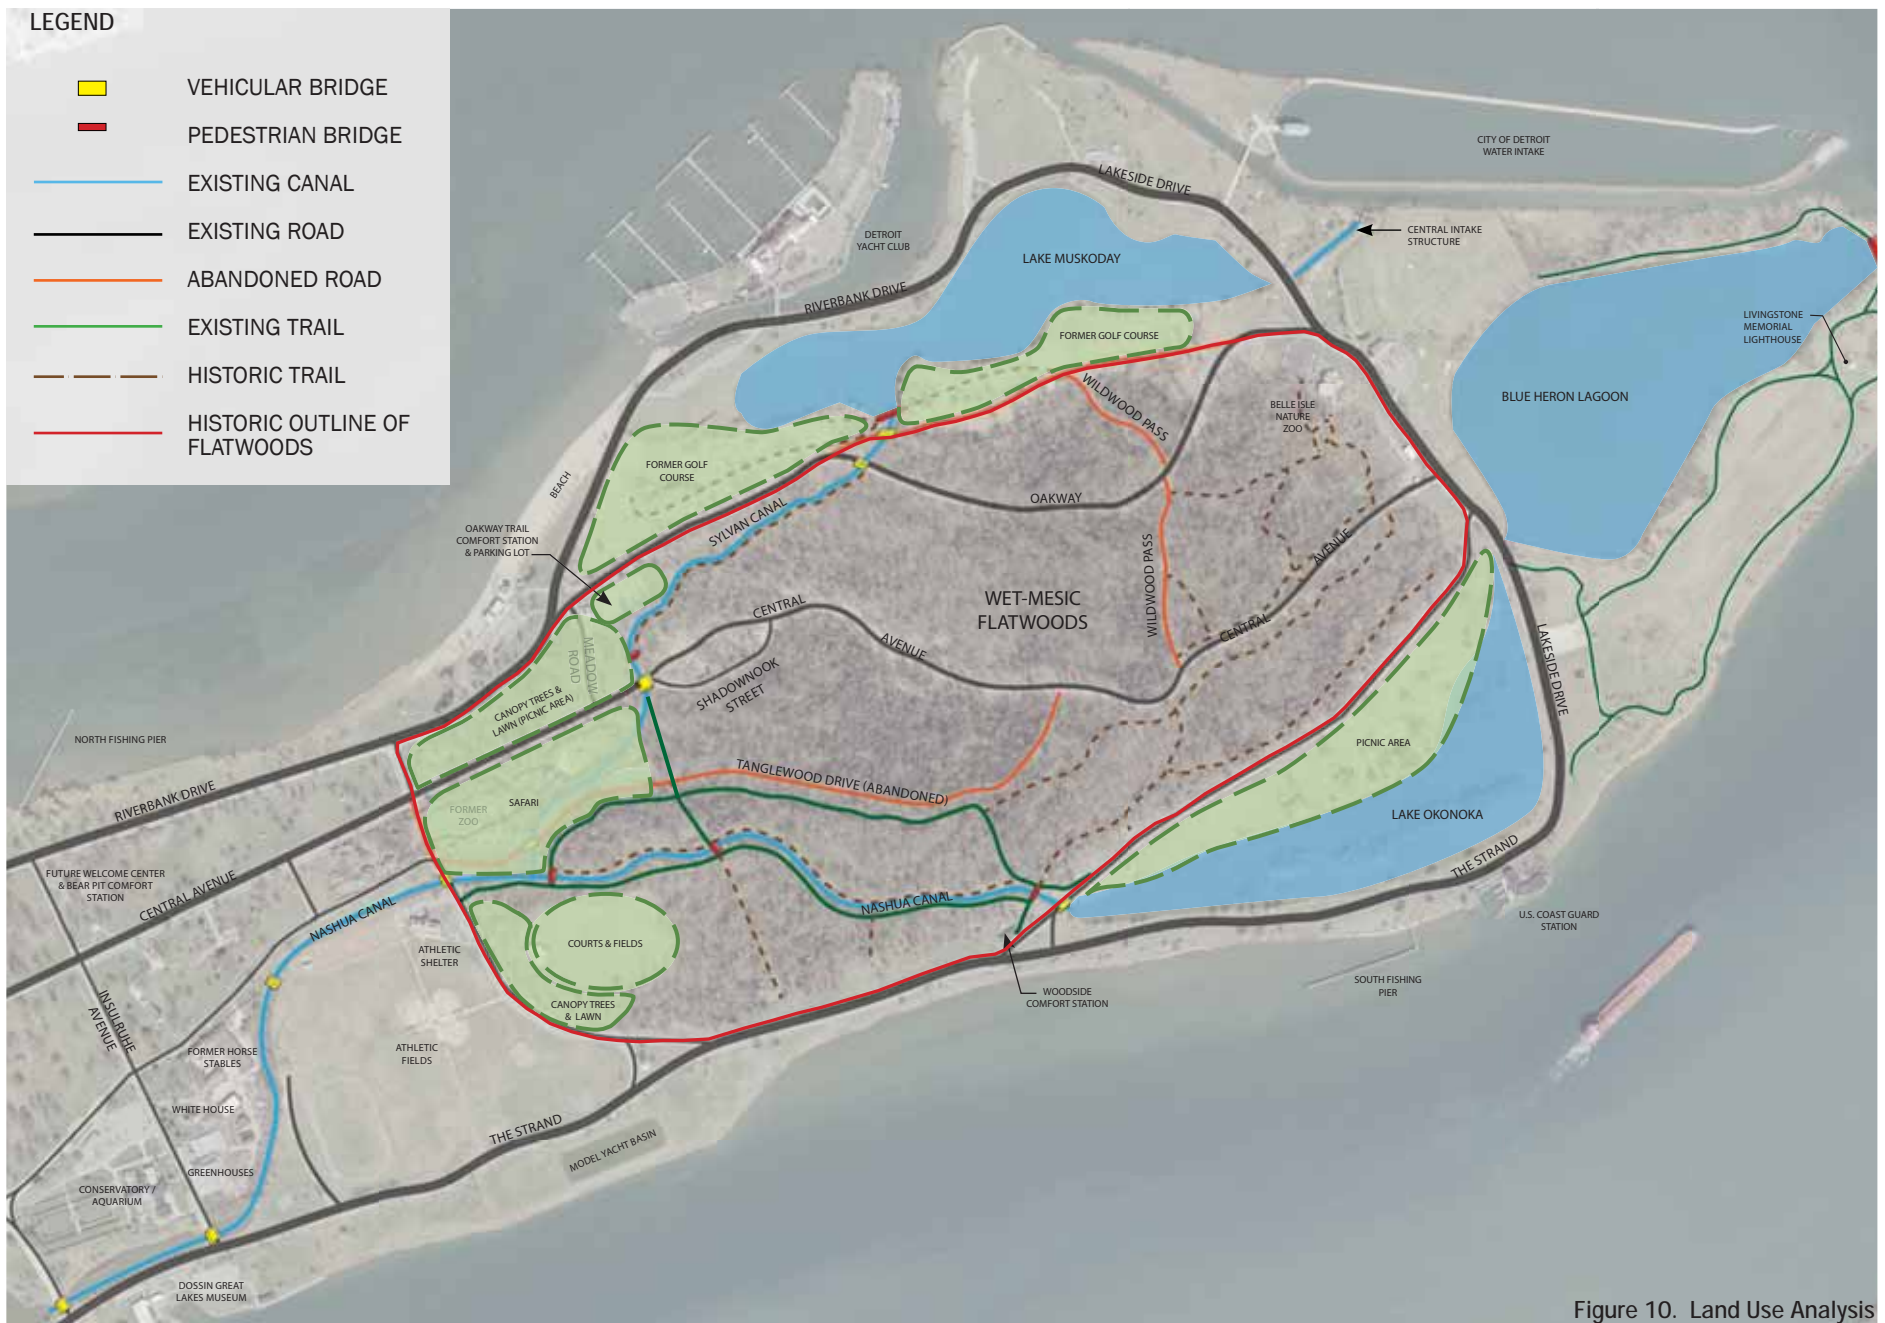
Figure 10. Land Use Analysis

Buildings and structures have been constructed around and within the perimeter of the flatwoods requiring tree removal, filling and cutting and fragmentation (Figure 10).

- **Athletic Courts and Field.** This use contains a concrete handball court, asphalt basketball court and a +/- 7 acre field that is occasionally used for open field recreation. The fill in this location is extensive and exceeds 7 feet in the center. The fill extends nearly to Nashua Canal, creating a linear remnant flatwoods band that contains several large flatwoods trees and good seasonal

ponding. Along the east side of the field extending into the natural areas, the flatwoods is partially degraded and may contain low amounts of fill (less than 1 foot). The tree lined perimeter along Vista Avenue contains several large flatwoods trees and original topography with many wet spots in the spring, but the understory has been replaced with turf. Restoration opportunities exist around the entire perimeter and along Nashua Canal.

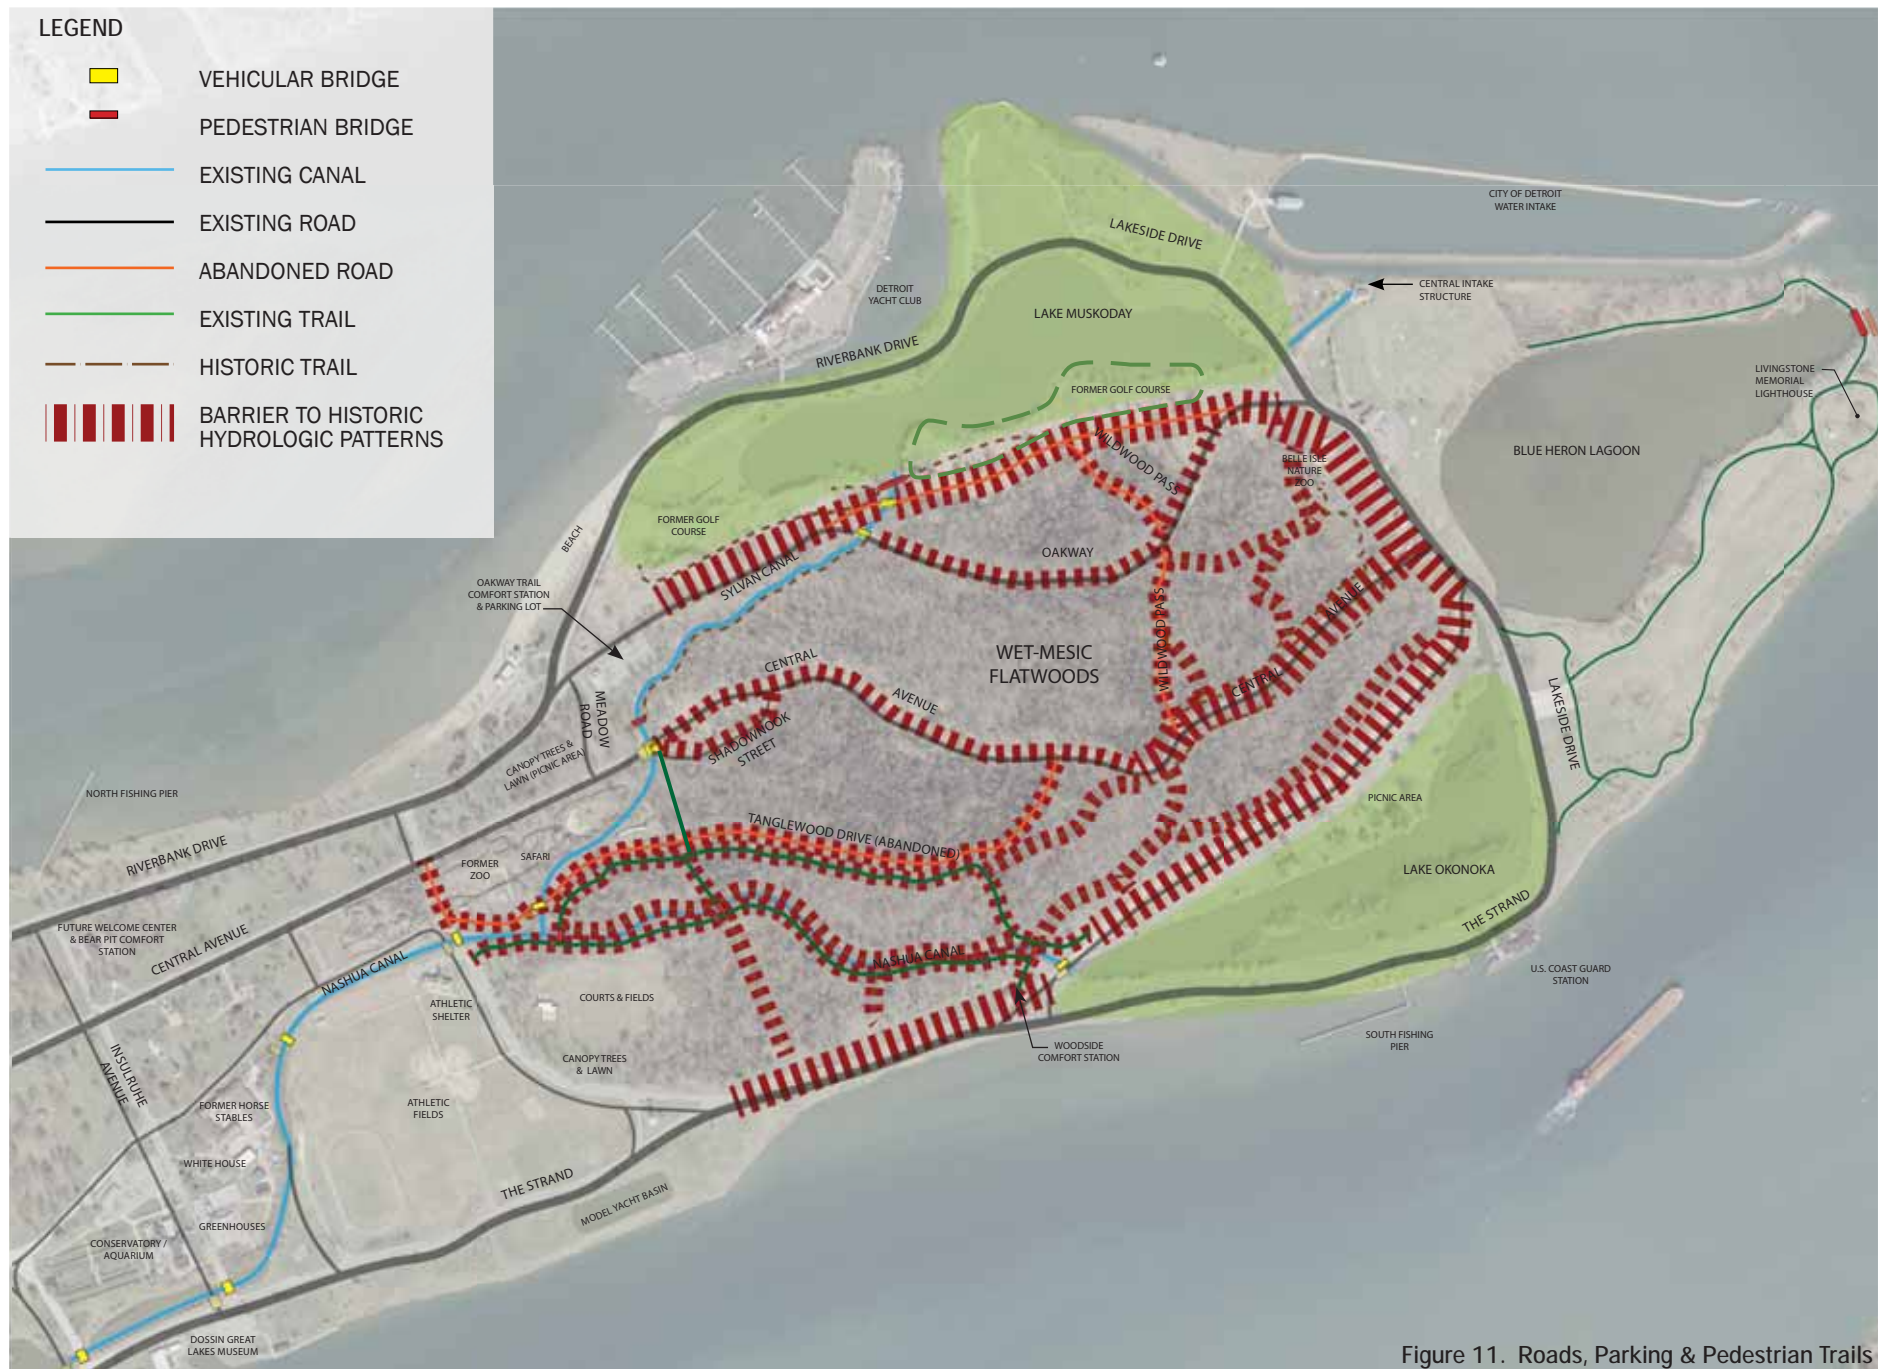
Figure 11. Roads, Parking & Pedestrian Trails

- **Roads, Parking and Pedestrian Trails.** The extensive roads, parking and trail systems extend throughout the flatwoods making this one of the most disruptive uses to the flatwoods hydrology. In almost all instances, these systems have been built on fill with little thought on maintaining pool hydrology and natural drainage patterns (Figure 11). Ditches and culverts were added to the flatwoods in response to the introduction of these features and were previously described above.
- **Roads and Parking.** The perimeter asphalt road system and contiguous parking (The Strand, Lakeside Drive and Riverbank Drive) is an essential use for park users. This system has no direct impacts on the flatwoods hydrology except that they were constructed on fill which removes the Detroit River connectivity to the historic wetland

complexes on the north and south side of the flatwoods. Due to their importance, these roads will remain but may be reduced in width in the future.

The internal asphalt road system (Woodside Drive, Central Avenue, Shadownook Street, abandoned Tanglewood Drive, Wildwood Pass, Oakway Trail and Meadow Road) fragment the flatwoods into cells that block historic drainage patterns and create upland shoulders that have become established with predominantly non-native upland plant species. Wildwood Pass on the north side of Oakway is gated and used by maintenance staff, while the south half has been converted to an active trail. Most of the roads have been constructed on less than 2 feet of fill and during the spring when pool development is greatest, standing water can be observed in several locations on opposite sides of the road providing indications of historic drainage patterns. The numerous, level 4 ditches and equalizer pipes were installed in many of these locations to address drainage but are now mostly non-functional adding to the concerns about pool hydrology and its effects on tree vitality.

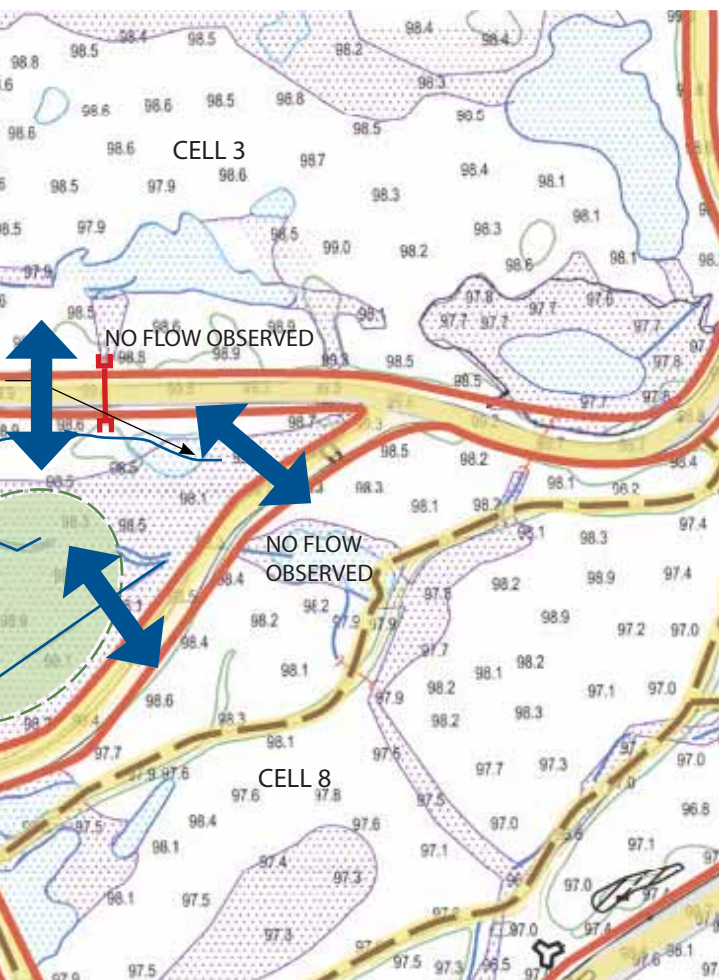
Figure 18. Flatwoods Division - Cell 5

Defined by Central Avenue, the Safari Zoo (closed), Sylvan Canal and Tanglewood Drive (abandoned), Cell 5 encompasses +/- 35 acres including the 1.75 acre portion of the Safari Zoo situated on the west side of the Sylvan Canal (Figure 18).

Cell 5 Restoration Strategies:

- Reduce footprint of Central Avenue to a single-lane or shared-use path including all shoulder fill (below contour elevation +/- 99.0), or remove in its entirety, creating surface water connectivity to Cell 3. If allowed to remain, consider the installation of boardwalk sections in the road to allow conveyance of surface water between cells (four locations).

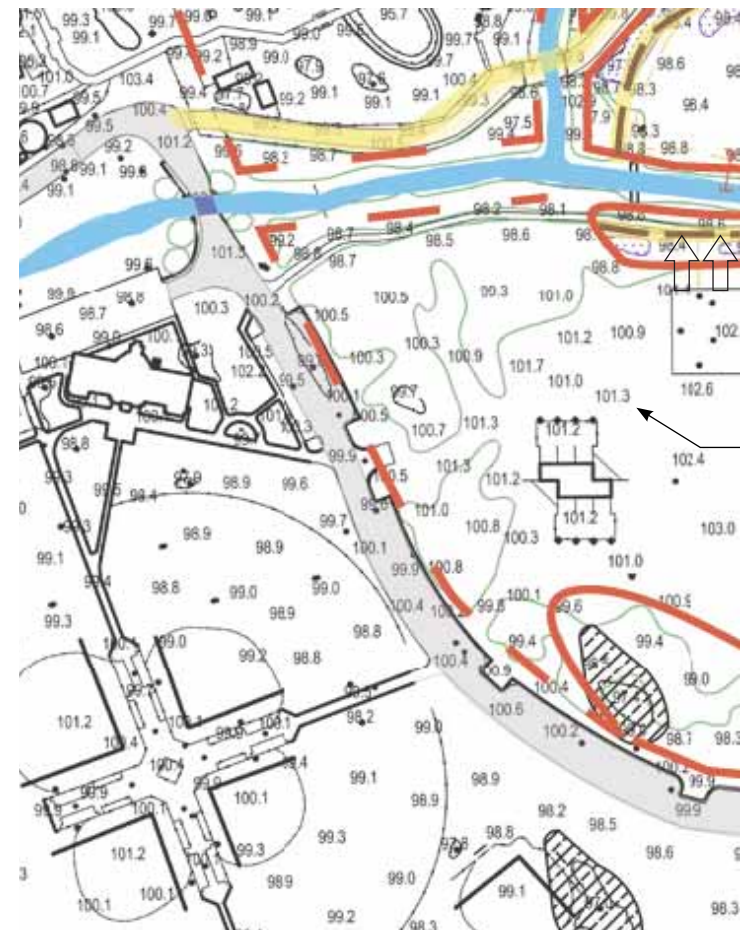
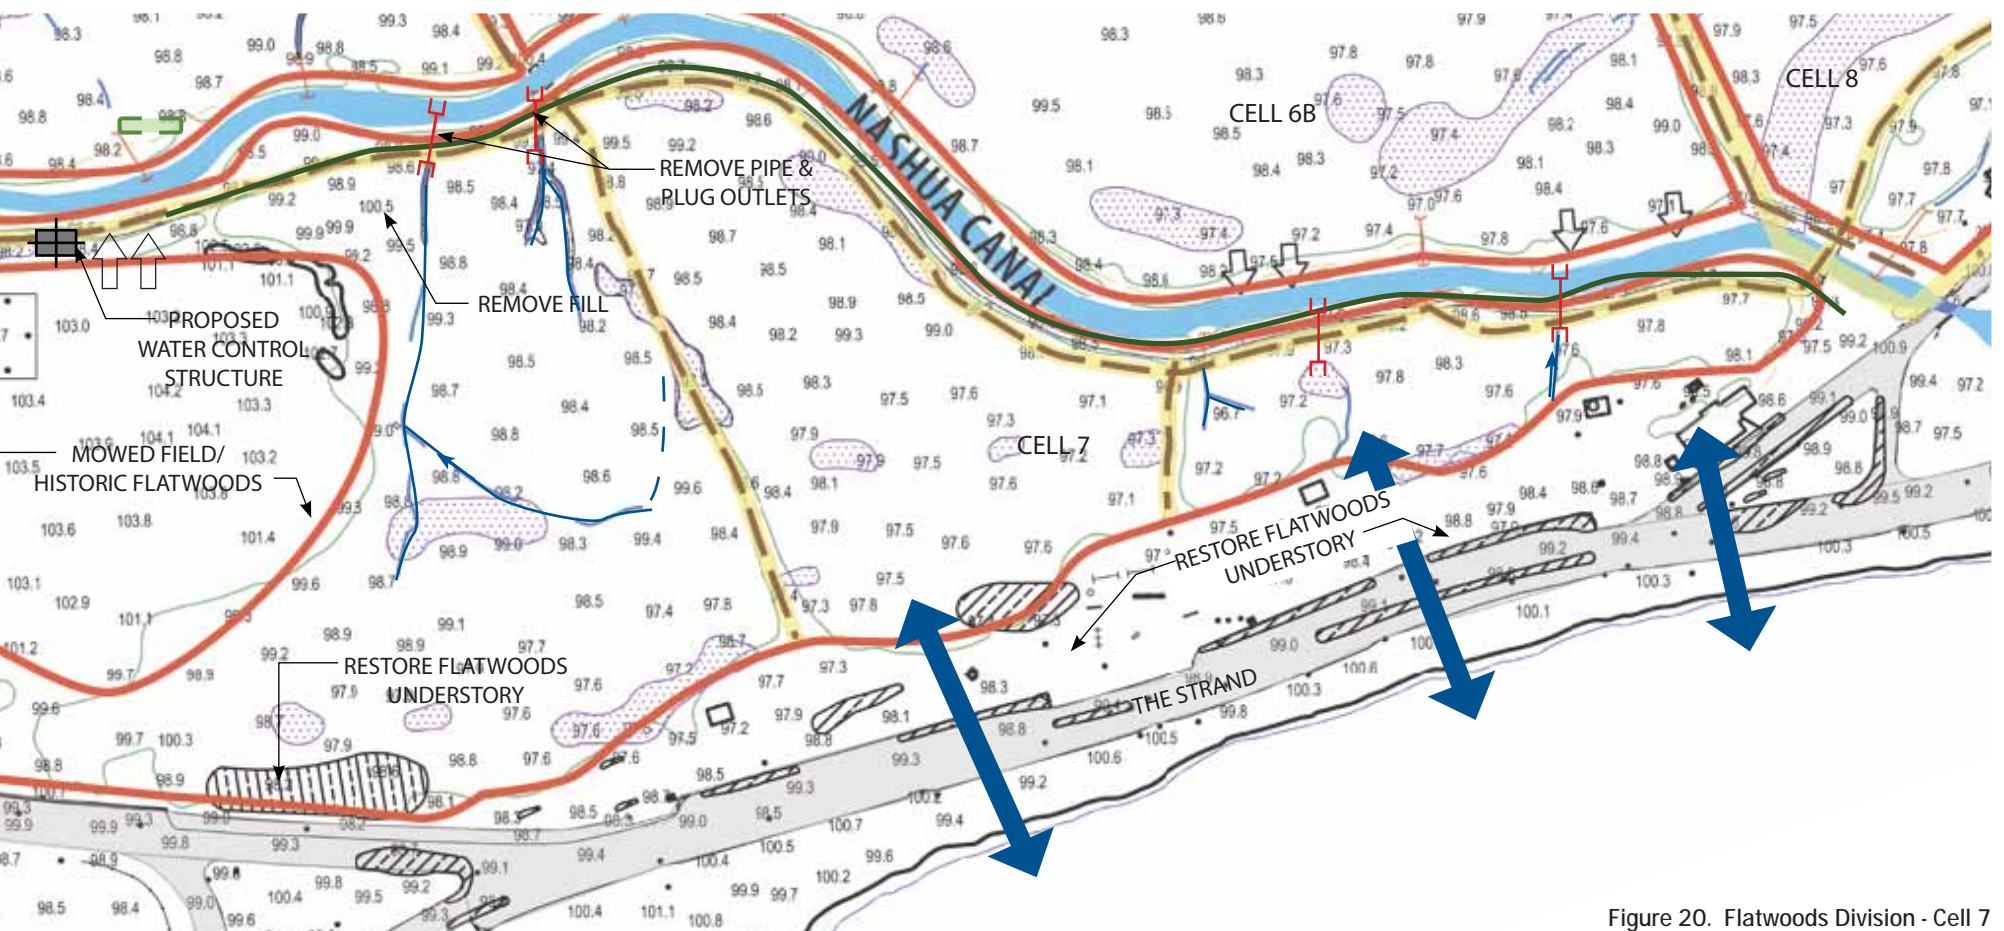
Figure 20. Flatwoods Division - Cell 7

Defined by Nashua Canal, Vista Drive and adjacent open field/basketball courts, The Strand and a small segment of Woodside Drive, Cell 7 encompasses +/- 26 acres (Figure 20). Historically, this cell was +/- 11 acres larger, extending west to Vista Drive and south to the edge of The Strand (now used as an open field, basketball and handball courts). In this location, up to 6 feet of fill has been placed over a +/- 7 acre footprint with the remaining perimeter closely following historic grades, except it is now lawn under tree canopy.

restore historical drainage patterns to the Detroit River.

- Consider restoration of this cell to extend to Vista Drive to follow its original boundary. This will require the removal of a large amount of fill, the basketball courts and the handball court. At a minimum, consider flatwoods understory restoration around the perimeter of this fill to historical west limits (Vista Drive).
- Remove surplus fill placed in flatwoods at northeast corner of mowed field and fill area.
- Between basketball court and Nashua Canal, widen natural areas as much as possible (+/- 100 feet) and install at least one water control structure to maintain linear pools.
