INSTITUTE FOR FISHERIES RESEARCH

Report No. 1089

Installation of a portable two-way fish weir in the outlet
from Birch Lake (T. 7S., R. 13W.), Cass County

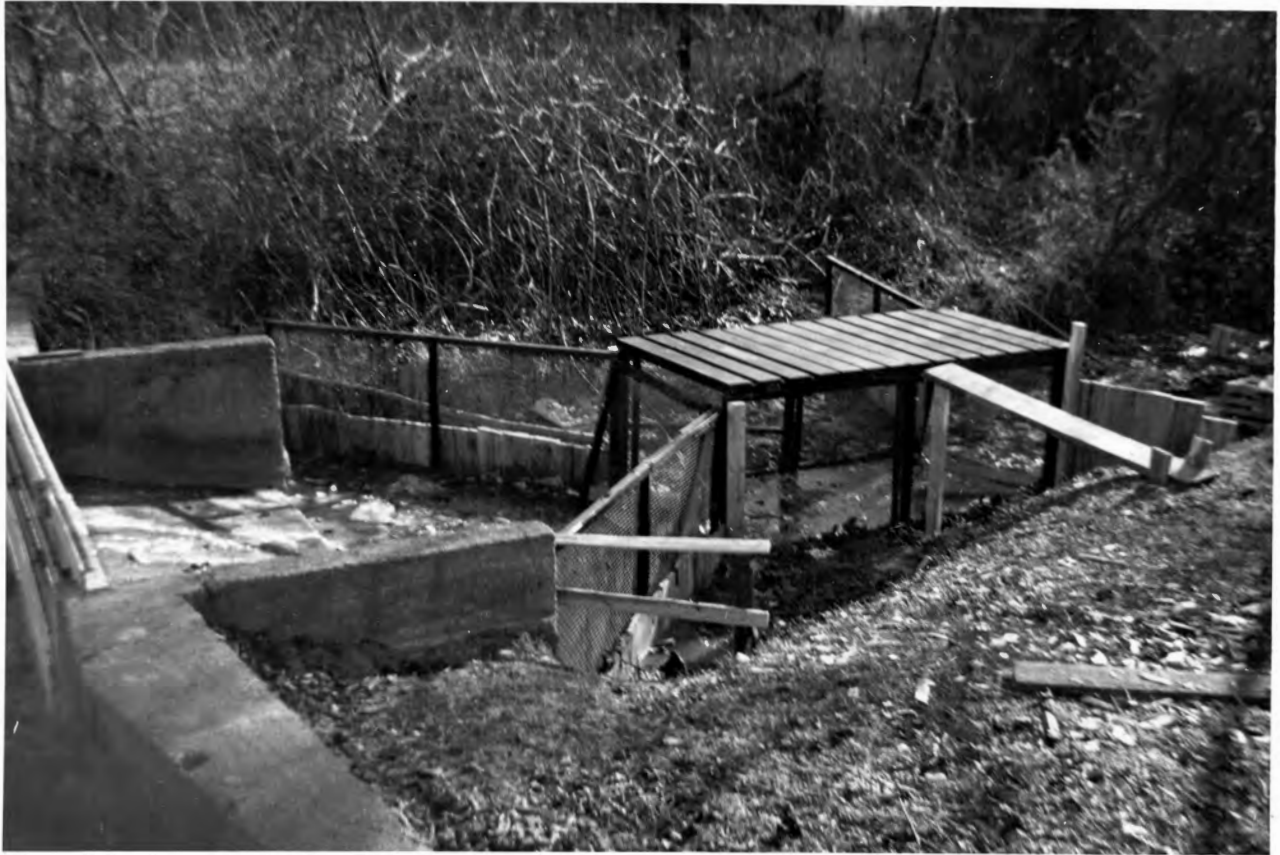
Figure 1.--The weir at Birch Lake just after its installation had been completed and before water was allowed to spill over the concrete dam.

The trap was set in mid-stream, with the upstream end about 6 feet below the base of the apron of the dam (See photo, Figure 1). It was anchored by driving 3" x 3" timbers into the ground at each corner and connecting these to the framework with lag screws. Wings were set on both upstream sides, extending from the corners of the trap to the abutments of the dam, each at a 30° angle with the bank. On the downstream end a wing was set on the left corner, and was run into the left bank. A wire wing was not used on the right corner; instead, a short wing of sheet piling was provided here. The tongue-and-groove boards were driven into the ground about 2 feet and were allowed to extend above the bottom about 3 feet. The downstream wings were set nearly perpendicular (at about an 80° angle) to the banks.
