REPORT NO. 910

DISINFECTION OF THE SPRING SUPPLY PONDS AND
RACEWAYS AT STATE FISH HATCHERY, ODEN, MICHIGAN

Leonard N. Allison
Fish Pathologist

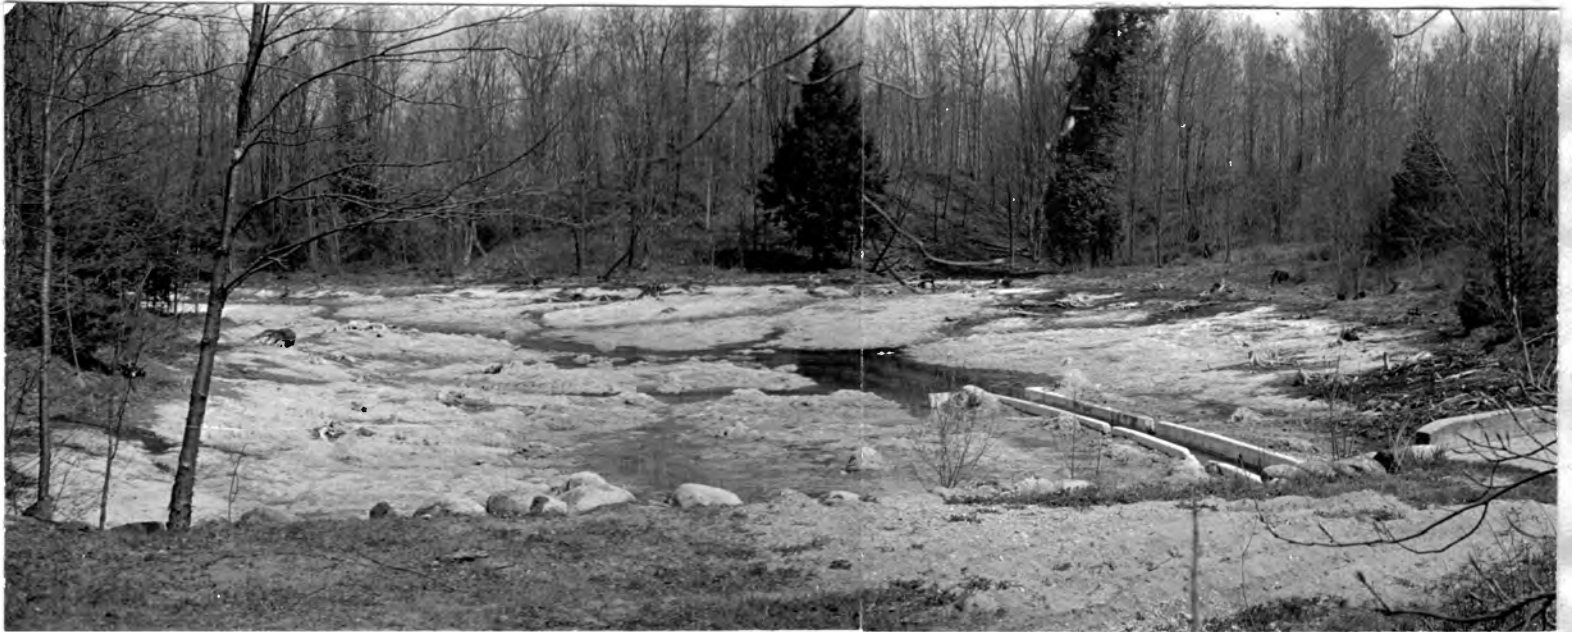
Figure 1. Spring Pond B.

The spring supply ponds were treated first. Several weeks prior to the treatment these ponds had been drained down and allowed to stand (Figure 1). Immediately preceding the treatment the outlets of the ponds were closed and the ponds were filled approximately one-quarter full.

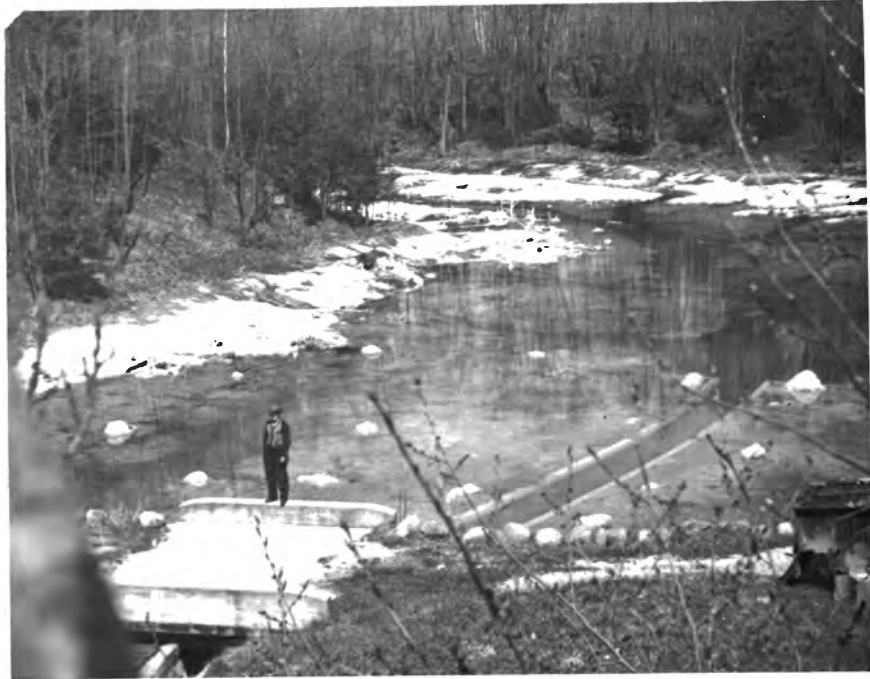
Figure 2. Spring Pond B.

The sides of the ponds were kept thoroughly soaked for a least half an hour with the chlorine solution pumped from the pond. A pumping unit from the planting truck was mounted on a boat and propelled around the pond (Figure 2). The solution was spread by two garden hoses which were attached to the pumping unit.

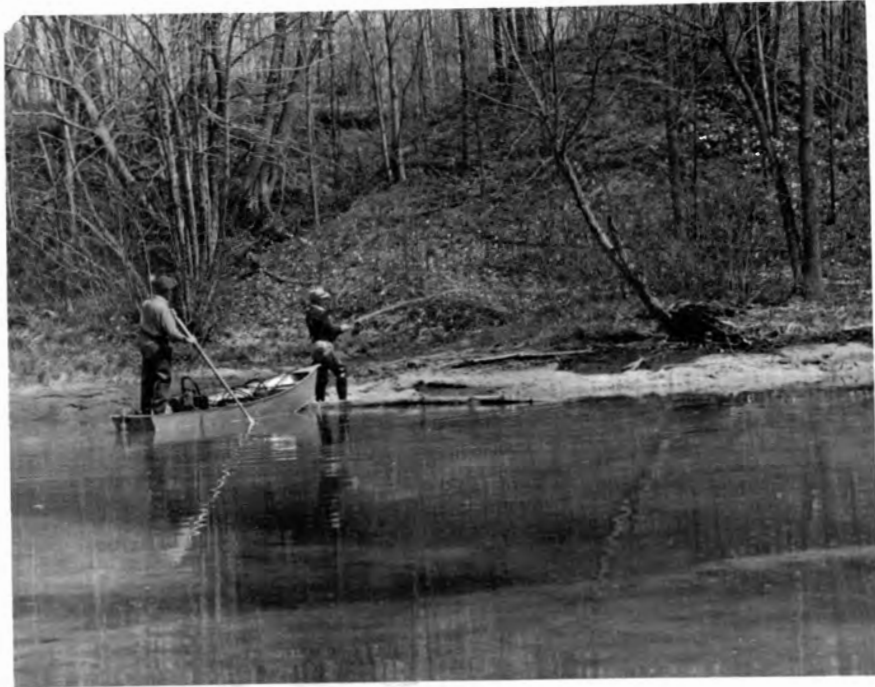
The raceways (Nos. 2, 3, 4, 5, 6) and the waste ditch from spring pond B to their union with the A series were disinfected the same day that the spring ponds were treated. The neutralizer was administered to the waste ditch at its junction with the waste ditch of the A series (Figure 3).

Figure 3. Spraying sides of Pond B

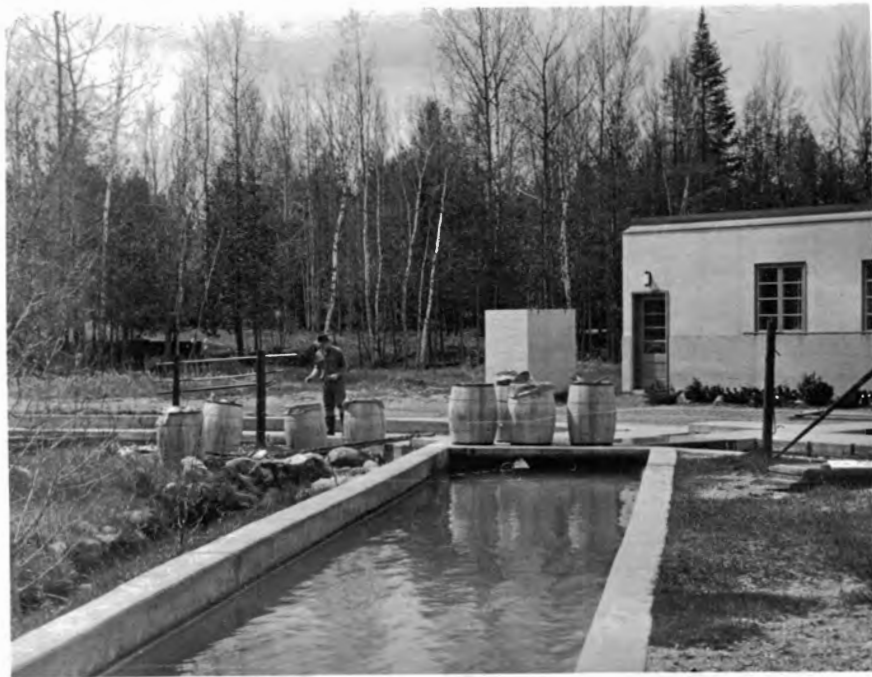
On the following day the series of raceways from spring pond A and Little A were disinfected, neutralizer being administered at the end of the waste ditch of this series (Figure 4). The disinfection of the raceways progressed in the direction of the flow of water.

Figure 4. Administering neutralizer at each end of B raceway series.

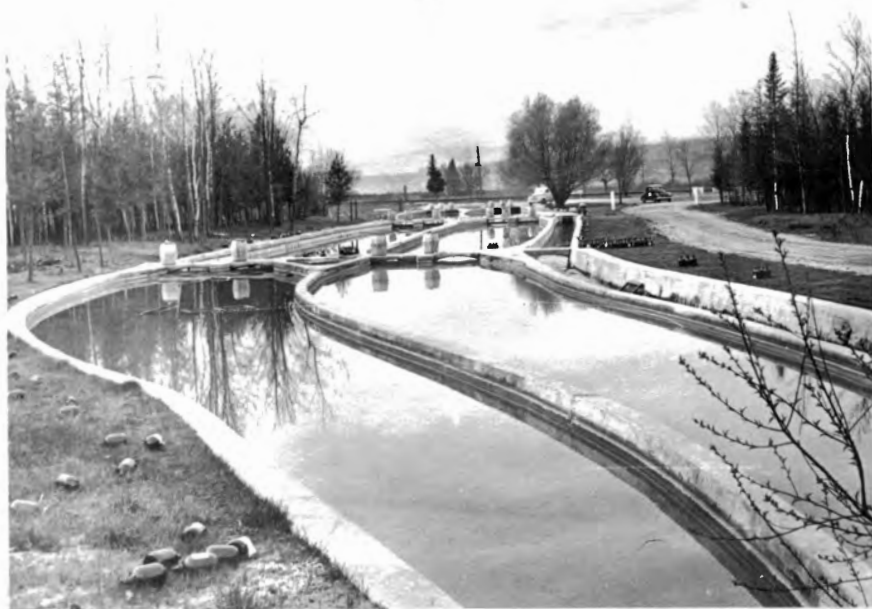
Figure 5. Raceways 19, 20, 21, 22, 23, 24 of A series after treatment.

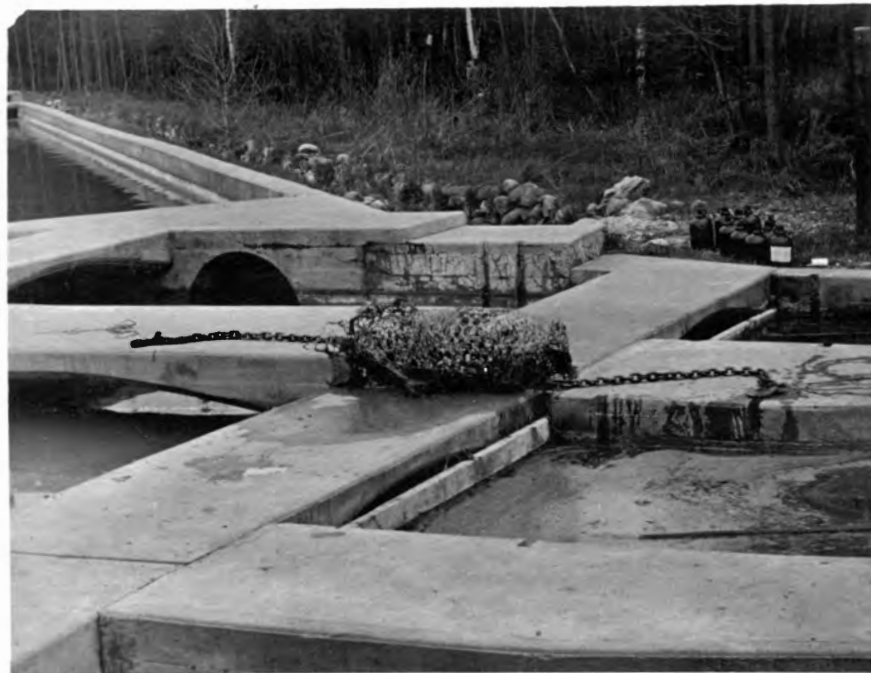
After the 15X Klensade was introduced into each raceway, a roll of chicken wire, weighted by a length of heavy chain was (Figure 6) drawn along the bottom a number of times (Figure 7). This turned over the gravel on the bottom of the pond to assure complete penetration of the chlorine

Figure 6. Roll of chicken wire and heavy chain for agitation of bottom of raceways.

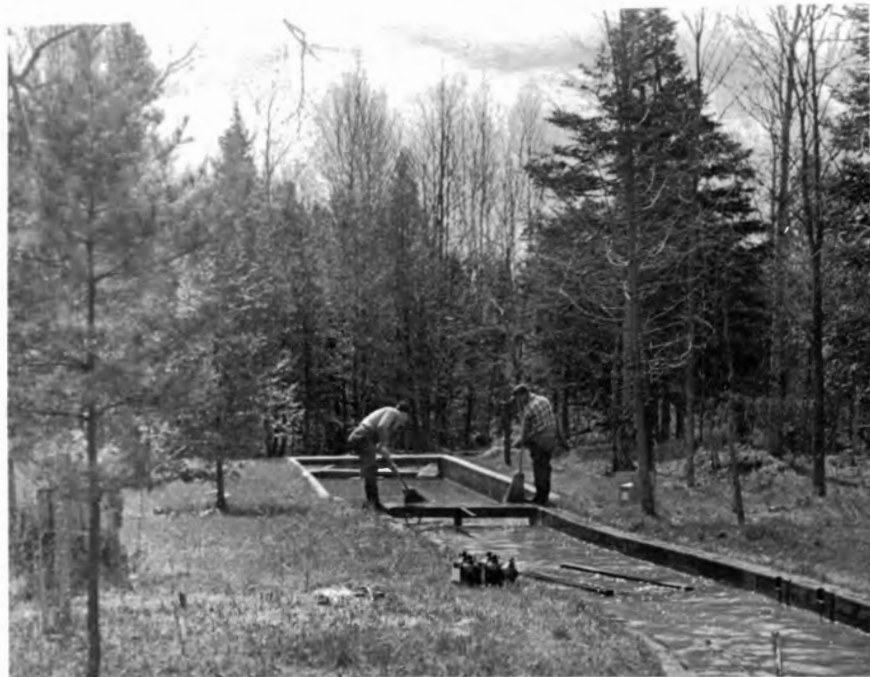
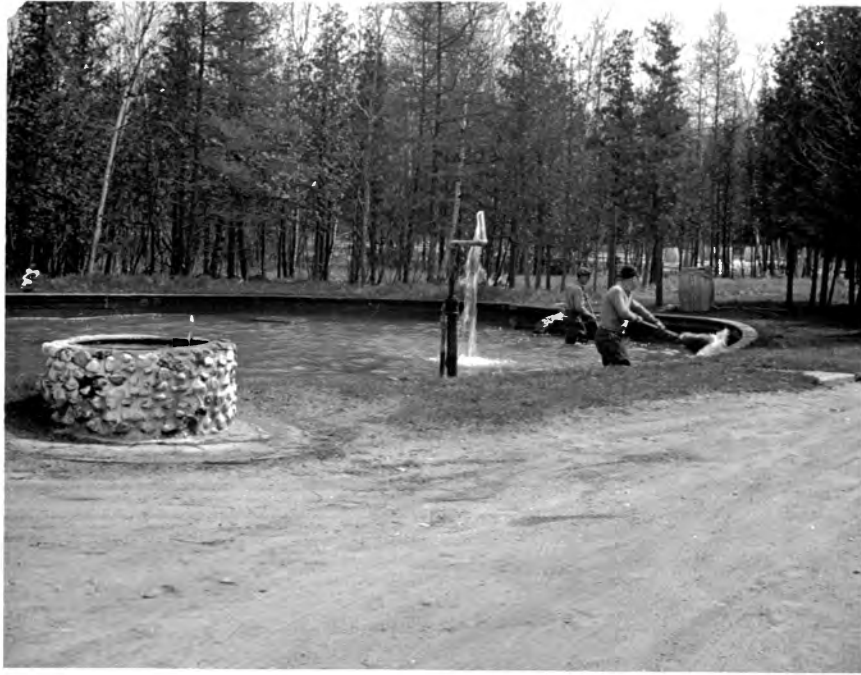
and also served to thoroughly mix the solution. The sides of each raceway which were above the waterline were kept wet for at least one-half hour by scrubbing with brooms (Figures 8 and 9).

Figure 8. Scrubbing sides of treated raceways.

Figure 9. Scrubbing sides of treated raceways.

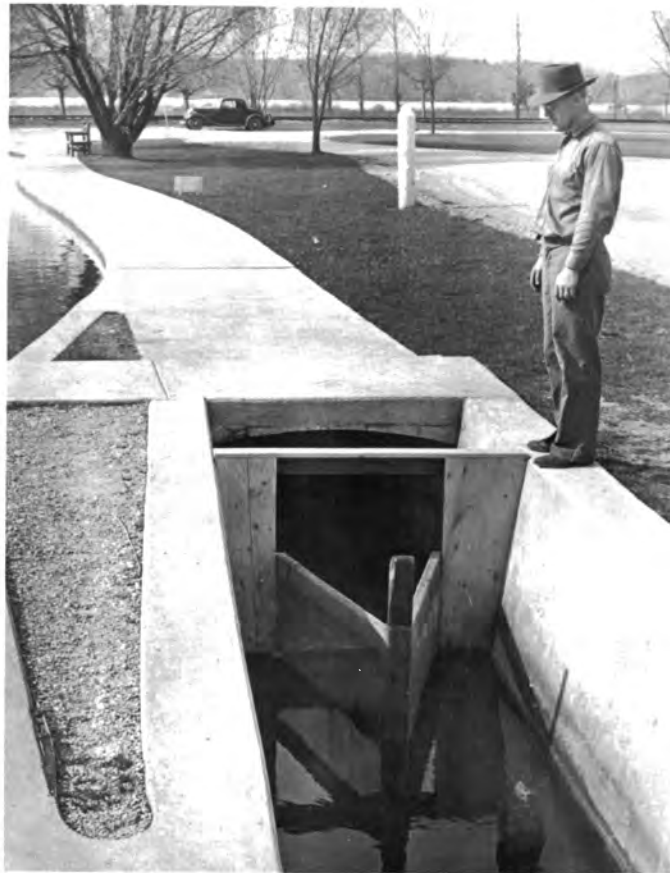
To prevent the migration of fish from Crooked Lake into the waste of ditches of the hatchery, a screen was installed at the lower end of the waste ditch (Figure 10. After this photograph was taken the top of the screen was covered to prevent fish from jumping over it.)

Figure 10. Screen at end of waste ditch.
The top was covered after the photo
was taken to prevent fish from
jumping over the screen.

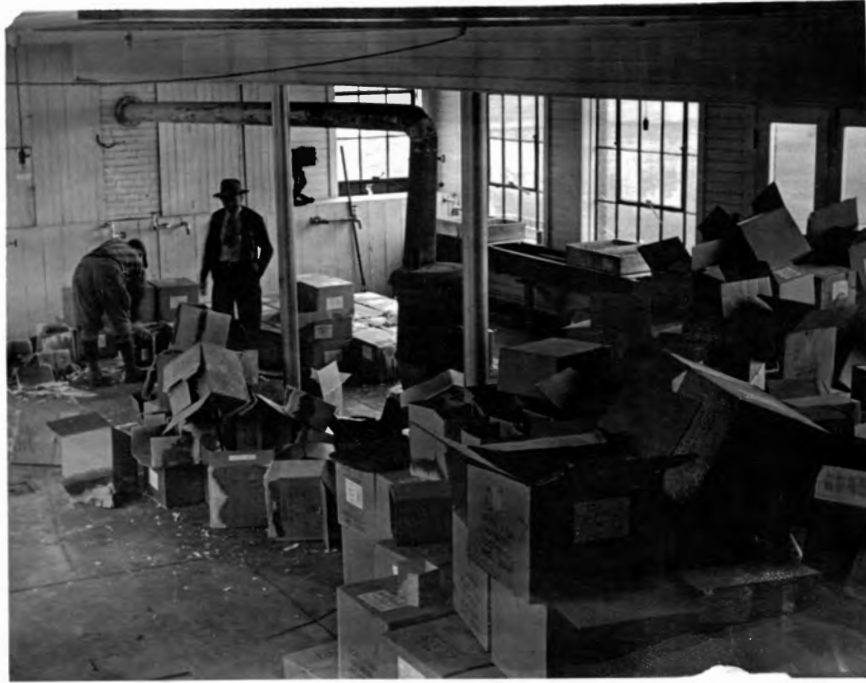
The use of a disinfecting solution packaged in one gallon glass jugs proved to be rather inefficient because of the fragility and great number of glass jugs to be handled (Figure 11). A disinfectant in powder form should be investigated for similar work in the future.

Figure 11. Debris accumulates in handling
2000 one-gallon jugs.
